Docket No. W-1333, Sub 0
Docket No. W-1130, Sub 11

BEFORE THE NORTH CAROLINA UTILITIES COMMISSION

REBUTTAL TESTIMONY
OF
MICHAEL J. MYERS
SECRETARY OF CURRITUCK WATER & SEWER, LLC
March 31, 2022

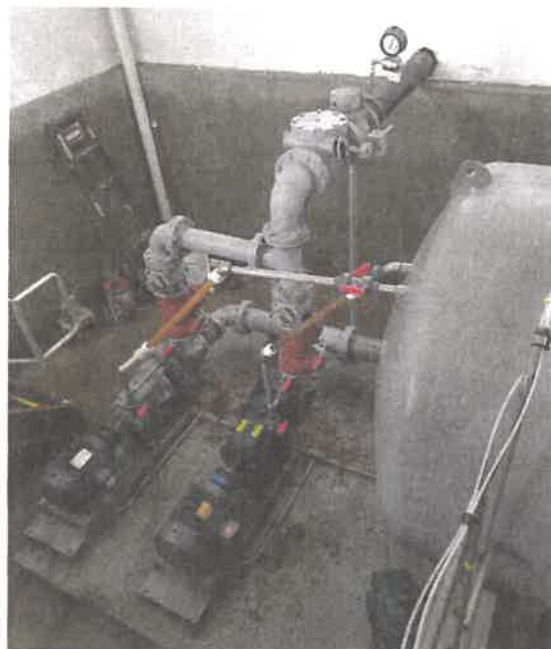
Inside the vacuum sewer receiving station building is the main vacuum tank. There is a robust coat of gray paint on the tank exterior, however, it had been recently reported the interior is in poor condition. The Engineer was not able to verify this. What was observed was an extremely messy and cruddy vacuum tank pit with water, sewage and oil on the floor, old broken and worn-out parts, rusty pipes and pump platforms, broken ladders, and loose wires.

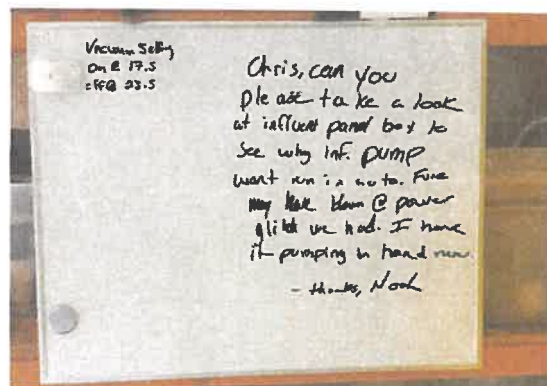
Mounted on wooden shelves on the main floor level of the vacuum sewer receiving station building is a white board for operator instructions, comments and communications. On the white board the lead operator left instructions to an assistant operator as follows: "Chris, can

you please take a look at influent panel box to see why the influent pump won't run in auto. Fuse may have blown @ power glitch we had. I have it pumping in hand now. Thanks, Noah."

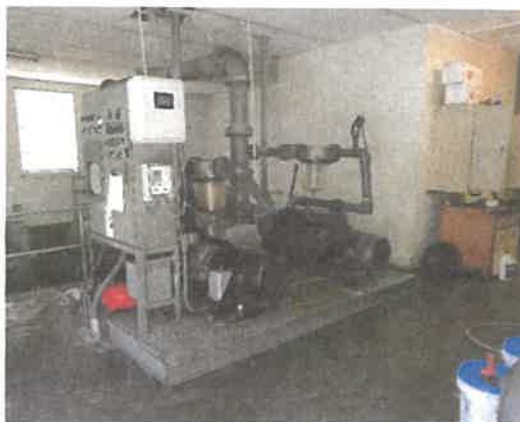
The vacuum pumps are located on the main floor of the vacuum sewer receiving building. The vacuum pumps are mismatched and one of the motors is scuffed. The pump platform is rusted, and loose and uncapped wires are strewn about. Oil and water are on the floor.

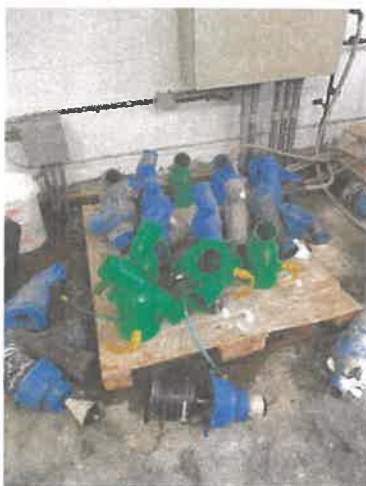
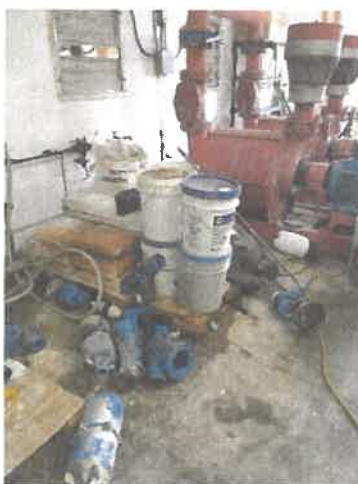
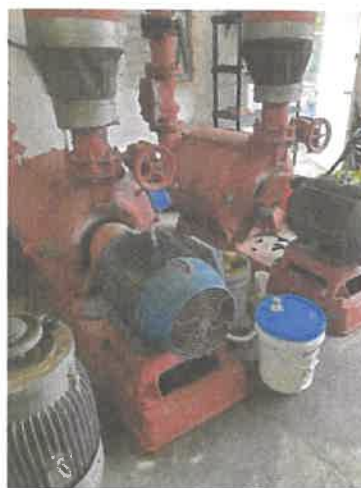
The main room in the vacuum sewer receiving station houses the electrical controls, the aeration blowers for the wastewater treatment plant, spare chemicals, vacuum sewer valve pit spare parts, the ultraviolet disinfection lights, and two cabinets for small parts. The condition of the room and equipment is trashy. There are buckets of unknown fluids lying around, there is a spare blower motor which may or may not be operable. Chemical bags are torn open and improperly stored. There is water on the floor. The spare vacuum valve pit assemblies are strewn in a heap, and it is unknown if any are operable or not.

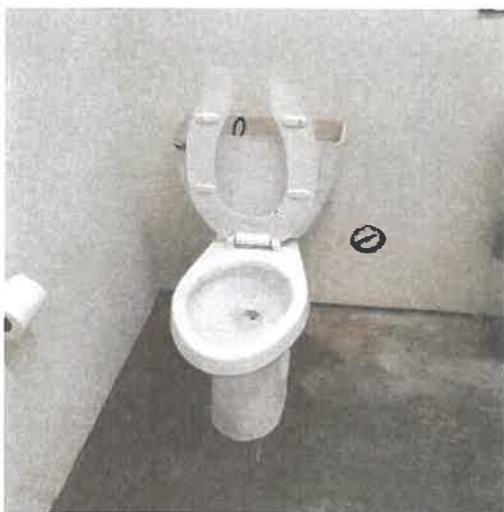
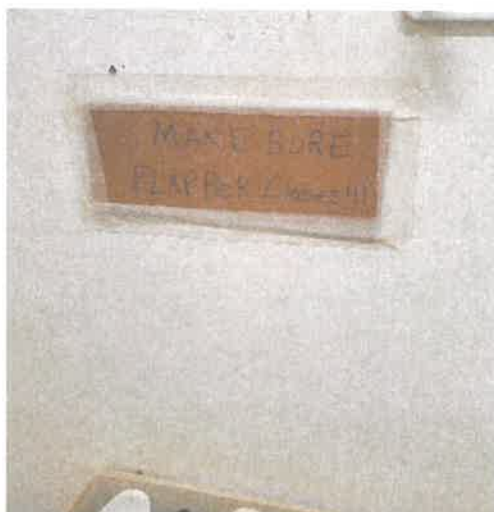
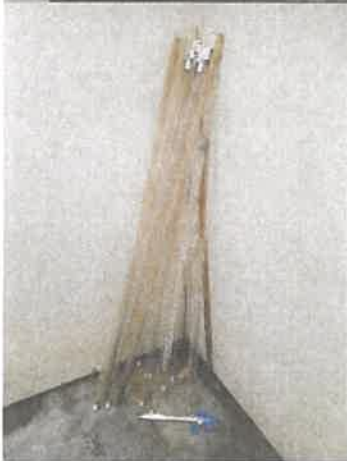
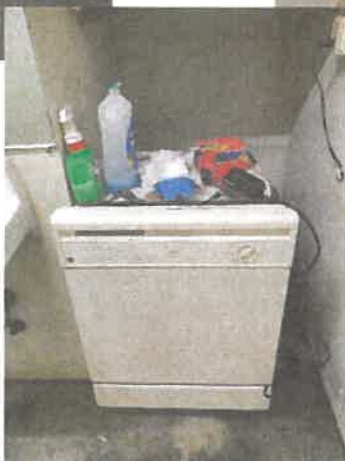
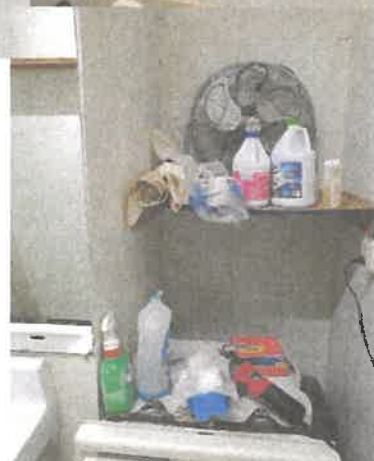
The bathroom is as dilapidated as the vacuum sewer tank pit area and main vacuum building blower and vacuum pump operating room. There is water on the floor. The toilet doesn't work properly and there is a sign on the wall above which says, "Make sure flapper closes." Spent and broken ultraviolet light tubes are stacked in one corner. For some reason there is a disconnected dishwasher in the bathroom that has junk lying on top of it. There is a spare blower motor placed behind the dishwasher. Above the dishwasher is a shelf with junk and a fan that doesn't work and a roll of original construction drawings that is old and so washed out that it is unreadable.

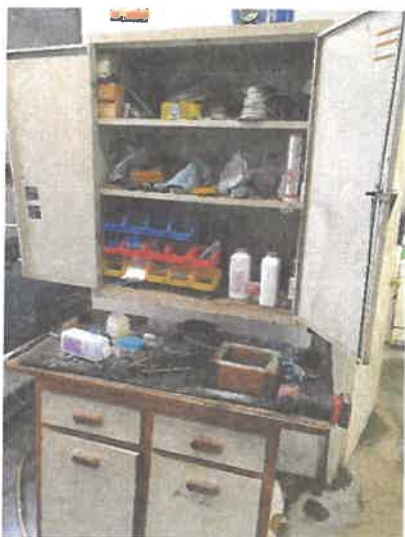
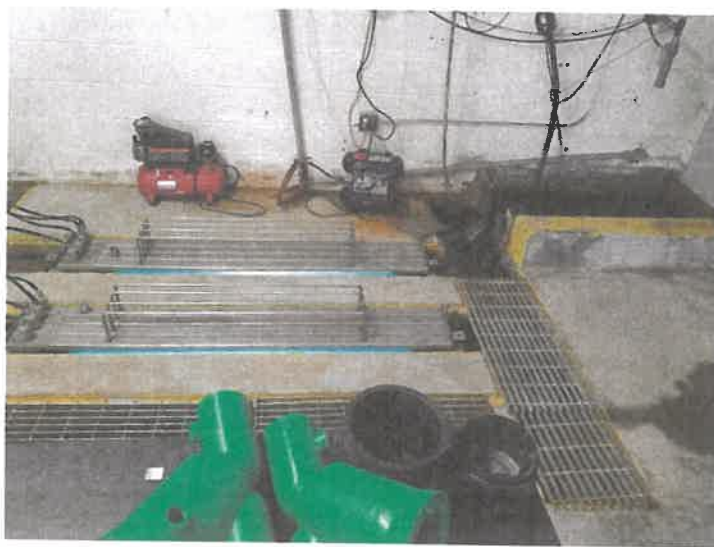
Also located in the main room in the vacuum sewer receiving station are two small cabinets and the ultraviolet disinfection lamps. The cabinets have oily junk stacked on them and the cabinet doors hang open. The ultraviolet lamp area has unsecured electrical equipment and wires strewn around in the wet environment.

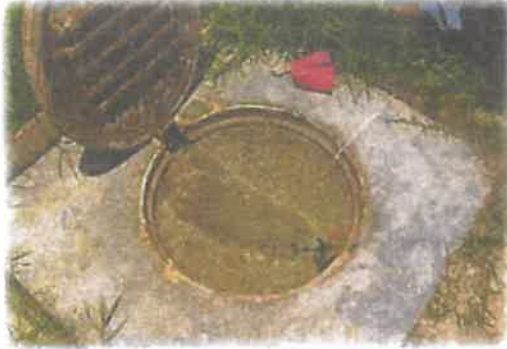
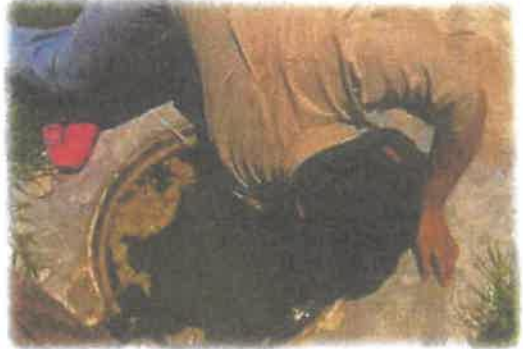
View of an Airvac Collector Tank in operation, general condition of the upper chambers.

¿ The collecting tanks, their rims and covers presented structural damage from the beginning, by not considering the damage caused by the high salinity in the environment and soil.

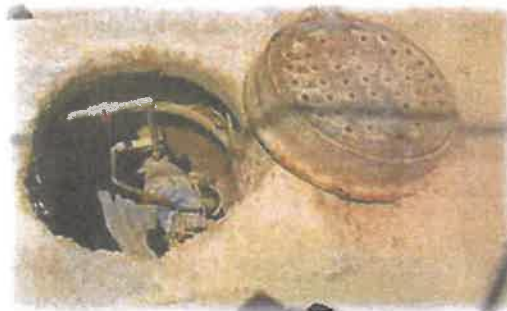
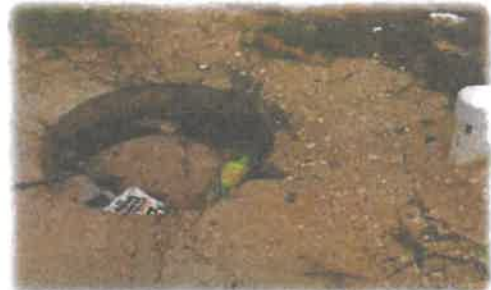
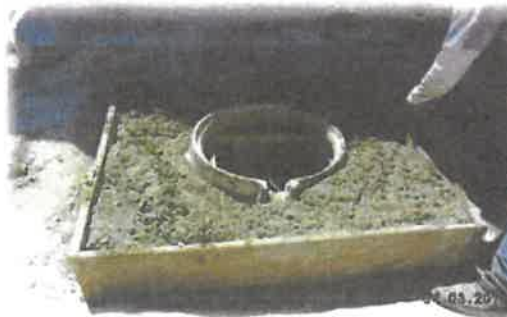
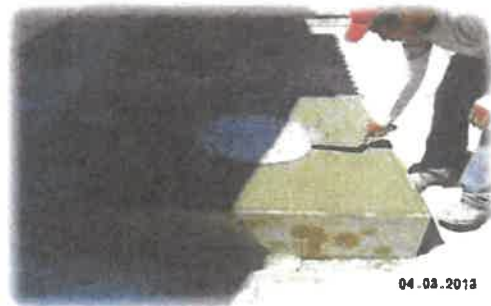
04.03.2013

65 of the 85 collector tanks presented failures in the 12 years of operation, most of them have already been repaired with their own resources, it was started by the most critical ones such as those observed.

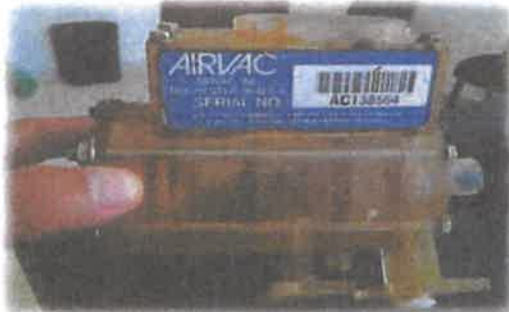
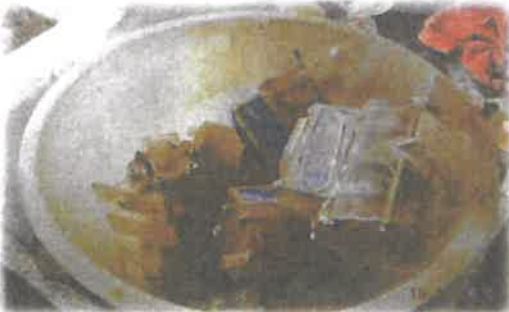
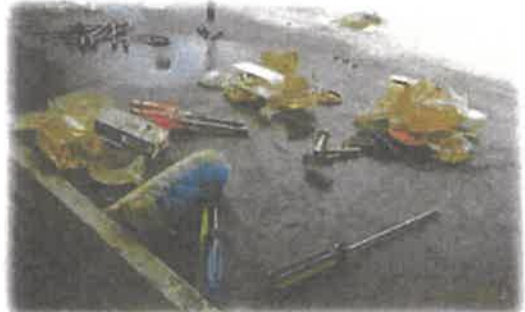
In addition to this lack of spare parts, we must consider the two complementary elements that make these tanks work properly, which are the vents of the Airvac valves and the gravity lines that frequently suffer damage that affects their correct operation.

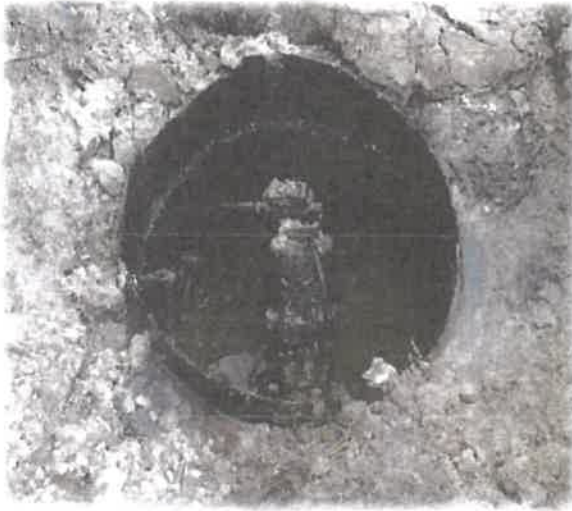
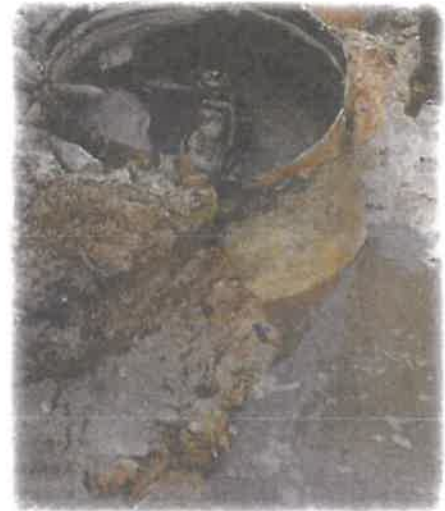
Airvac collector tank in poor condition, with serious leaks of sewage into the subsoil and water table.
