Chapel Hill, NC, Stoneridge Subdivision (flooded drive complaint)

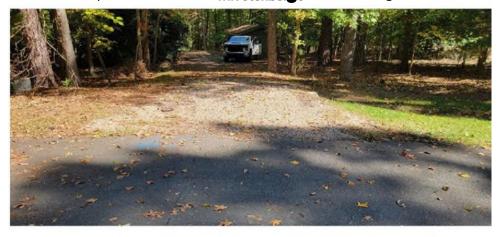
Aqua Drive on left and Mr. Stanbards drive to the right

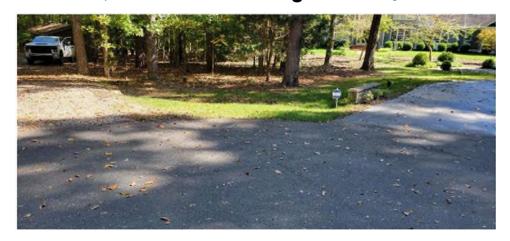
Aqua drive on left and **Mr. Stanbars**'s drive to the right

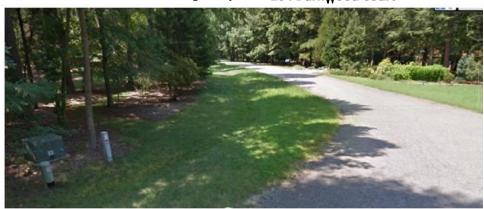
Street ditch facing away from 200 Duranteed Con
