Public Staff Late Filed Exhibit 2

Attachments to Company's Response to  
Public Staff Data Request 3-5 - Bremo

RE: Follow-up to pH incident at Dominion – Bremo Power Station

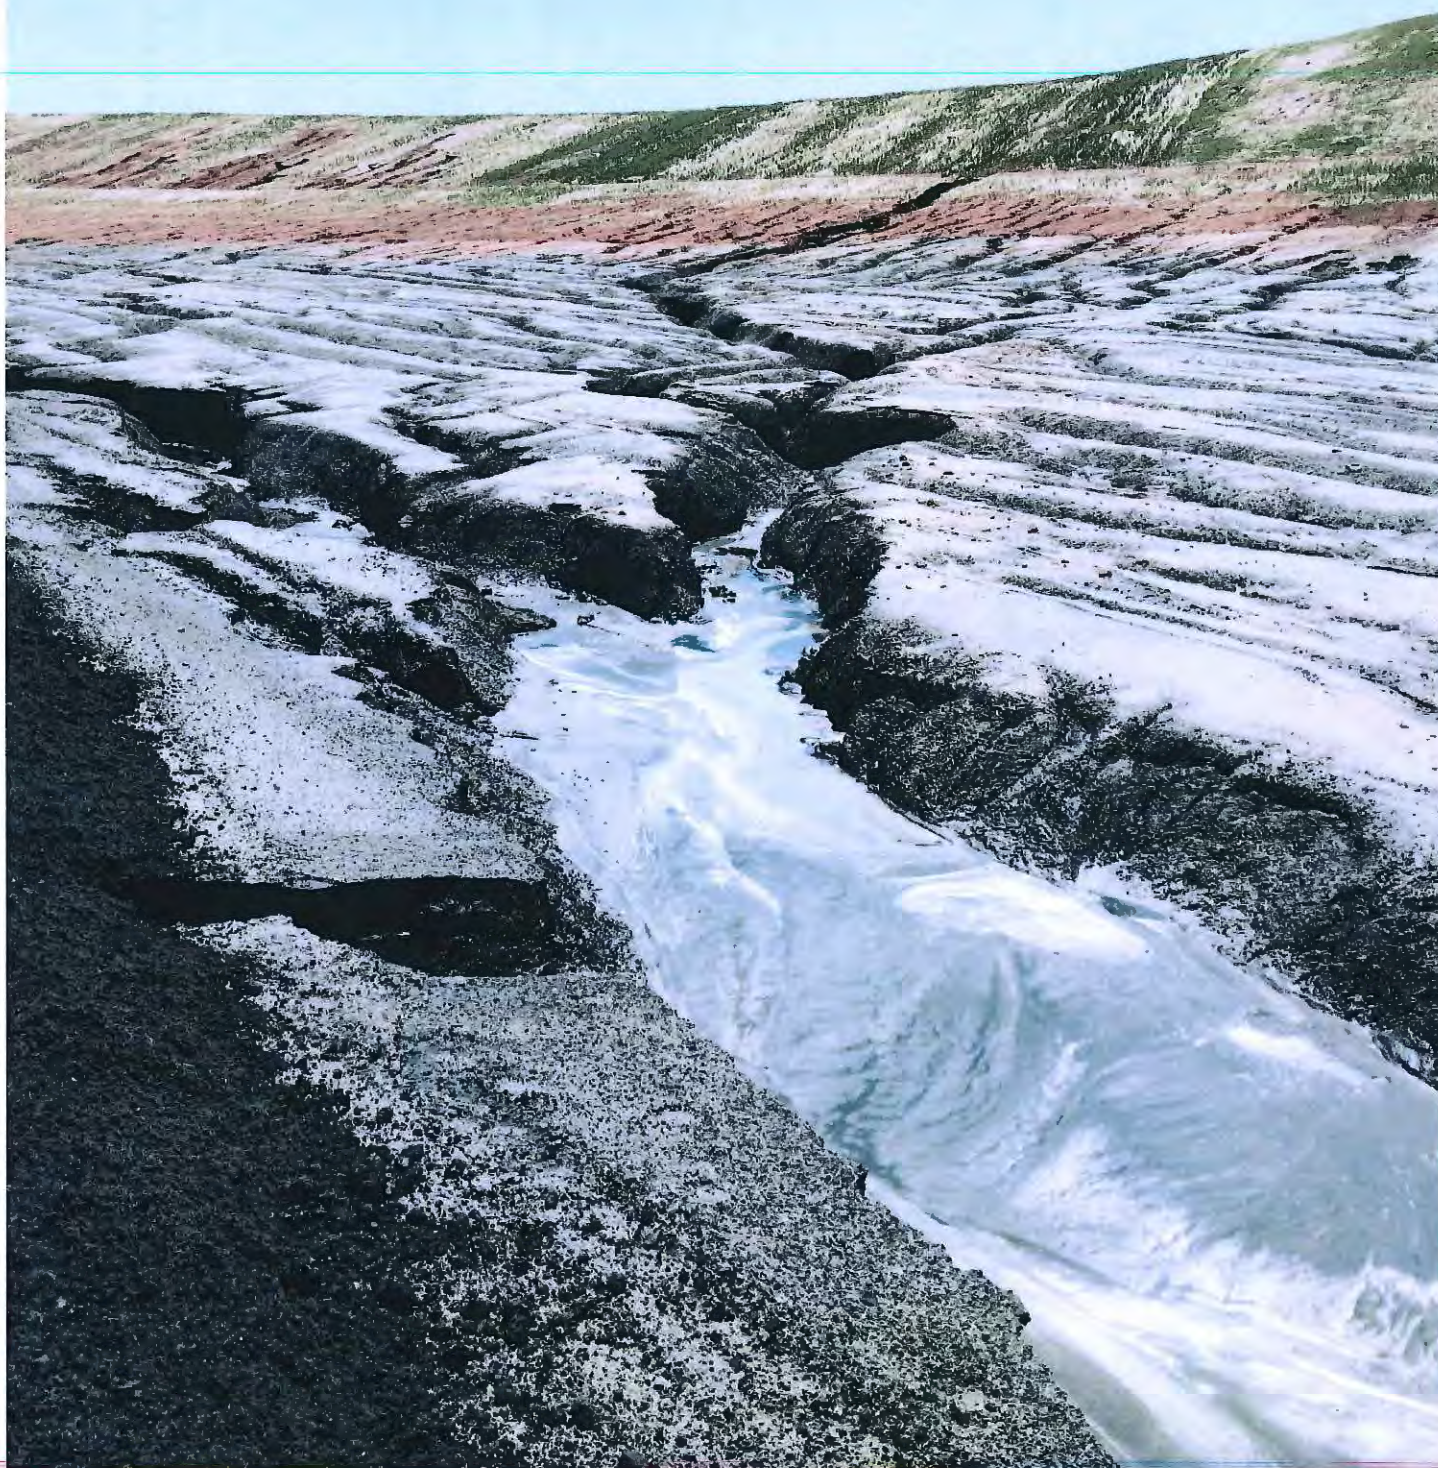
**PHOTO 1: Dominion - Clover Power Station Landfill**  
**View of erosion rill formed during May 15-16 rainfall event.**  
**Note: Depth of rill in foreground estimated at 12 inches.**

Prior to the telephone notification, 4.05" to 4.7" of rainfall was measured within a twelve-hour period. The heavy rainfall event caused the formation of two erosion rills on the recently reconstructed interphase slope where vegetation is not yet fully established and were deep enough to cut into the underlying ash layer. In addition, several areas of small rills occurred on the active area of the landfill's slopes. Backfilling and compaction activities on the two larger rills, along with a compaction test verification were completed May 21<sup>st</sup> afternoon and a dirt cover was reestablished the morning of May 22<sup>nd</sup>. The other smaller rills were also repaired by the close of business on May 21. Reseeding and mulching of all repaired areas is scheduled for May 27<sup>th</sup>. Reseeding will include the addition of grass matting in the areas of slope erosion. The benches in those areas will be reinforced with additional riprap to reduce the potential for erosion concerns.

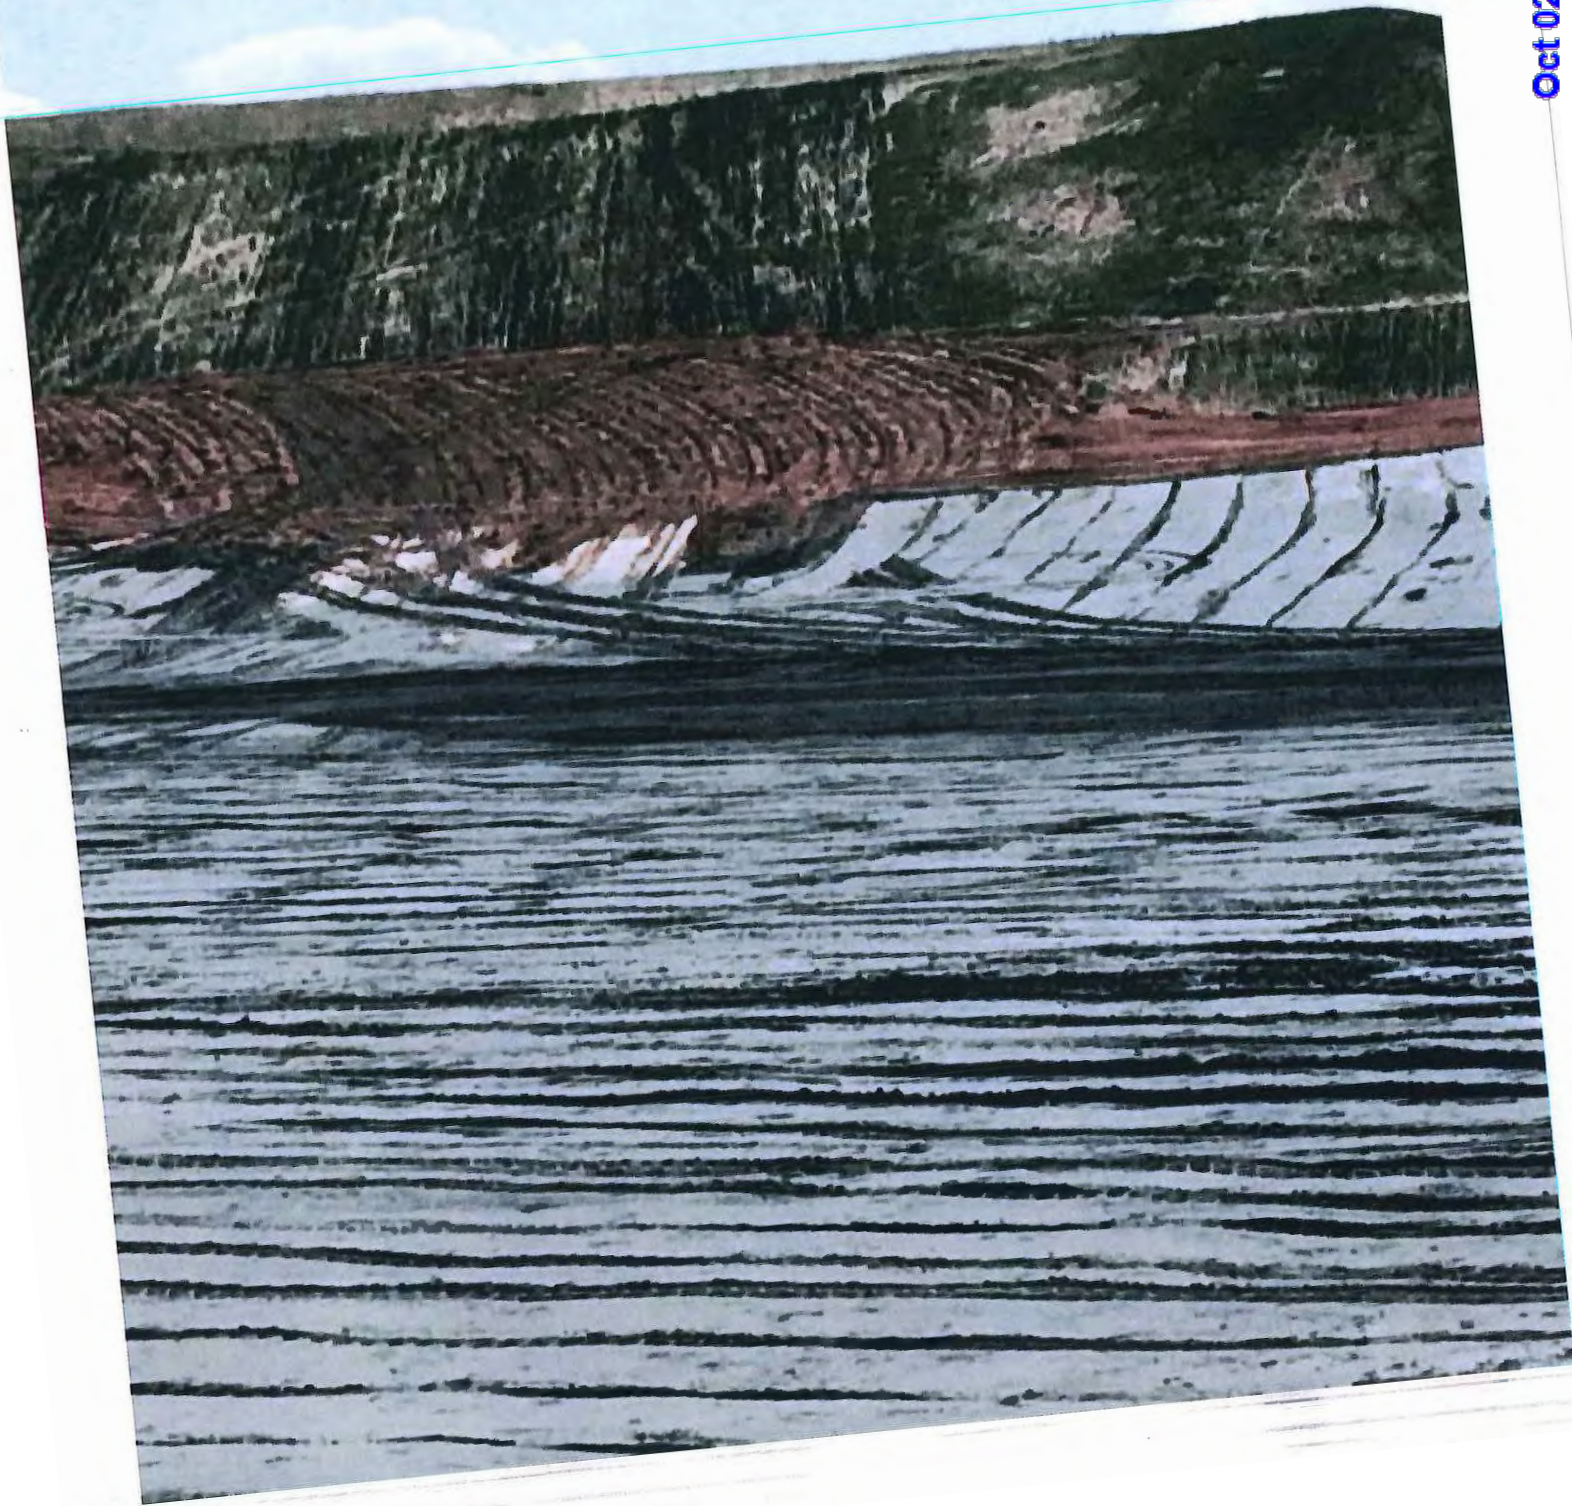
**PHOTO 2: Dominion - Clover Power Station Landfill**  
View of area depicted in Photo 1 after repairs and recompaction.

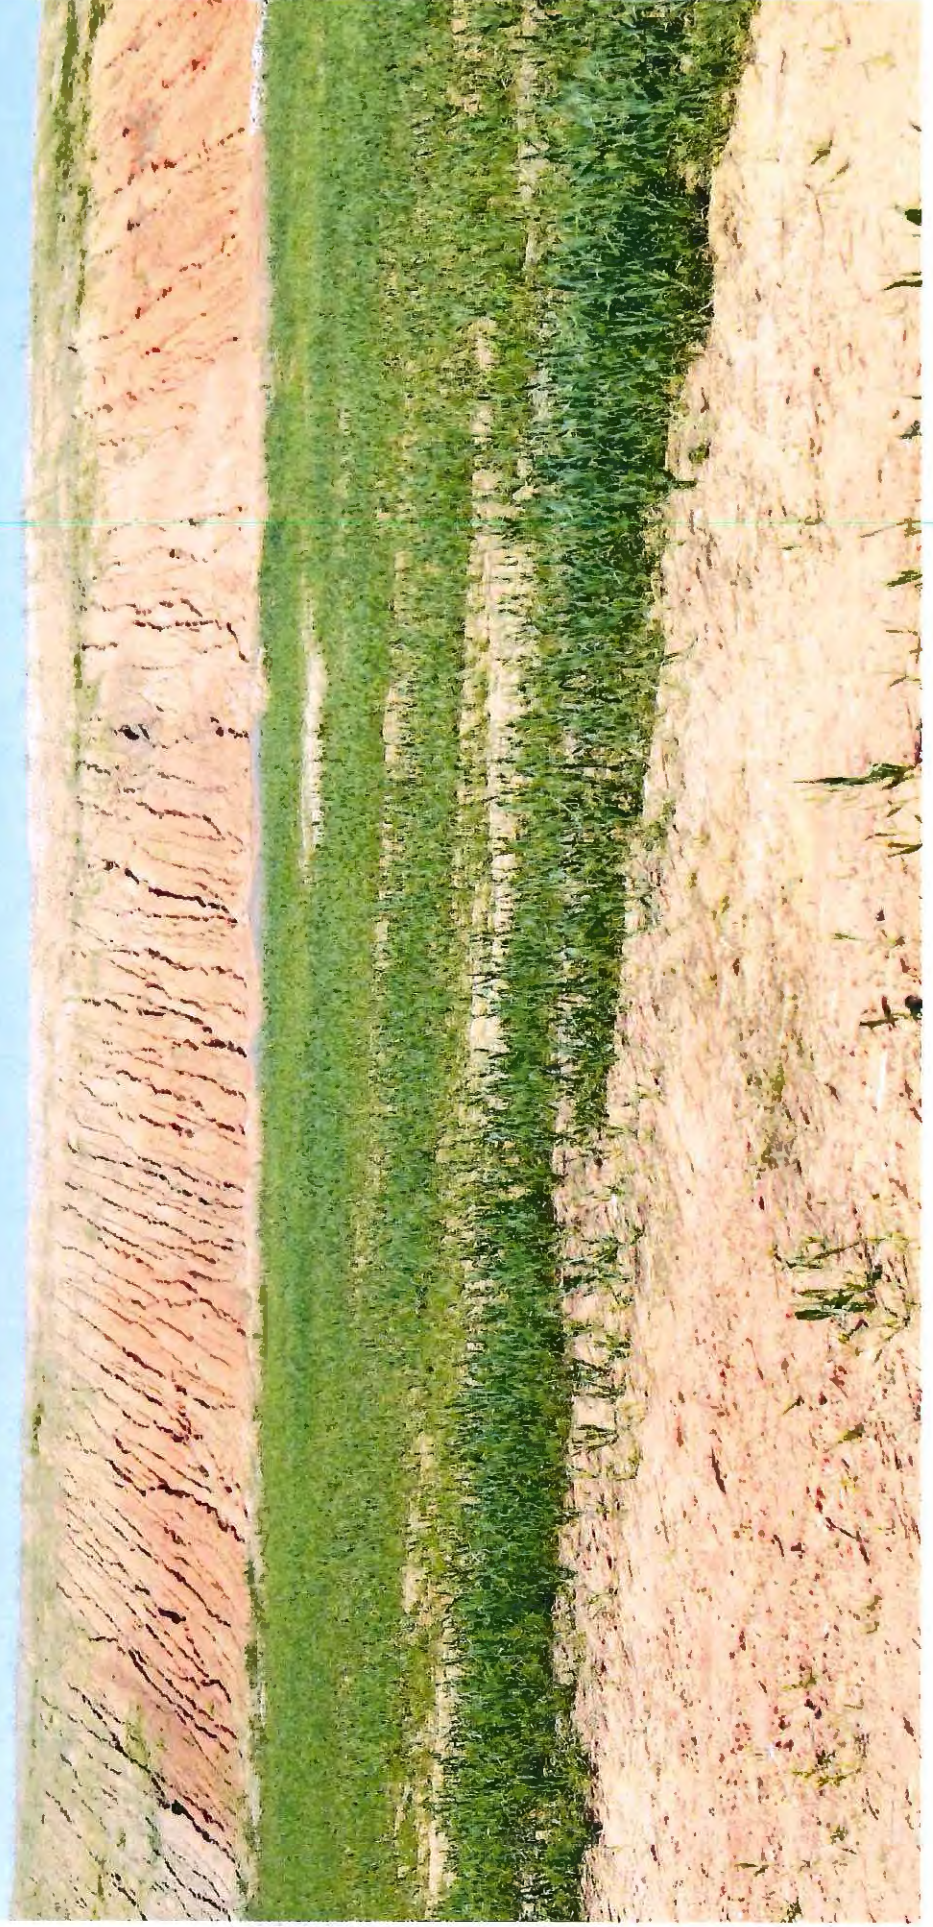
**PHOTO 3: Dominion - Clover Power Station Landfill**  
View of small erosion rills formed along the slope during May 15-16 rainfall event.

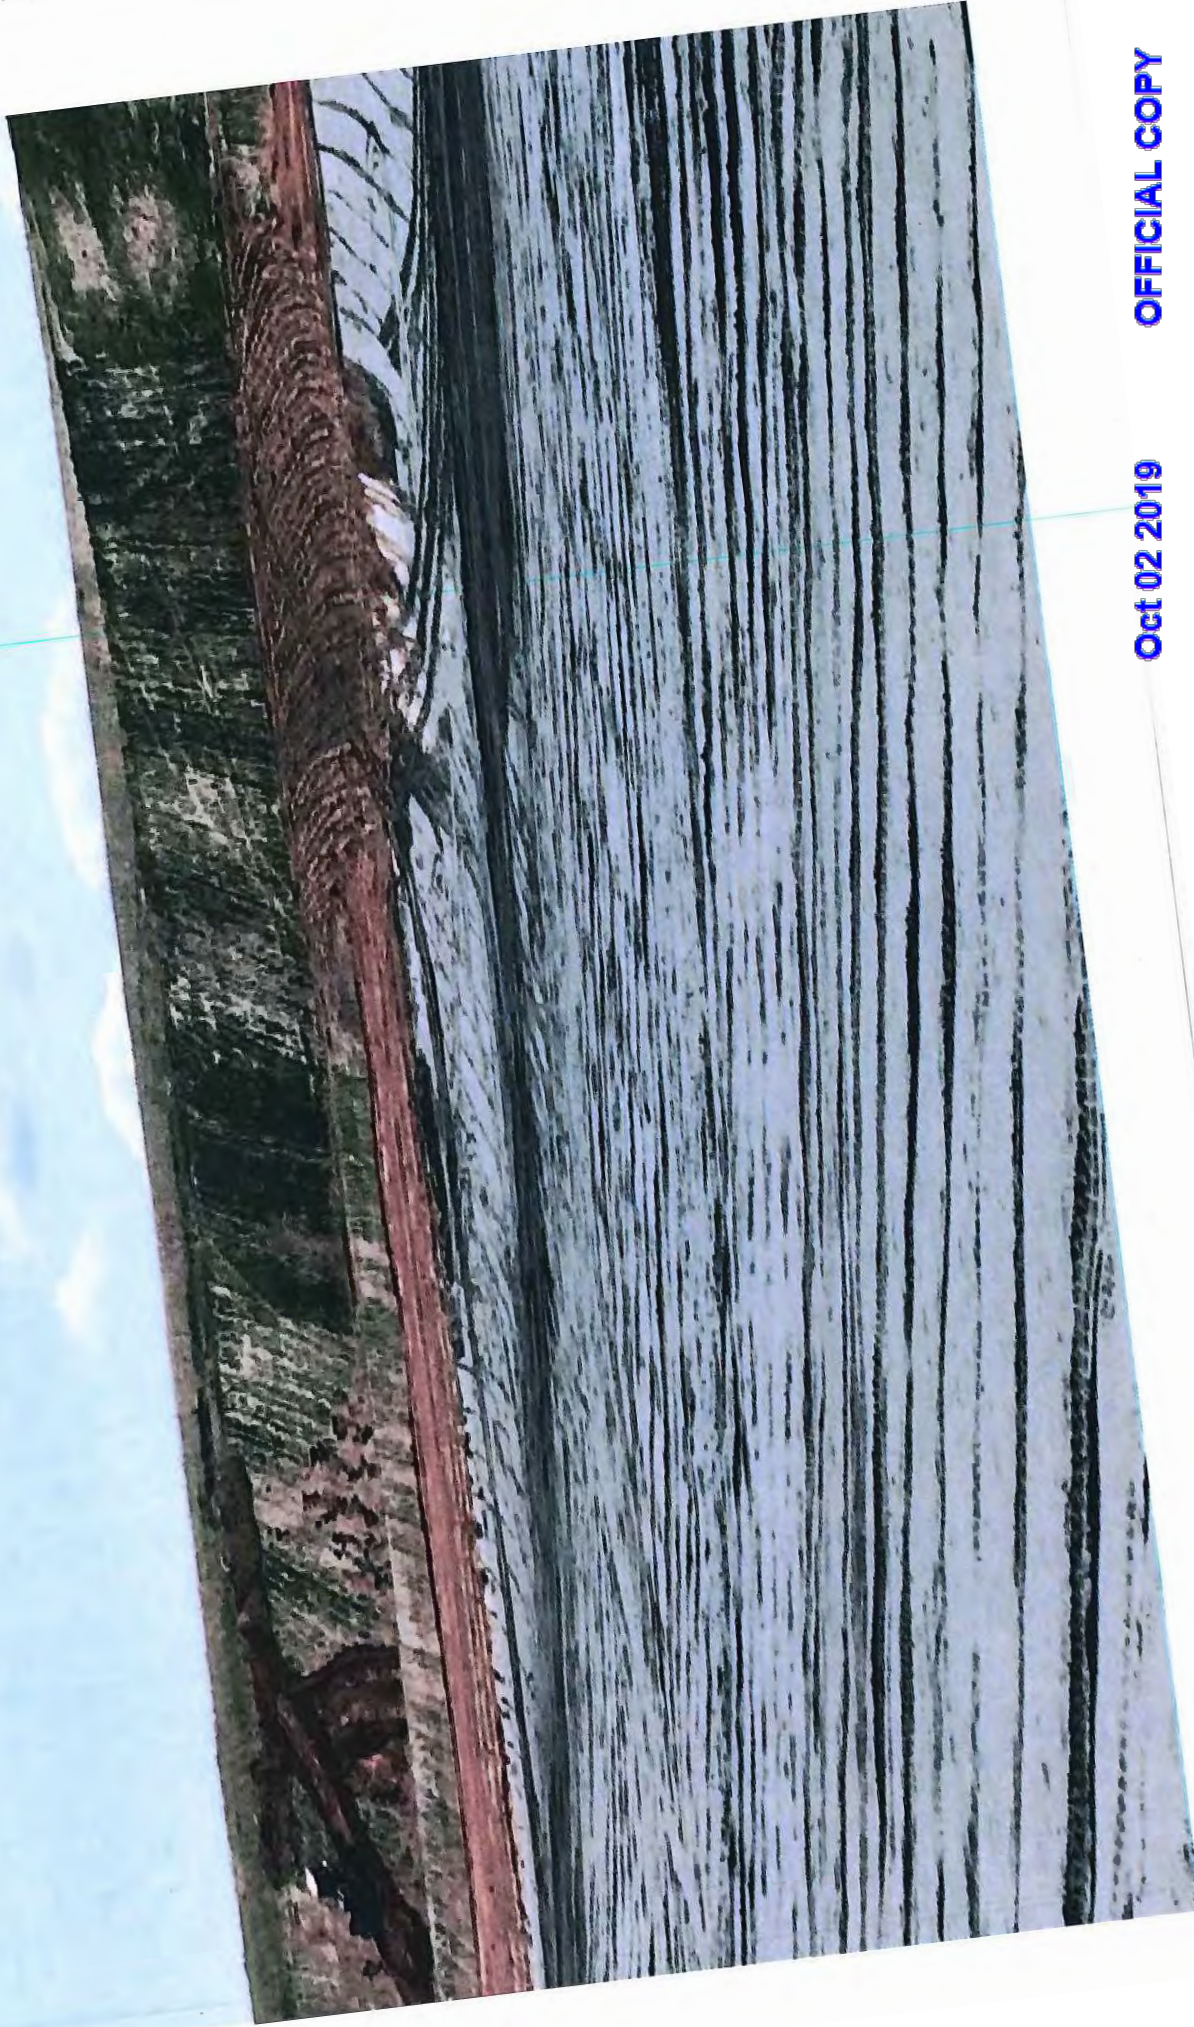
**PHOTO 4: Dominion - Clover Power Station Landfill**  
**View of area depicted in Photo 3 after repairs and**  
**recompaction of slope.**

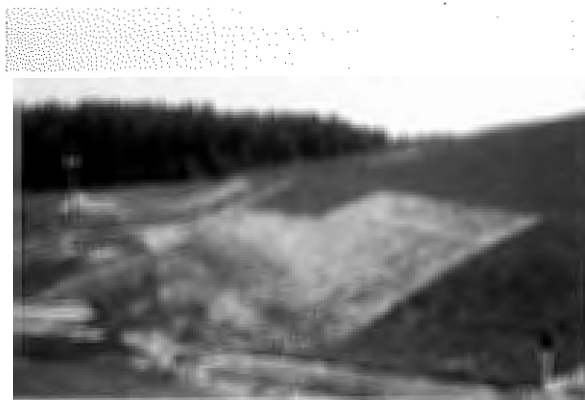
**Photo Attachment I – August 3, 2007**  
**Inspection Report References 9 VAC 20-80-270.C.19 and 9 VAC 20-80-270.F**  
**Summary of actions taken and concerns in response to the seep at Stage II Western**  
**Slope - Old Dominion Electric – Clover SWP No. 556**

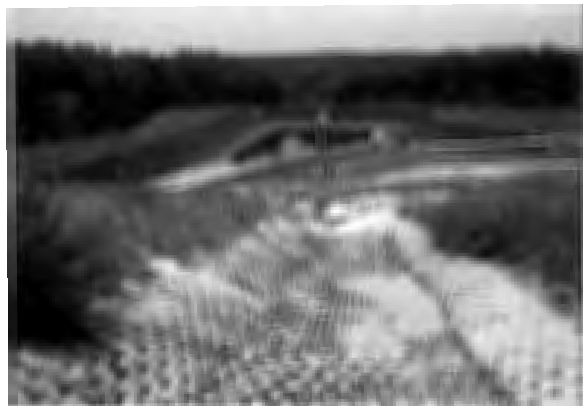
The seep appears to be centered around the fabric form slope drain. Discharge was observed on both sides of the slope drain system. Further discussion and examination of the slope drain indicates that erosion undercutting the slope drain may be the source of the seep outbreak. (Photo taken from Stage II – Western Slope. Photo direction E)

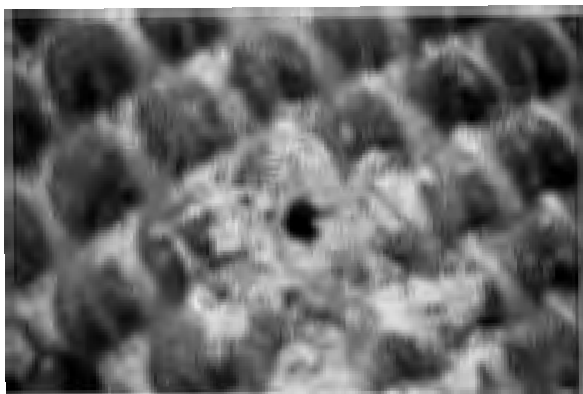
An examination of the slope drain indicated numerous cracks allowing stormwater to undercut the drain channels. It was also observed large portions of the slope drain appeared to have the supporting clay layer eroded away, leaving an unintended stormwater channel beneath the fabric form directly over the liner system. Areas of the channel had been grouted to fill in the eroded areas; however, this raises concerns regarding the condition of the liner in these areas. If the liner has been cut, torn or stretched by these repairs, the potential for CCB waste to mix with stormwater appears to be increased. (Photo taken from Stage II – Western Slope – Photo direction W)

A probe inserted into this hole extended approximately 24" down before contacted solid material. This hole was located upgradient from area where the seep had broken out. Areas extending several feet up and down the slope drain give under foot traffic raising concerns that a large volume of stormwater may enter this channel during intense rainfall stretching or damaging the liner. An additional concern is that once captured in this area the stormwater builds hydraulic pressure, exiting through the sideslopes, destabilizing the slopes, or exiting through the drainage layer in the liner system creating the observed seeps. ( Photo taken from Stage II - Western Slope. Detail hole in fabric form.)

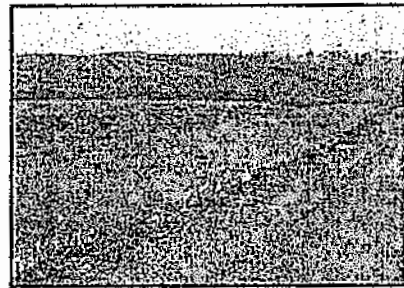
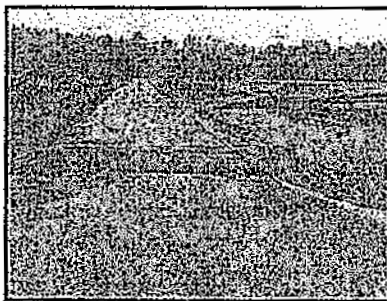
During the rain event, the berm failure occurred where the installed check dam was located. The perimeter ditch was filled to capacity with ash laden rainwater. A previously placed straw bale was in front of the culvert pipe leading from the Cell 12 check dam into the center sedimentation pond. The straw bale restricted flow into the culvert pipe and filled the perimeter ditch to capacity.
