# Due Diligence Assessment

Produced for Bald Head Island Transportation Authority

March 5, 2019

Bald Head Island Transportation Authority (BHITA) is performing due diligence on the Ferry Terminal and related waterfront structures at the Deep Point Marina (DPM) and Bald Head Island (BHI) sites in North Carolina. Moffatt & Nichol was contracted to carry out an above and below water inspection of these during the week of December 17-21, 2018. The purpose of the inspection was to assess the overall general condition of each structure, identify major deficiencies, and recommend needed repairs within a 10-year planning horizon.

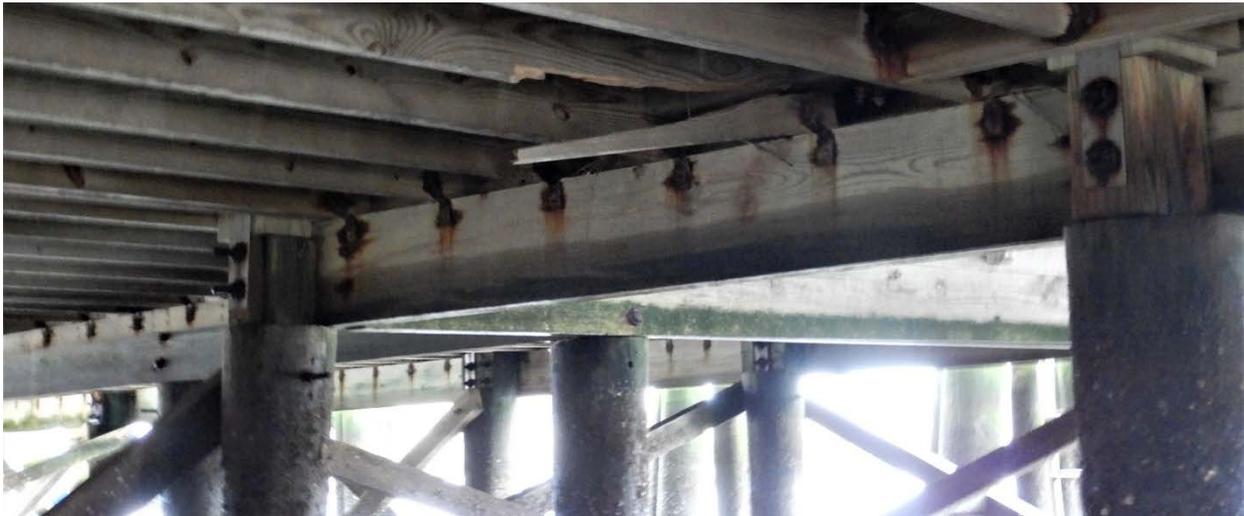
FIGURE 2-4: DPM B-GATE CONTRACTOR LANDING UNDER DECK FRAMING

Summary	
Construction	Timber
Overall Condition	Satisfactory
Repair Priority	Medium
Significant Defects	Steel tie straps are corroded/ wasted. Joist boards split 2 places
Recommendations	Repair minor timber framing defects and corroded steel tie straps.
Recommended Repairs Estimate	\$11,000

Note the corroded tie straps at each joist and broken joist at one location

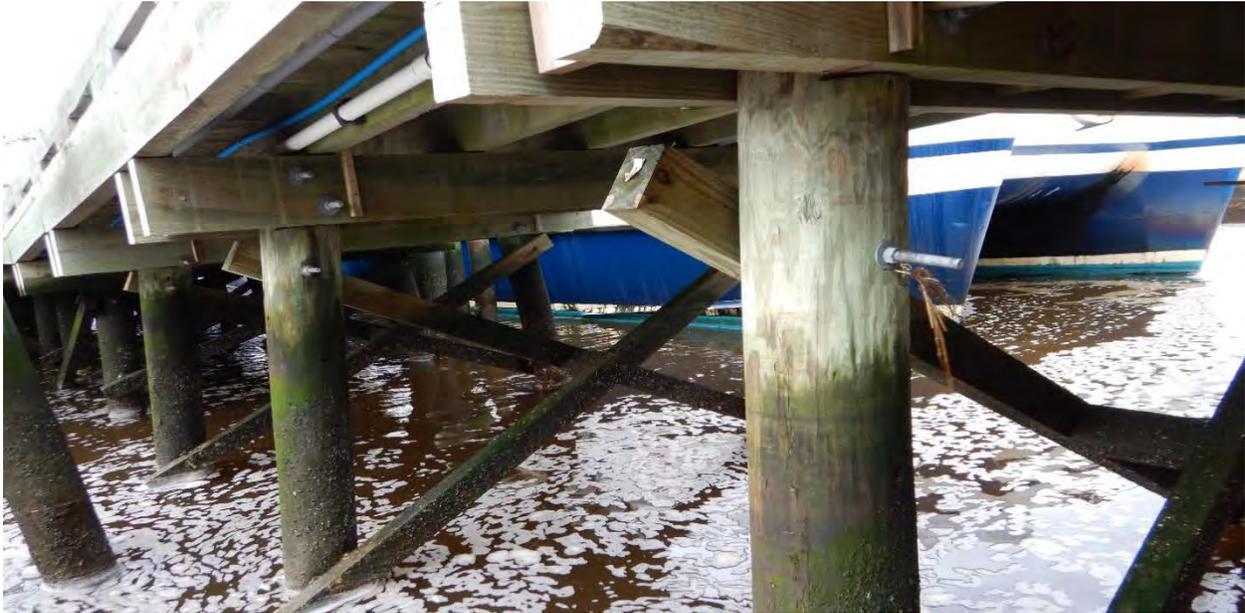
**FIGURE 2-6: DPM MAINTENANCE FIXED PIER TIMBER PILE BENTS**

Summary	
Construction	Timber
Overall Condition	Good
Repair Priority	Low
Significant Defects	Open bolt holes in piles.
Recommendations	Repair minor defects including bolt holes in timber piles and split bracing.
Recommended Repairs Estimate	\$1,000

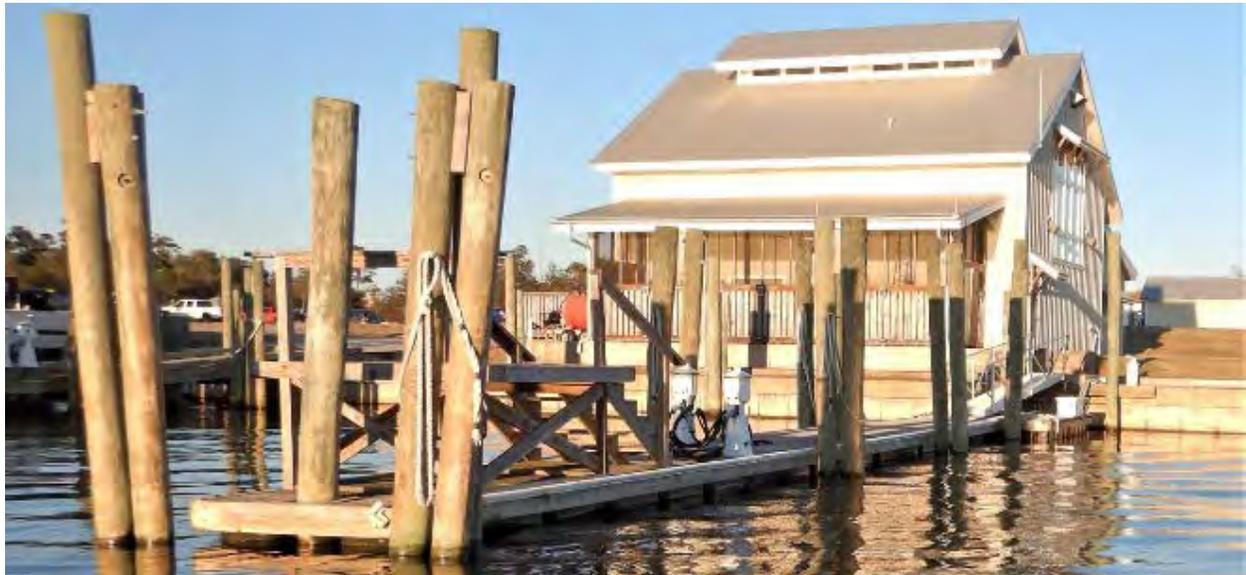
**FIGURE 2-7: DPM MAINTENANCE FINGER ELEVATION VIEW (LOOKING NORTHWEST)**

Summary	
Construction	Floats with Timber Piles
Overall Condition (Gangway Support Piles)	Satisfactory
Repair Priority	Low
Significant Defects	Gangway support pile section loss
Recommendations	Repair/replace gangway support pile
Recommended Repairs Estimate	\$10,000

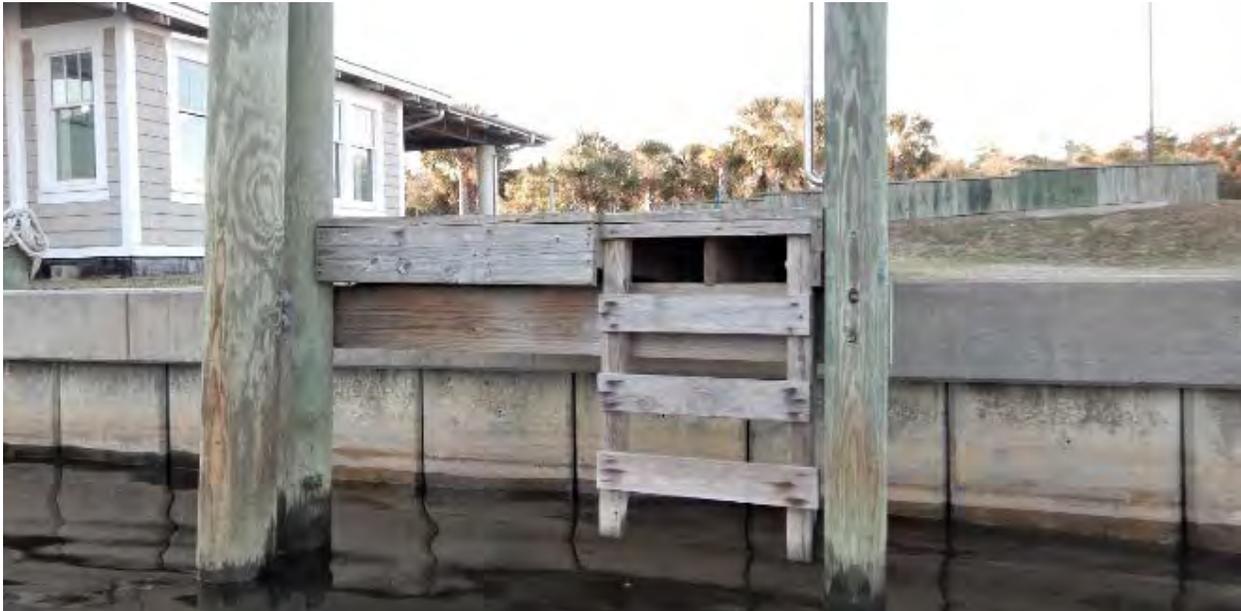
**FIGURE 2-9: DPM "H" BERTHING PLATFORM ELEVATION VIEW (LOOKING WEST)**

Summary	
Construction	Timber
Overall Condition	Good
Repair Priority	Low
Significant Defects	Minor abrasions on piles
Recommendations	Routine Inspection & Maintenance
Recommended Repairs Estimate	\$0

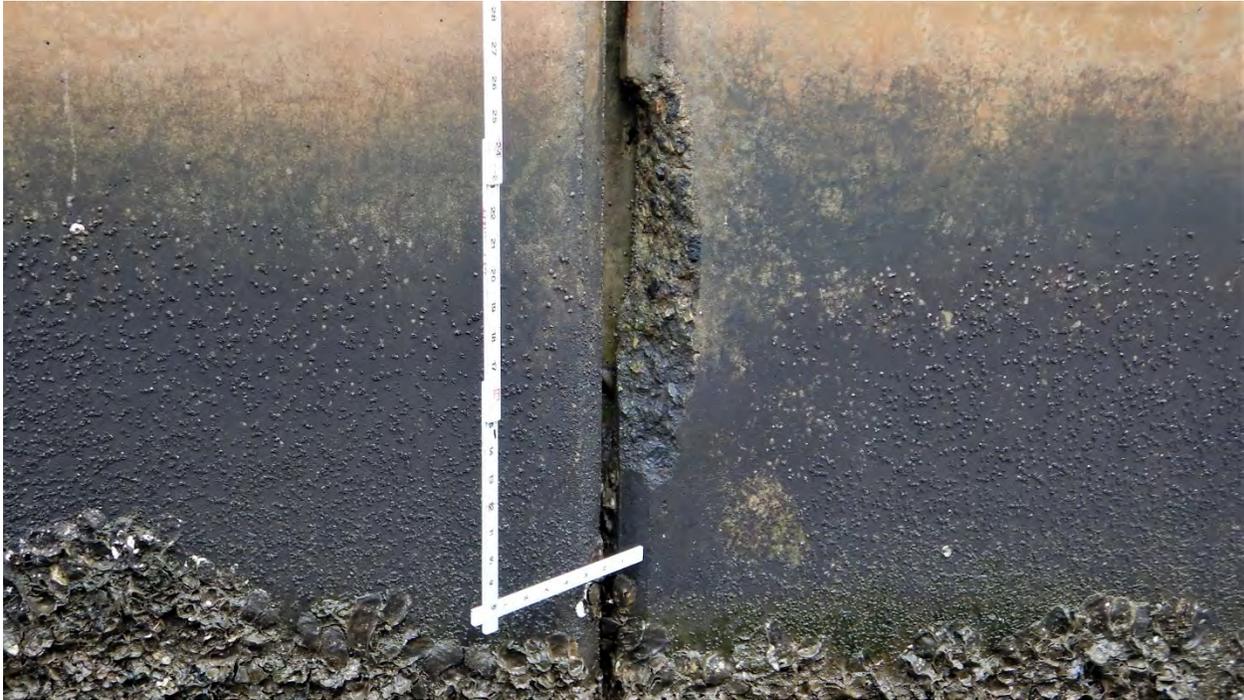
FIGURE 2-13: TYPICAL CONCRETE SHEET PILE SPALL

The spalls and cracking in the sheets are typically along the groove side of the tongue-and-groove interlock, exposing the tongue from the adjacent sheet but not creating open voids. Areas behind the wall have loss of fill or “sinkholes” which are typical for this type of construction. Locations with minor fill loss and sinkholes can be addressed by regular maintenance with replacement sand/stone fill material when needed.

Note tongue-and-groove fit between the sheets, visible inside the spall

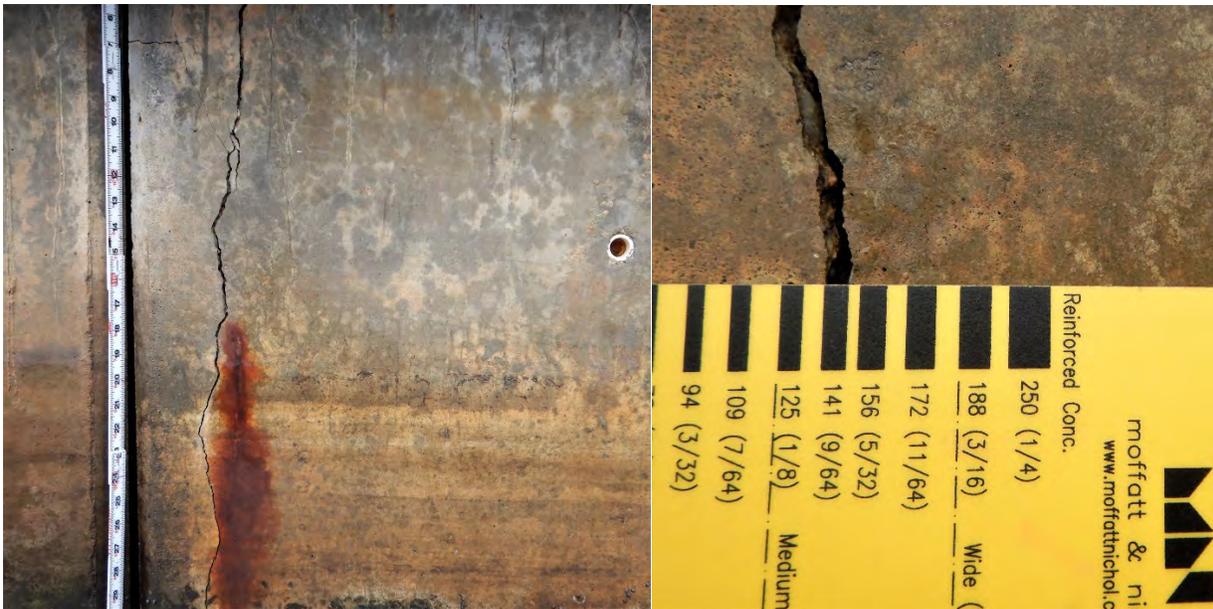
FIGURE 2-14: CONCRETE SHEET PILE CRACKING

Overall and close up view shown of medium-width “worst case” cracking observed in the bulkhead wall at intermittent locations

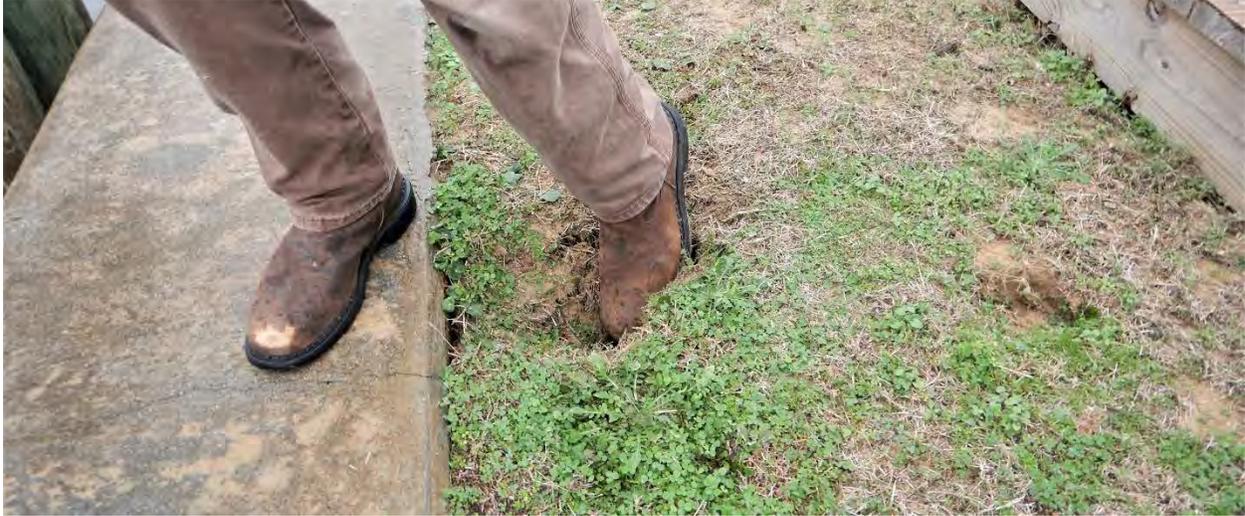
FIGURE 2-15: TYPICAL SINKHOLES BEHIND WALL

Sinkholes in sand fill behind interlocking concrete sheet pile construction of this type is typically caused by migration of the sand backfill through the joint. This may be mitigated by varying the size and gradation of repair materials, i.e. backfilling with larger size gravel or stone. More robust repairs including the installation of filter fabric and/or the use of grout or flowable fill could be considered in the future if sinkholes become larger or more prevalent. Fill loss should be monitored during routine inspections to determine if more substantial repair methods are recommended.

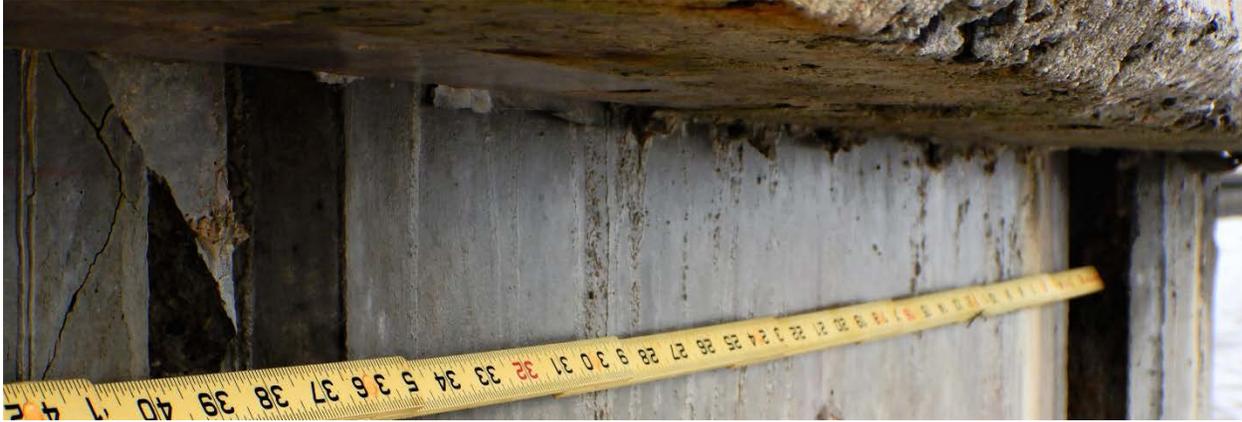
FIGURE 2-17: DISPLACED CONCRETE SHEET PILES AT BULKHEAD REPAIR SECTION

The bulkhead repair section was inspected above and below water and found to be in satisfactory condition. The sheets were found to be intact with no voids or signs of recent movement.

A permanent repair should be planned for the next major Capital Expenditure (CAPEX) cycle and should be designed to address the berthing/mooring forces imposed by the tug and barge at the adjacent DPM Barge Ramp.

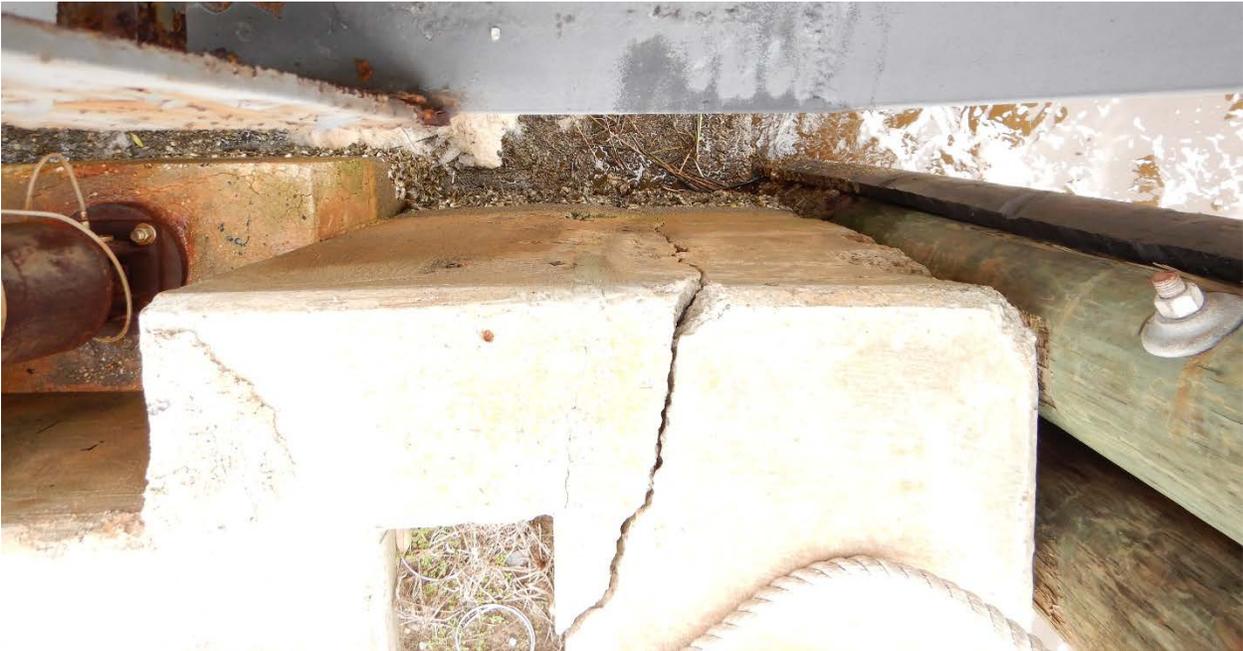
FIGURE 2-19: DPM BARGE RAMP TENSION CRACK IN CONCRETE SUBSTRUCTURE

The DPM barge ramp concrete substructure and adjacent sheet pile bulkhead repair area are in satisfactory condition but may require retrofit/replacement within the 10-year planning horizon or beyond. A tension crack has developed in the ramp substructure and the adjacent section of bulkhead wall has previously displaced and been repaired. The crack damage appears to be caused by the berthing/mooring forces imposed by the tug-barge. This area should be monitored for signs of worsening and the forces evaluated in greater detail for

Above and below water inspection found the structure to be in satisfactory condition with a crack in the concrete substructure wall corresponding to the adjacent bulkhead repair area as well as minor to moderate corrosion affecting the ramp steel framing, cylinder bases, and other weldments.

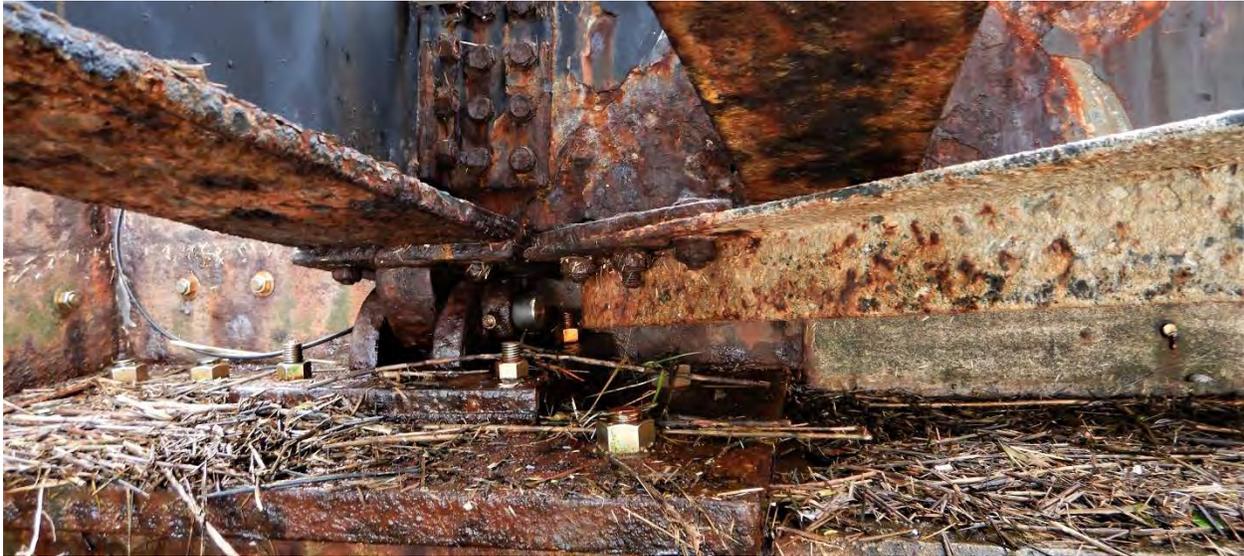
FIGURE 2-21: BHI BARGE RAMP STEEL FRAMING MODERATE CORROSION

The BHI Barge Ramp is similar to its counterpart at DPM, with a moveable steel frame loading ramp and reinforced concrete substructure with concrete sheet pile side walls and bulkhead. These were found to be in satisfactory condition with moderate corrosion to steel elements and minor spall and cracking defects on the concrete sheet pile side and bulkhead walls.

The steel barge ramps at DPM and BHI are in satisfactory condition however may require refurbishment/replacement within the 10-year planning horizon due to corrosion of framing elements. In order to minimize disruption to barge operations, replacement is preferable and fabricating at least one new ramp would allow the shortest time for removal and installation. It may be cost effective to refurbish one of the existing ramps after it has been replaced (instead of fabricating a second replacement) and then return it to service in place of the remaining original.

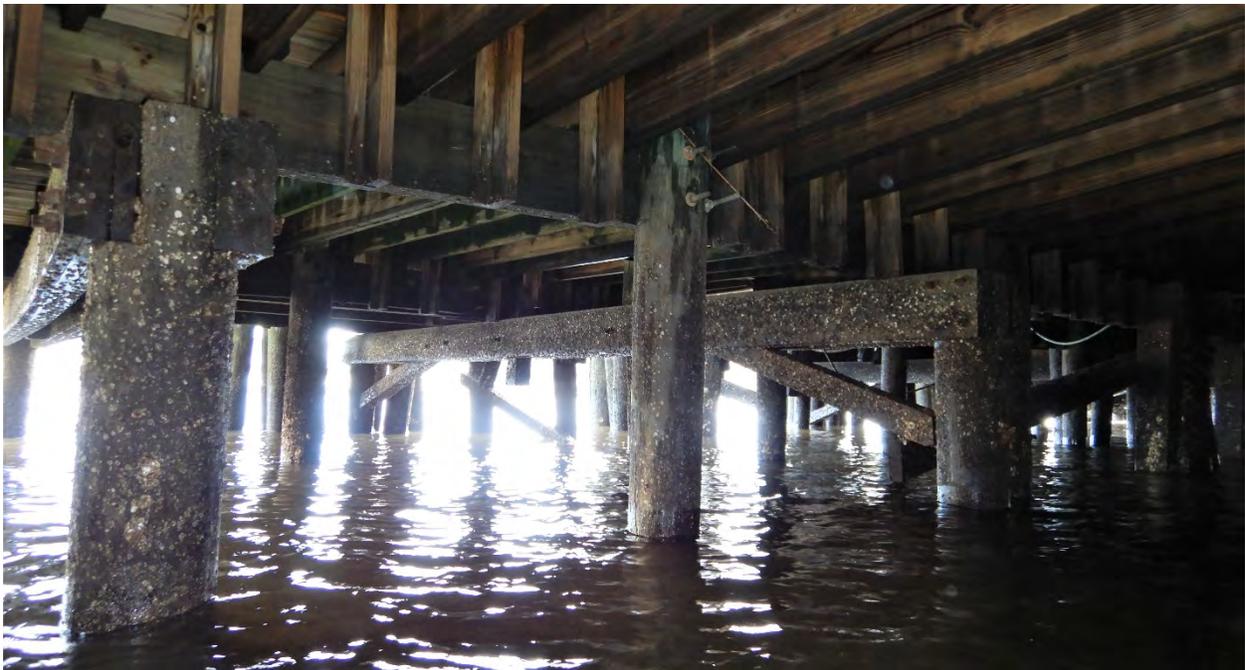
FIGURE 2-25: BHI PASSENGER LANDING UNDERDECK VIEW (LOOKING EAST)

Two long-span crutch bents are visible at left and center of the photo. Bowing of timber crutch bent cap visible to the left (others similar).

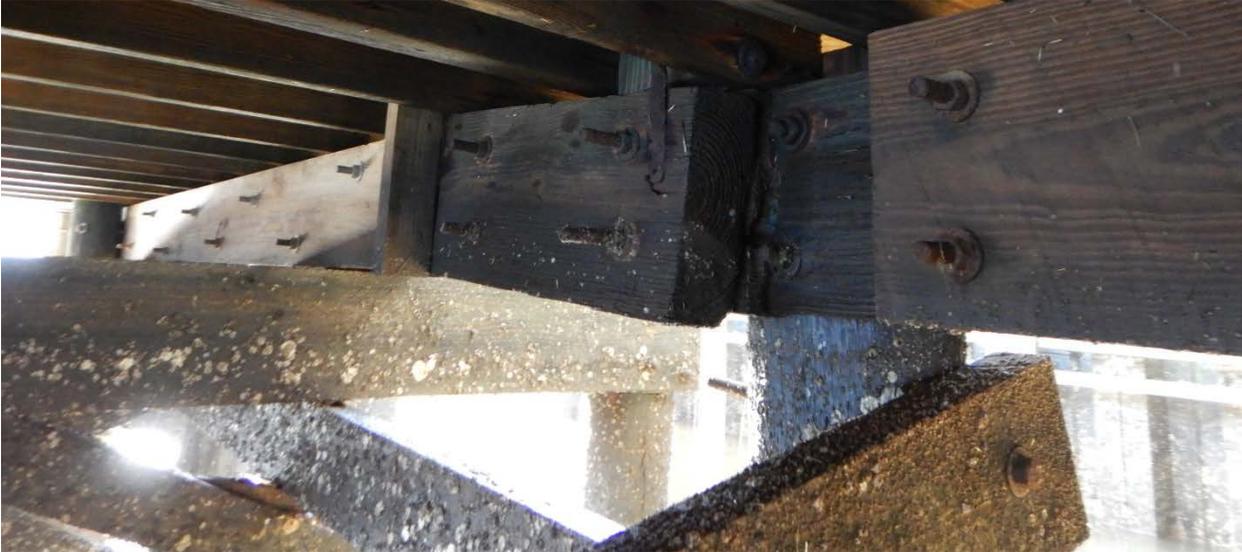
FIGURE 2-26: UNDERDECK VIEW OF TIMBER STRINGER

Stringer has been repaired with thru-bolts "sistered" boards. Note the various repairs do not form a continuous member and are out of alignment.

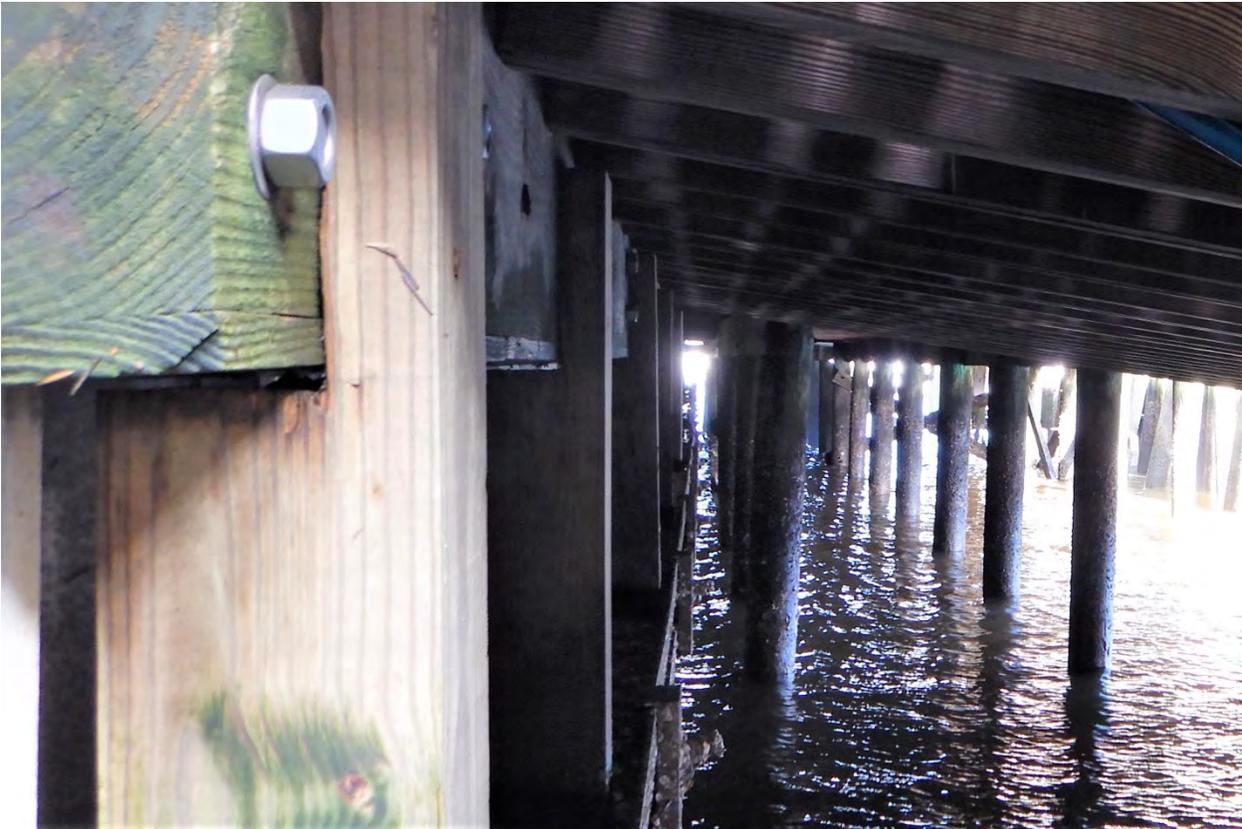
FIGURE 2-27: UNDERDECK VIEW OF CARGO RAMP

Cargo ramp at Passenger Landing is supported by the marina bulkhead wall (foreground). For comparison, the adjacent Contractor Landing is fully supported with a row of timber piles (center background).

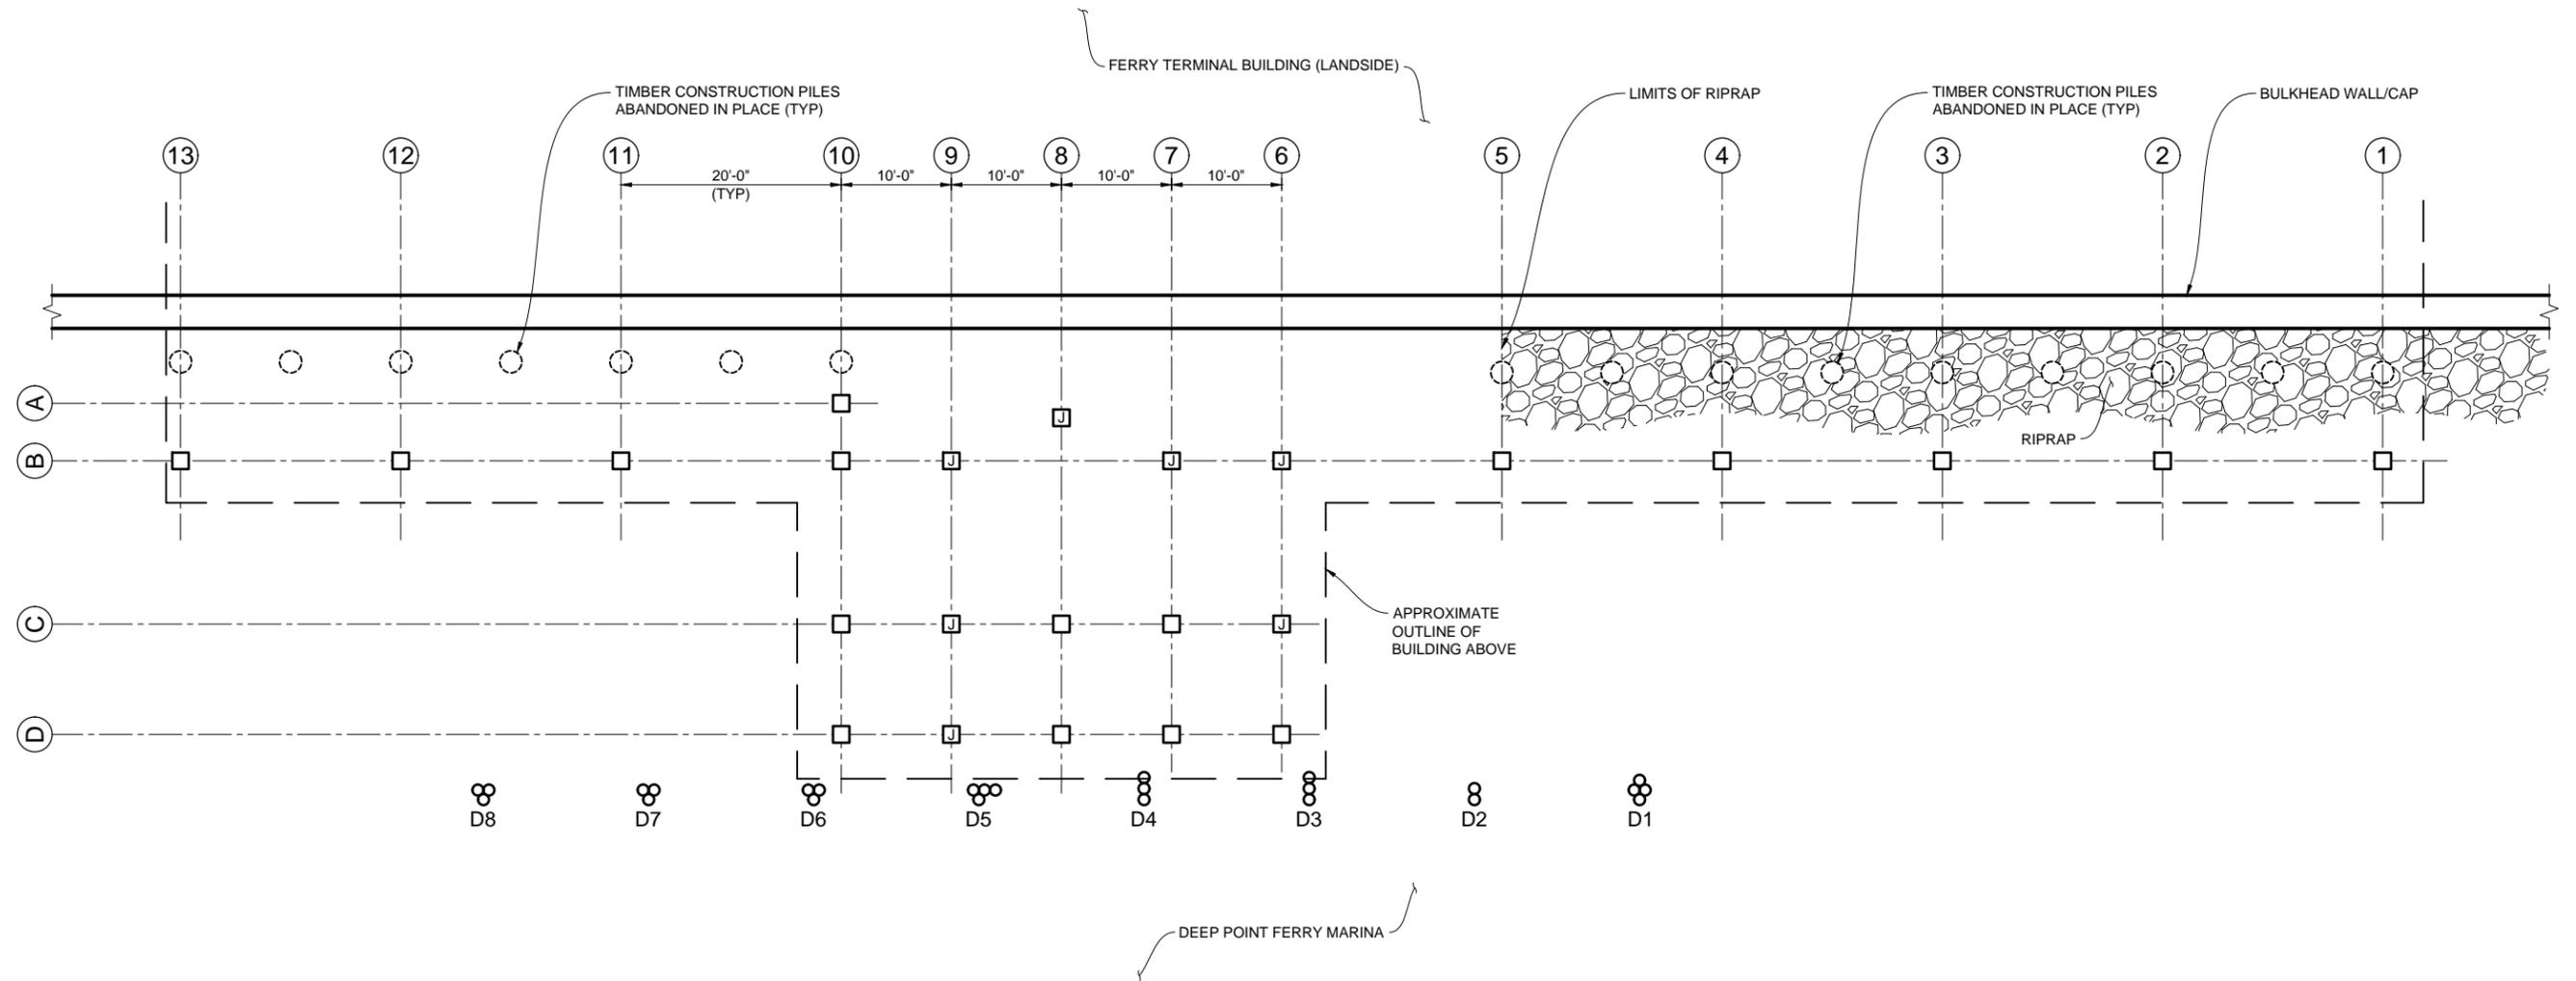
**A-GATE PASSENGER TERMINAL PILE PLAN**

Seven of the 24 concrete support piles have been retrofitted with fiberglass and epoxy jackets, reportedly following original construction (pile driving). These were found to be in good condition with no signs of deterioration or damage. A series of timber piles along the bulkhead wall were installed to support construction loads and are no longer serving any function. The mudline along the bulkhead wall has been fortified at the south end with cut off sections of concrete pile laid sideways and rip rap stone at the north end between Bent 1 and Bent 5. See the marine pile plan layout (FIG-A1) in Appendix A for more detail.
