PV Interconnection Inspections Conducted for Duke Energy

Shawn Fitzpatrick, P.E.

Advanced Energy

June 17, 2015

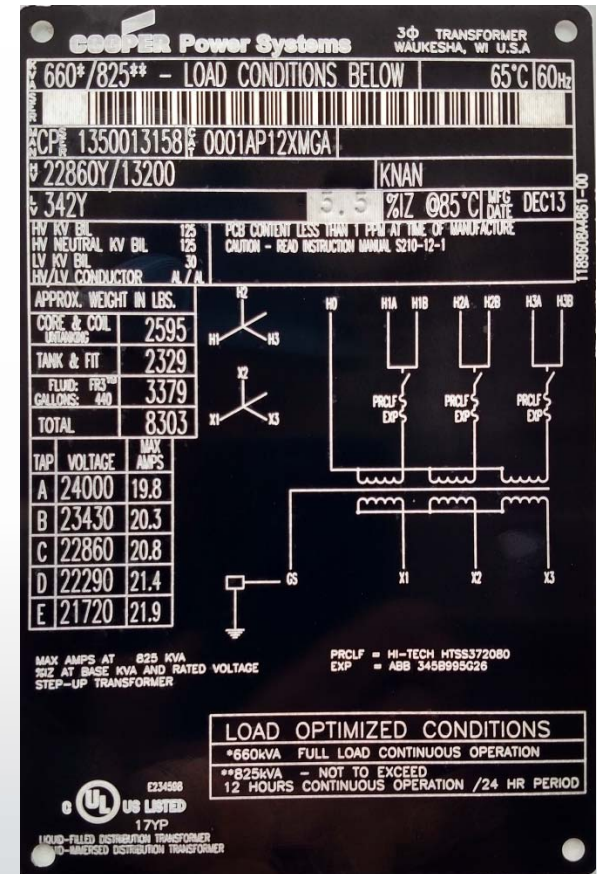
- Inverter manufacturers specify the types of transformers that can be used with their inverters
- Advanced Energy (AE) found that with some transformer types, inverters do not always detect a loss of single phase power on the three phase utility distribution line
- 4 of the 15 sites inspected have a transformer type that desensitizes the inverter's ability to detect a loss of single phase power on a three phase line
- This is a potential safety concern and Duke Energy has taken measures to address the issue

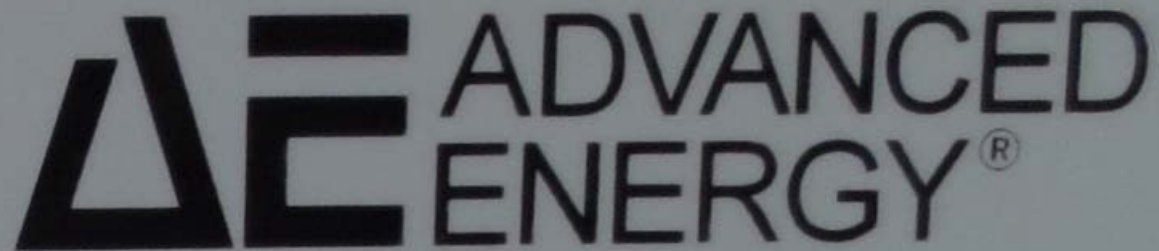
This Inverter has the following trip points set and can only be changed by AE personnel.

Under Voltage- 0.90, 10 cycle delay

Over Voltage- 1.10, 10 cycle delay

Under Frequency - 57.0Hz, 10 cycle delay

Over Frequency - 60.5Hz, 10 cycle delay

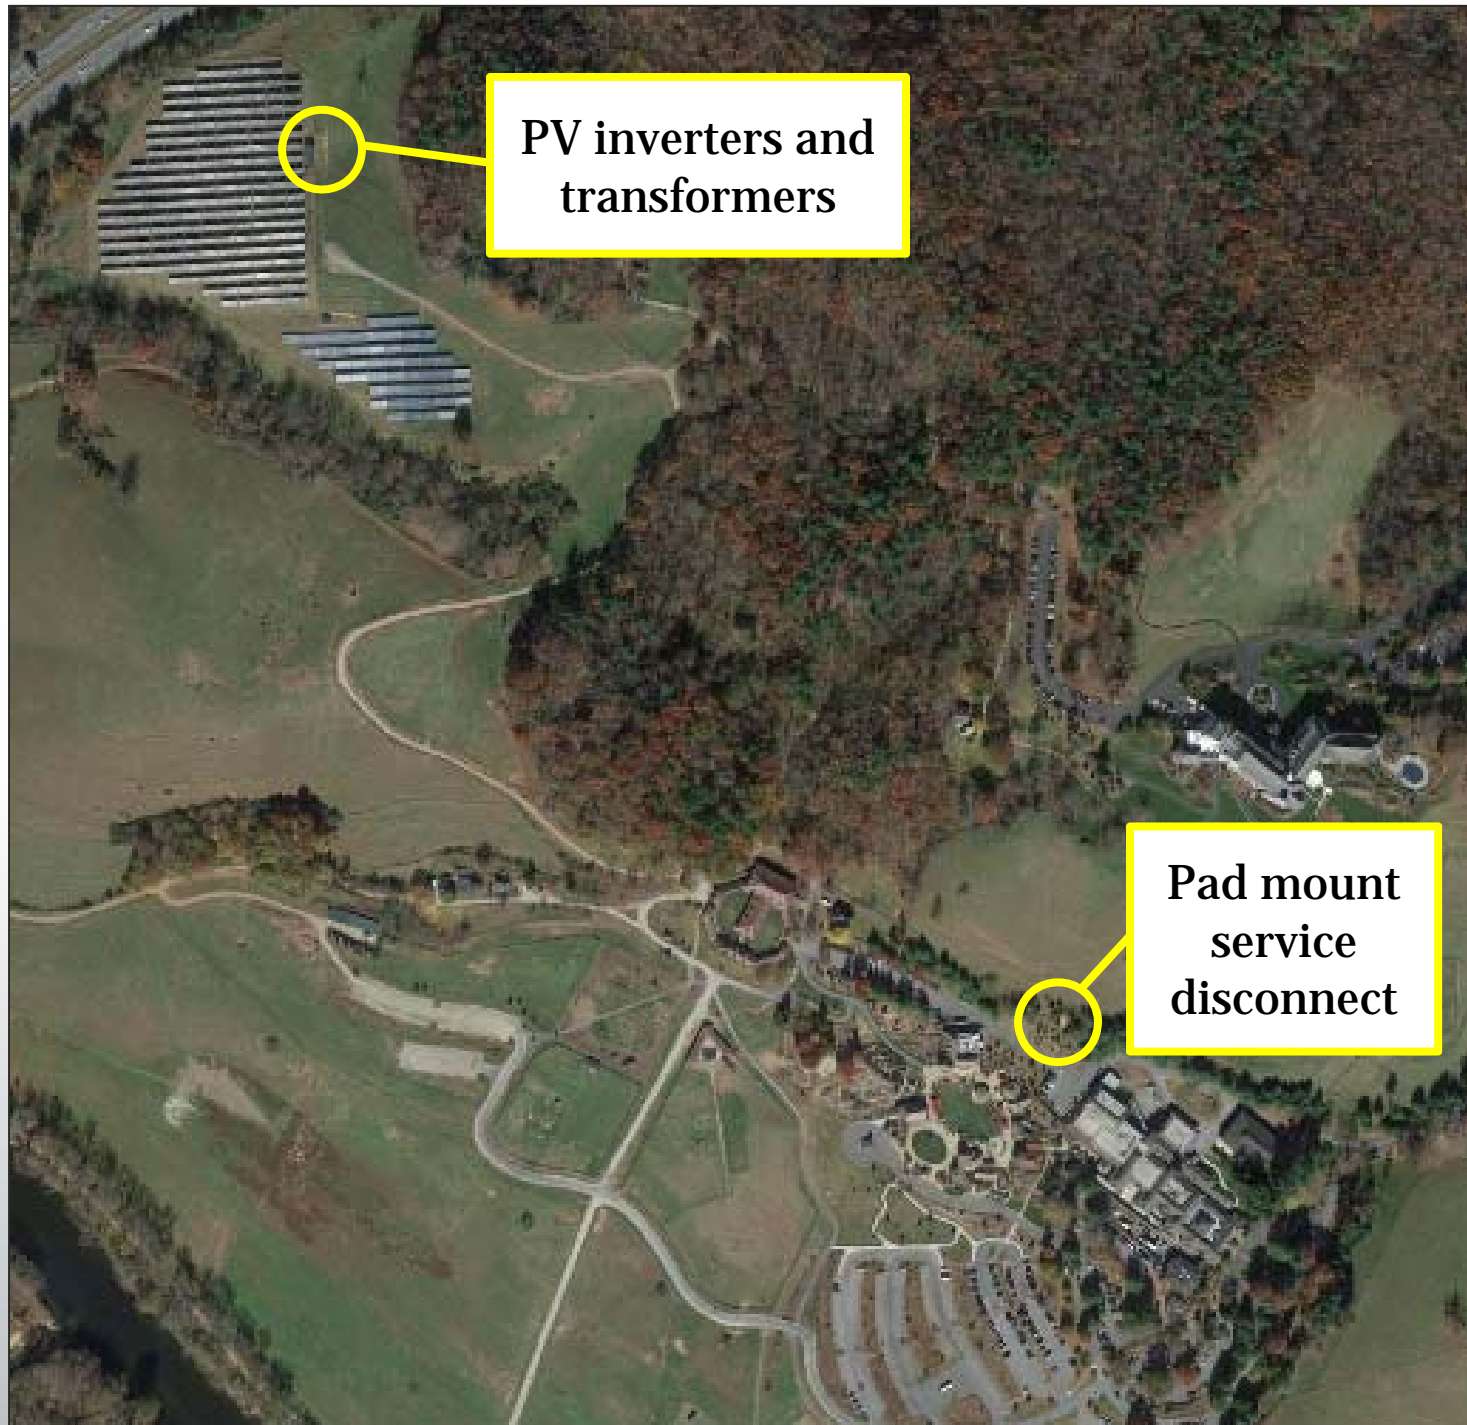
- 2 of the 15 sites do not have a customer owned service disconnect located at the PV site, creating unsafe situations
- 1 of these 2 does have a customer owned service disconnect, but it is located $\frac{1}{2}$ mile away at a poorly marked pad-mount disconnect switch

**PV inverters and
transformers**

**Pad mount
service
disconnect**

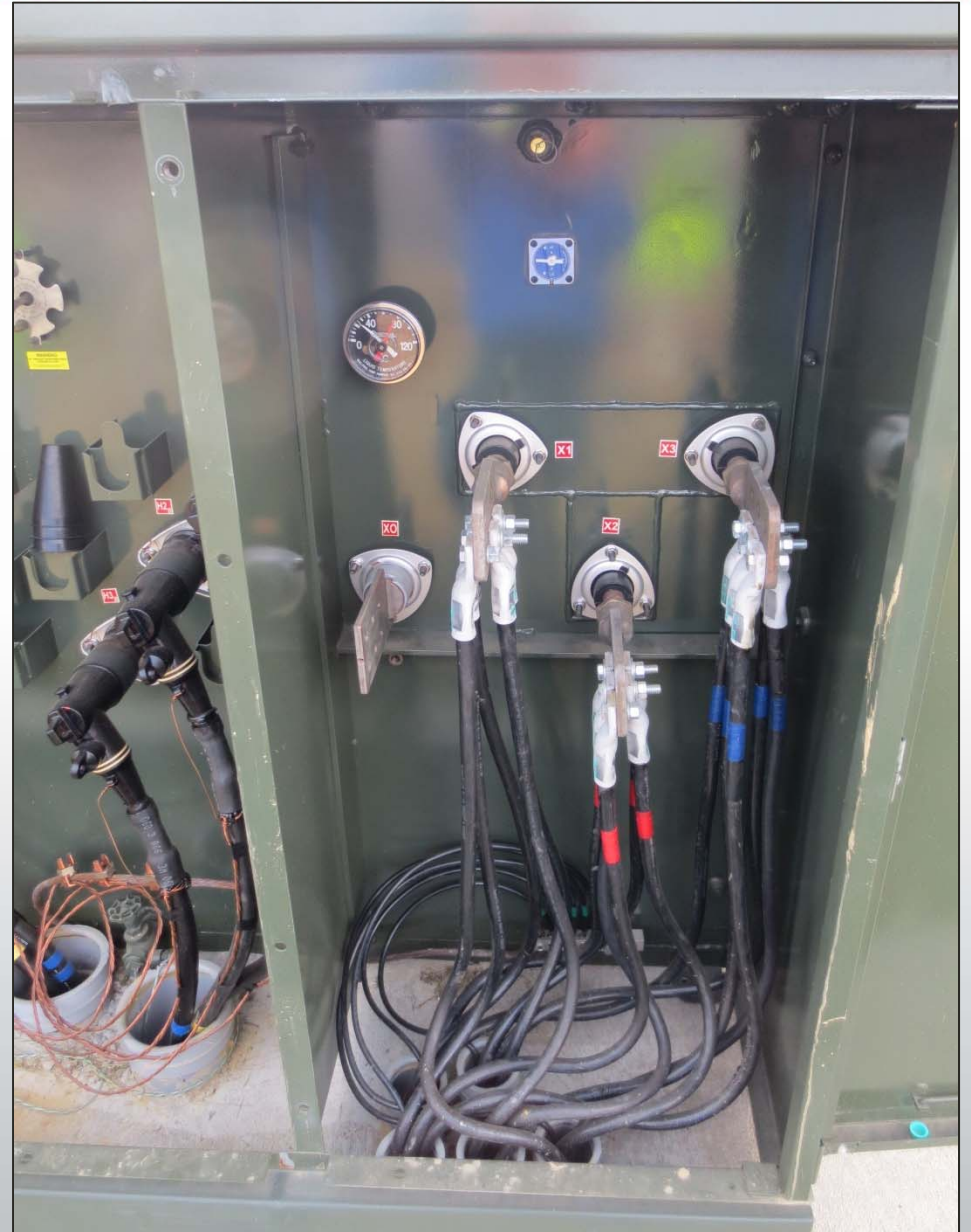
- 8 of the 15 sites do not have the required AC ground detectors on ungrounded AC inverter feeders

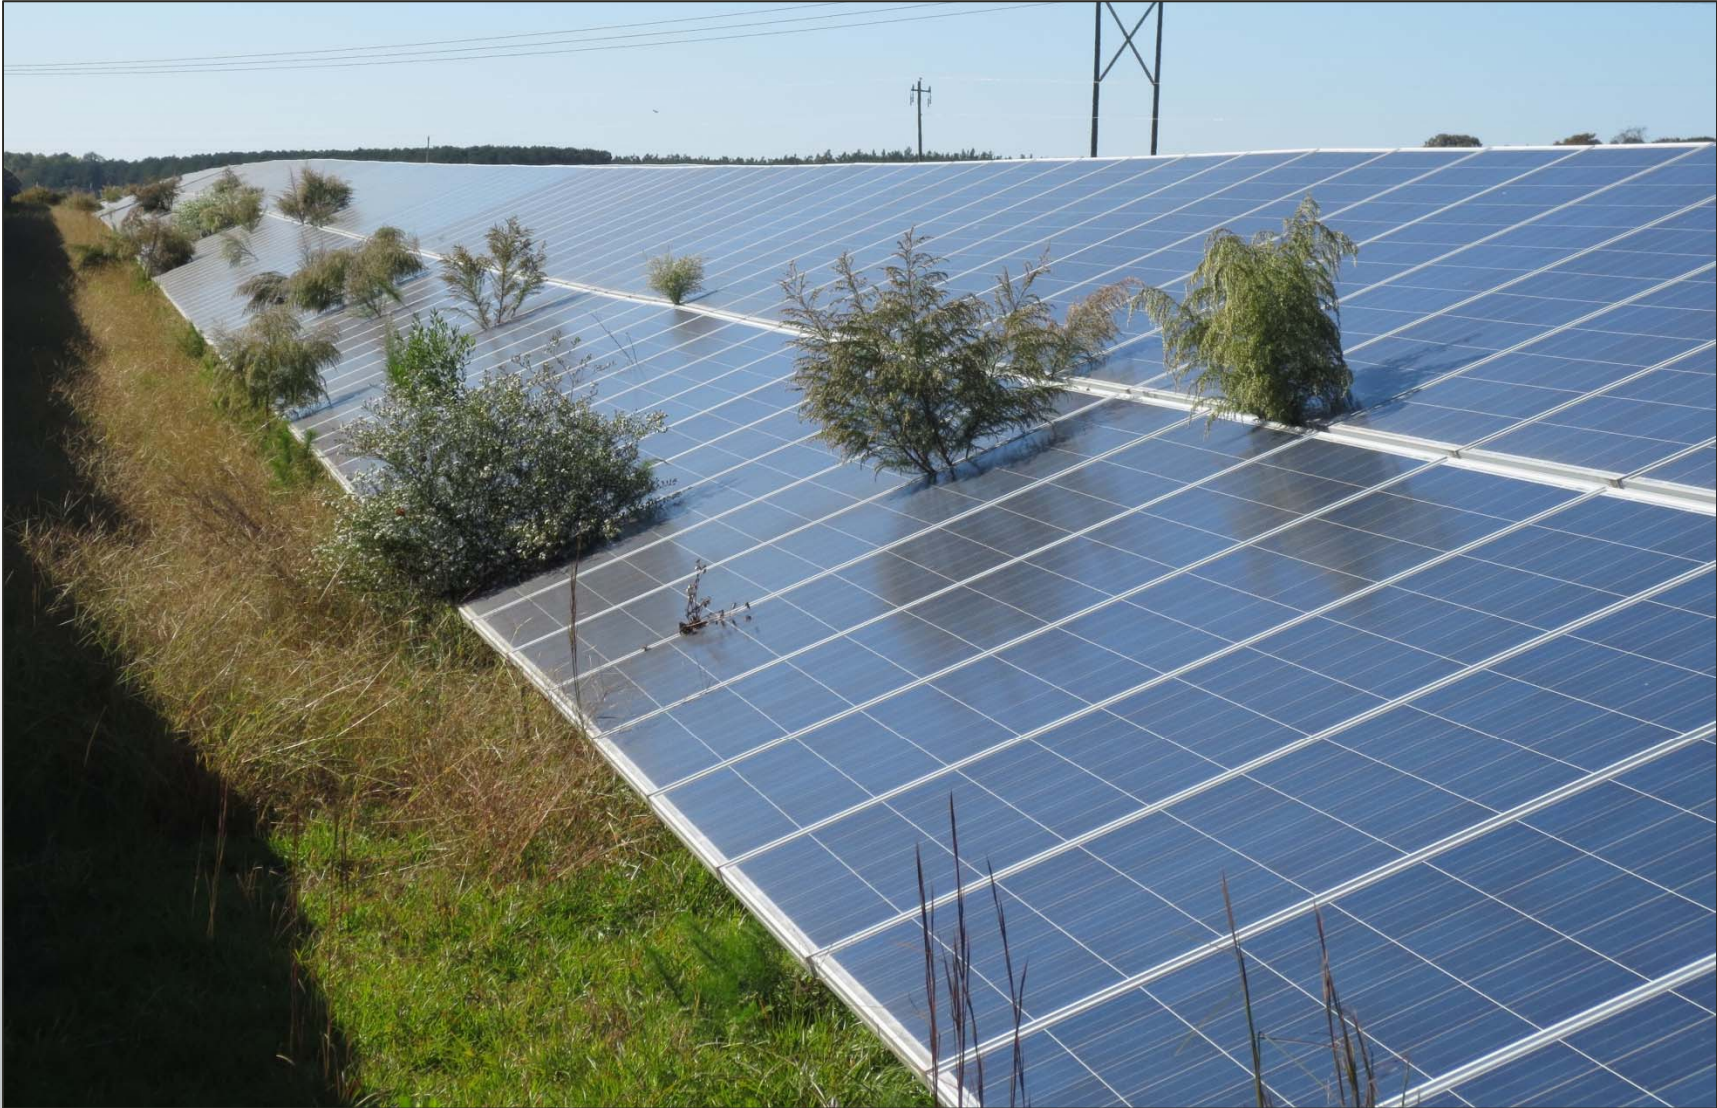
Solar/tree farm – 85.9% performance factor

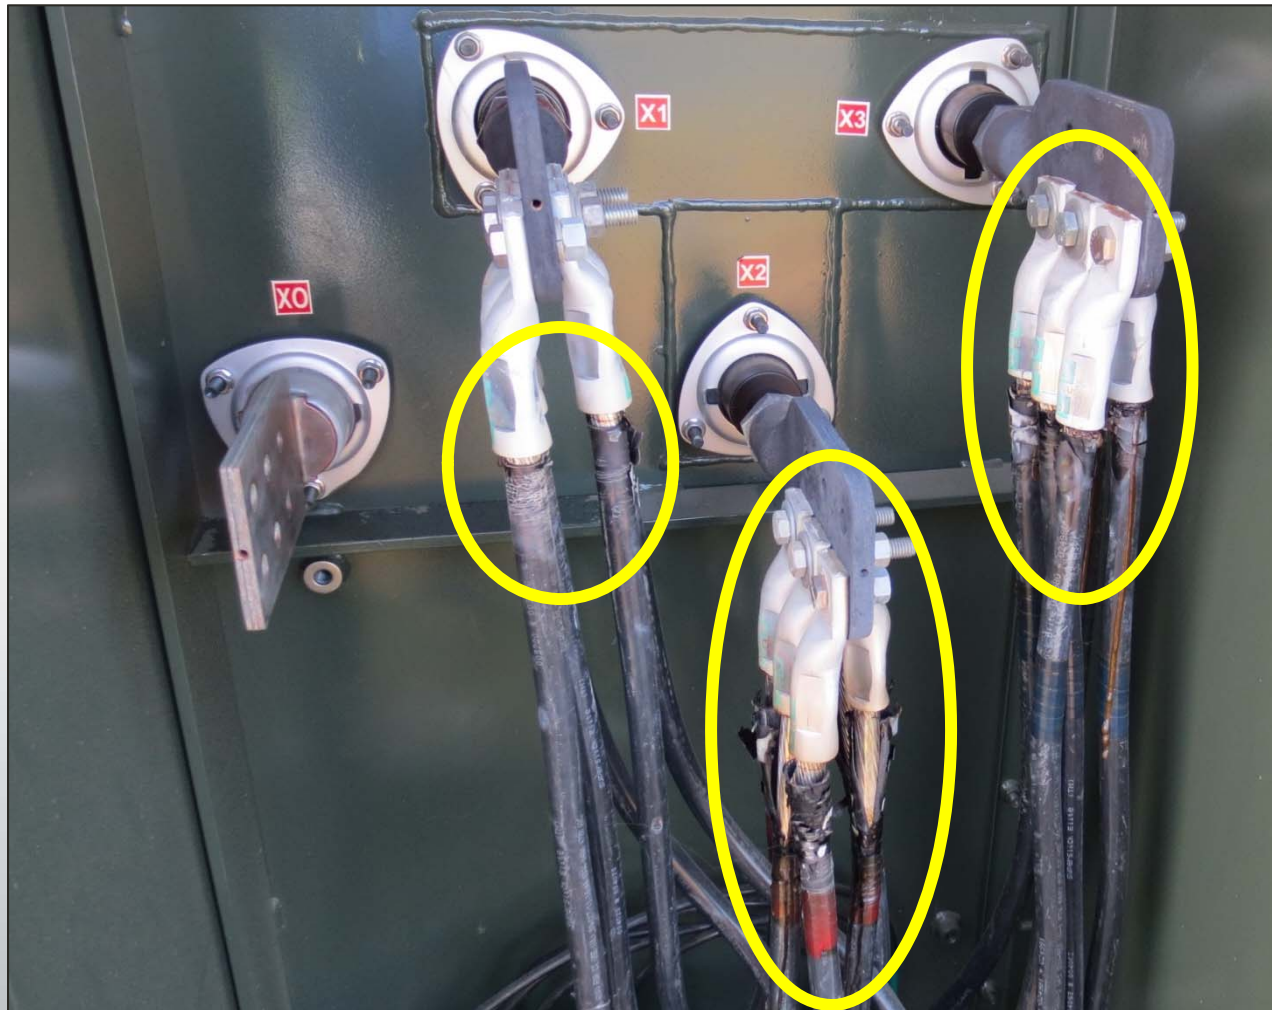
- Insulation was burned off the secondary conductors within one transformer

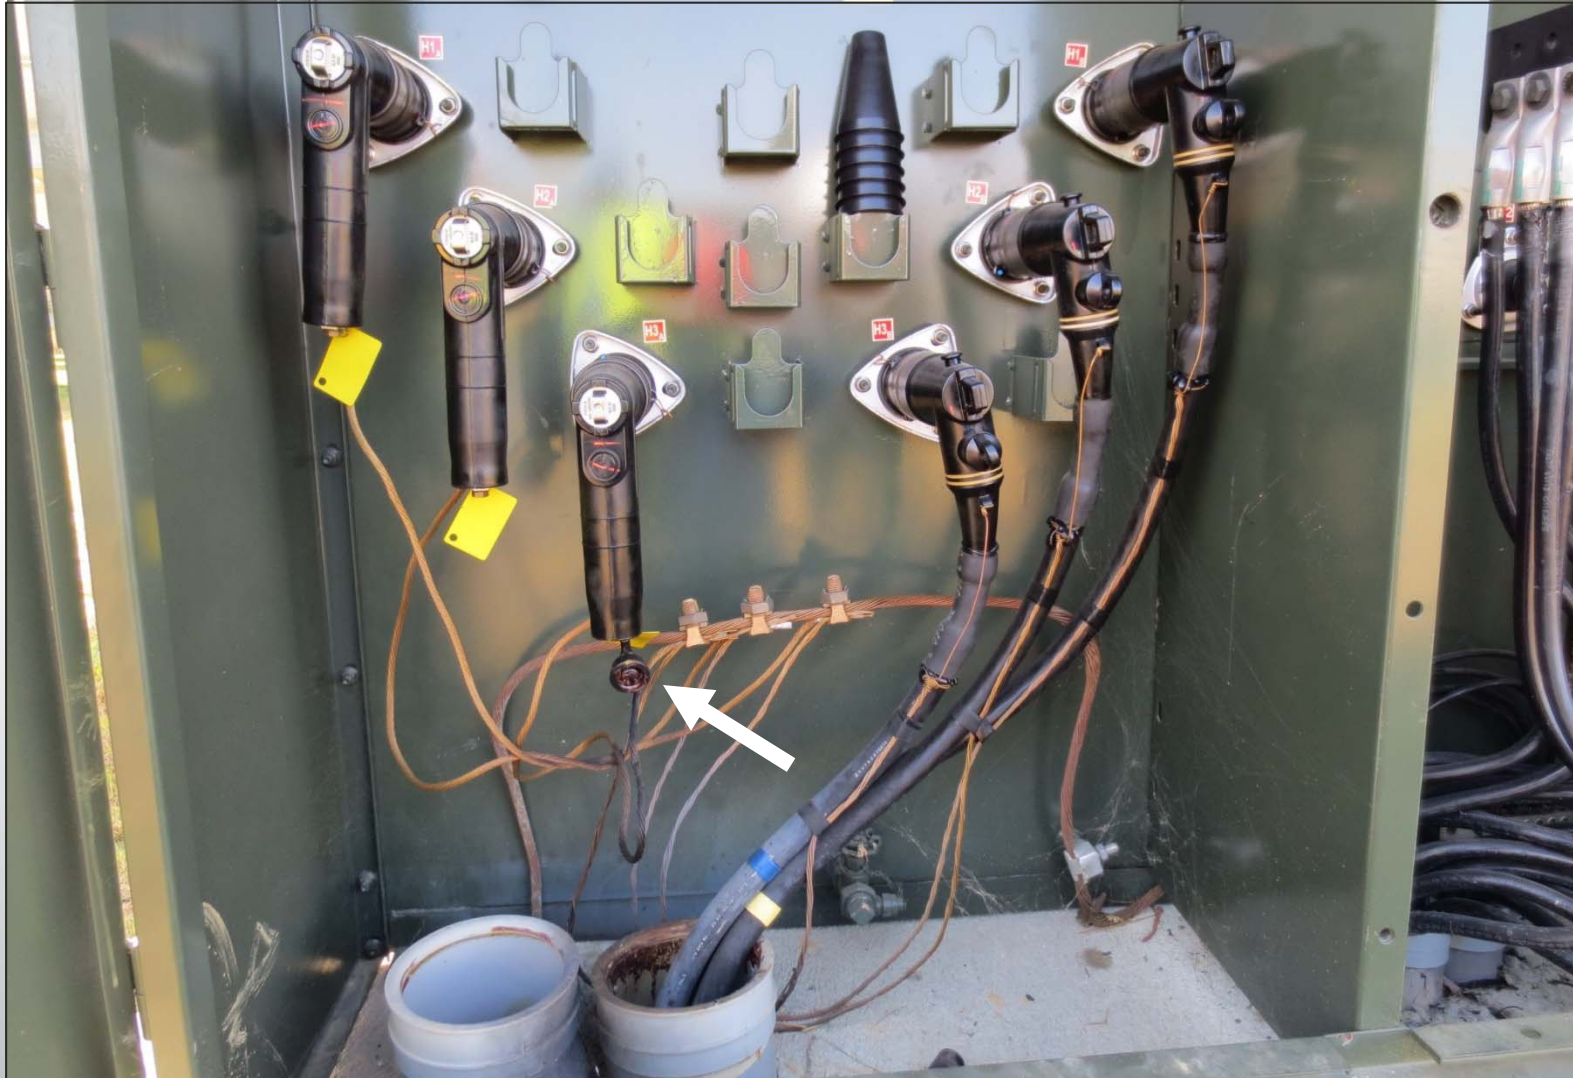
- One surge arrester was blown out
