**RE: Duke Energy Carolinas, LLC's and Duke Energy Progress, LLC's
Comments in Support of Inspections for Legacy Solar Generating
Facilities
Docket No. E-100, Sub 101**

- Present the technical findings from the nine sites in the 2018/2019 periodic inspection pilot
- Provide examples of safety, reliability and power quality issues to look for in a self-inspection
- Not a comprehensive list of all items that could be found in a self-inspection
- Not a training on the self-inspection program details. The self-inspection program is still under development through the 2021 pilot process.

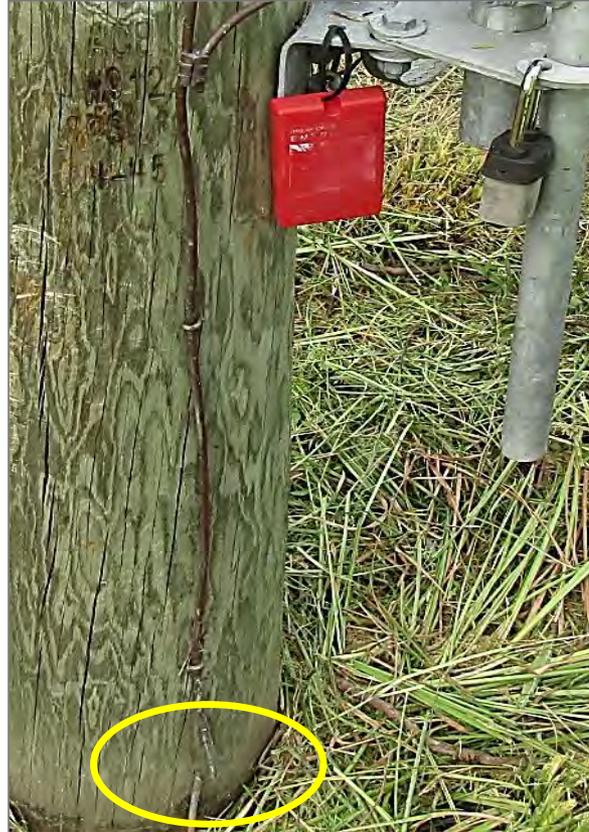
- Gang Operated Air Break (GOAB) switch pole ground cut just above grade
- GOAB switch is unsafe to operate, so site cannot be safely de-energized by O&M personnel

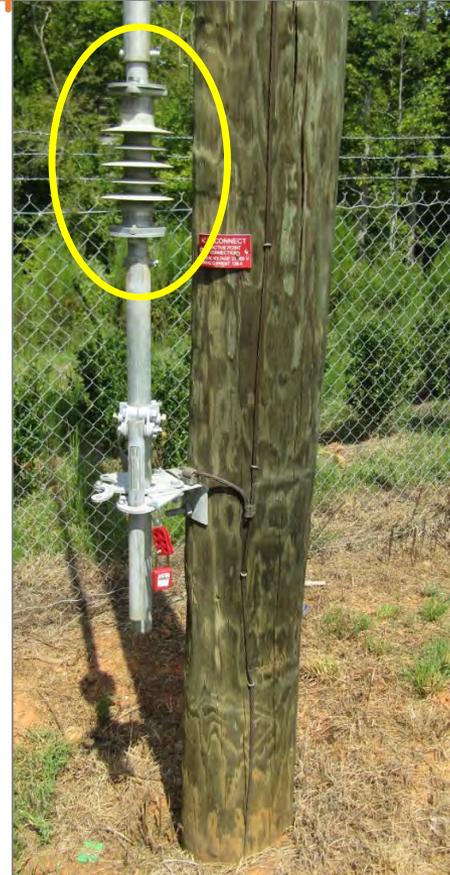
Immediate Safety Issues – GOAB Pole Control Rod Insulator

The GOAB control rod insulator is located too close to grade level, creating a hazard for the switch operator.

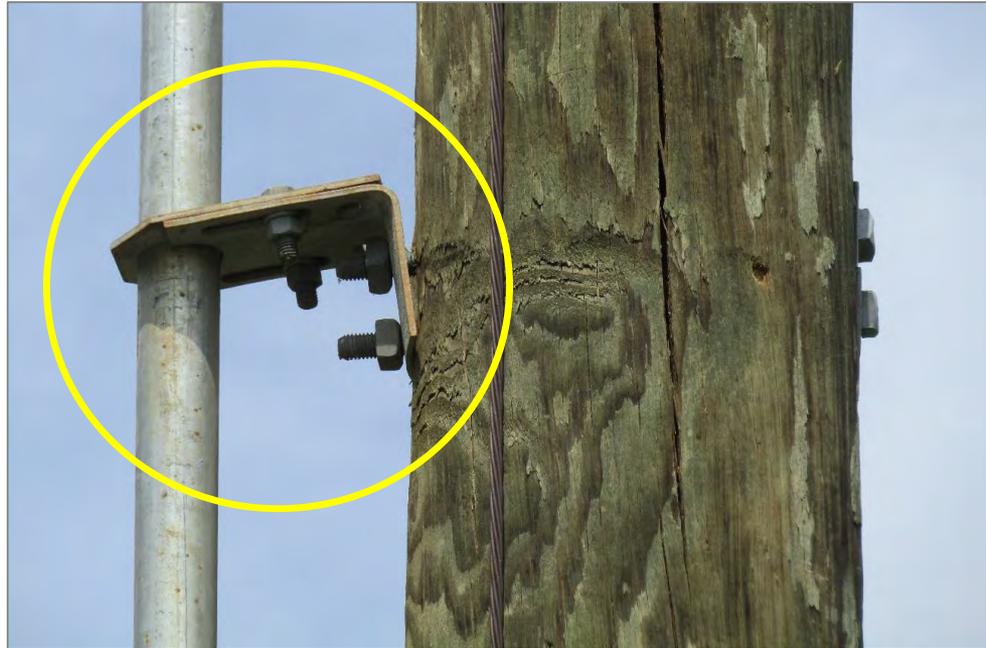
Immediate Safety Issues – GOAB Pole

All GOAB handle and control rod brackets are very loose due to pole drying/shrinkage, lack of maintenance and lack of locking hardware, making the switch unsafe for operation.

NESC 012C, 120A and 121A; NEC 90.1(B), 110.3(B), 110.12 and 110.13; RUS 1728F-803 locknuts;
Duke 03.00-100D lockwashers

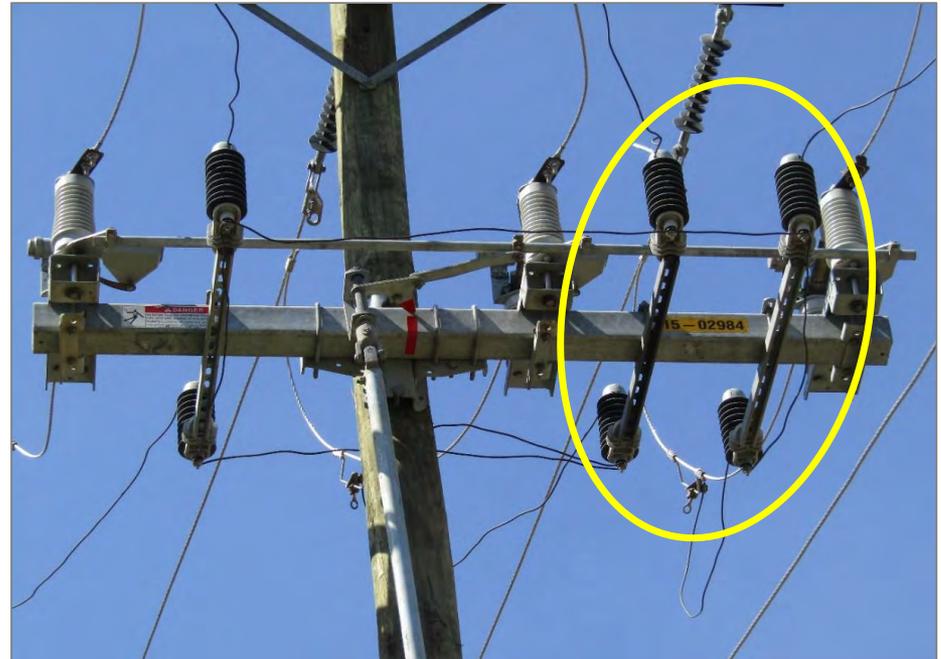
- Incorrect arrester mounting brackets and mounting locations cause insufficient phase-to-phase and phase-to-ground clearances
- 12 inches phase-to-phase and phase-to-ground clearance where NESC requires 18 inches minimum
- Arresters are unnecessary for normally closed GOAB switches on solar facilities

NESC Tables 235-1 and 235-5 Minimum Conductor Clearances

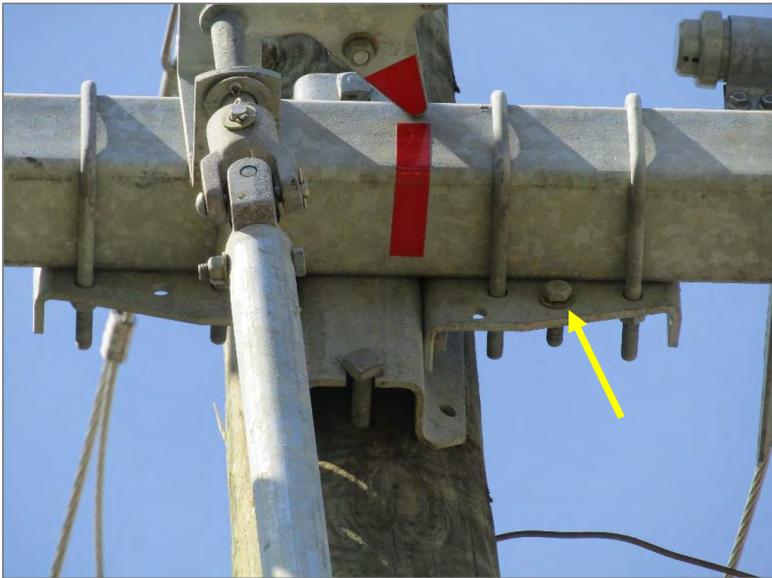
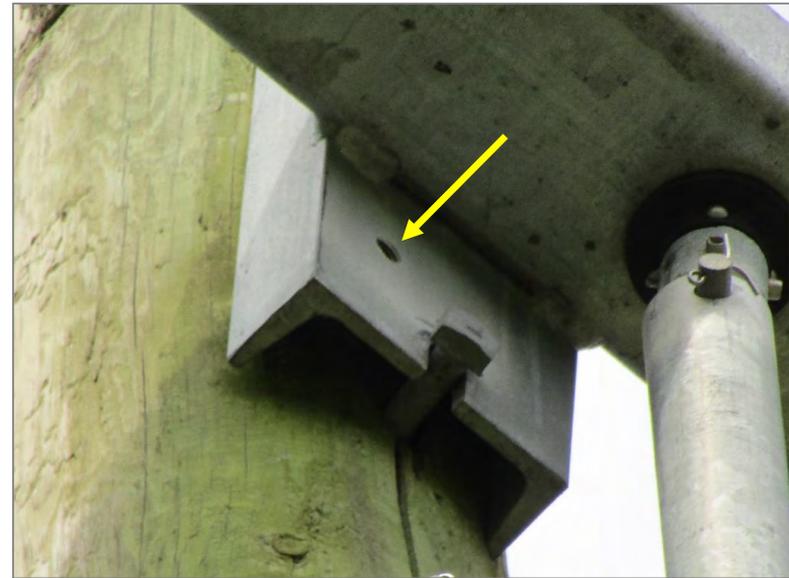
- Missing GOAB frame ground lug
- Missing 2 AWG solid copper jumper from GOAB frame to system neutral

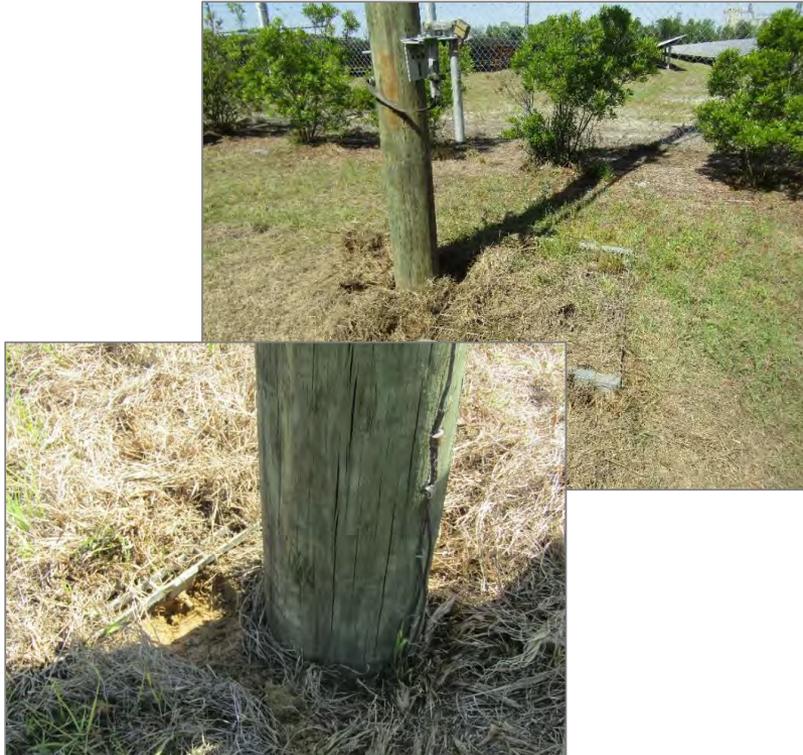
Inadequate GOAB Platform Ground

- An undersized 4 AWG solid copper pole ground is installed where 2 AWG solid copper is required
- An undersized 6 AWG bare stranded copper switch platform ground wire is installed where 2 AWG bare solid copper is required
- The platform has a single connection to the pole ground where it is required to have a looped connection from the pole ground, to the ground rod, to two connections on opposite sides of the platform, back to the pole ground

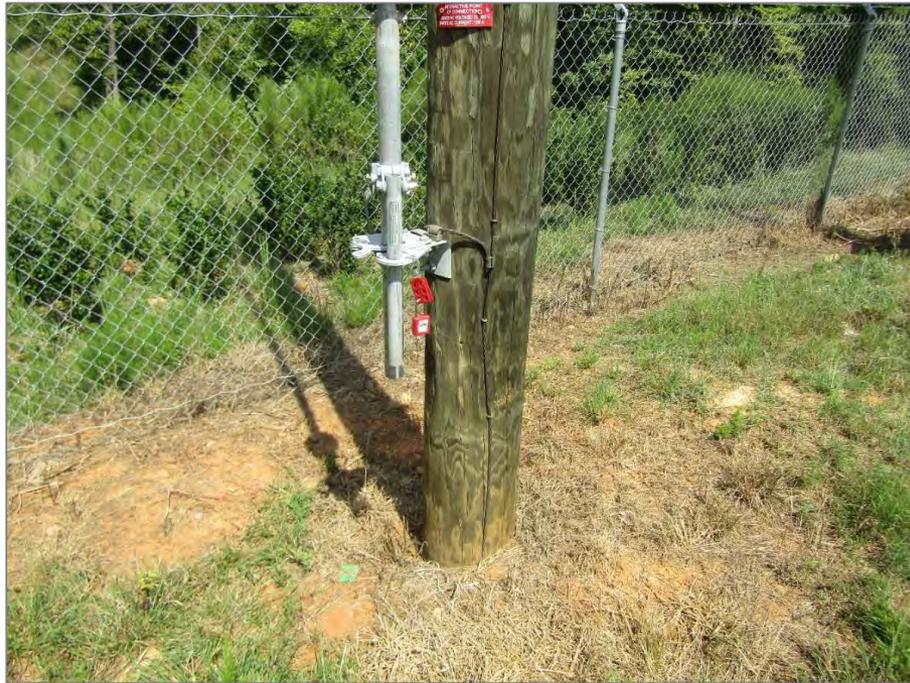
Missing GOAB Ground Grid

Single 2 AWG bare stranded copper pole ground goes below grade to a ground rod instead of a looped ground grid.

Duke 08.10-37; RUS 1728F-803 drawings H3.1 and H4.1

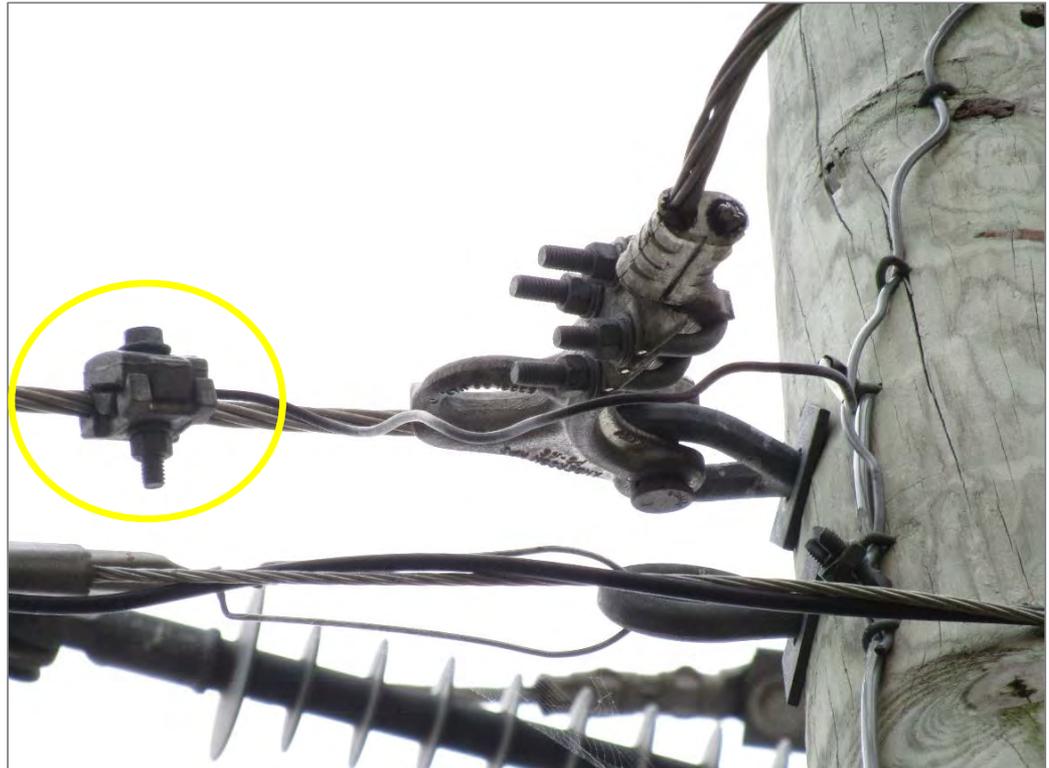
- Pole ground connection to system neutral using a mechanical connector
- A compression connector is required

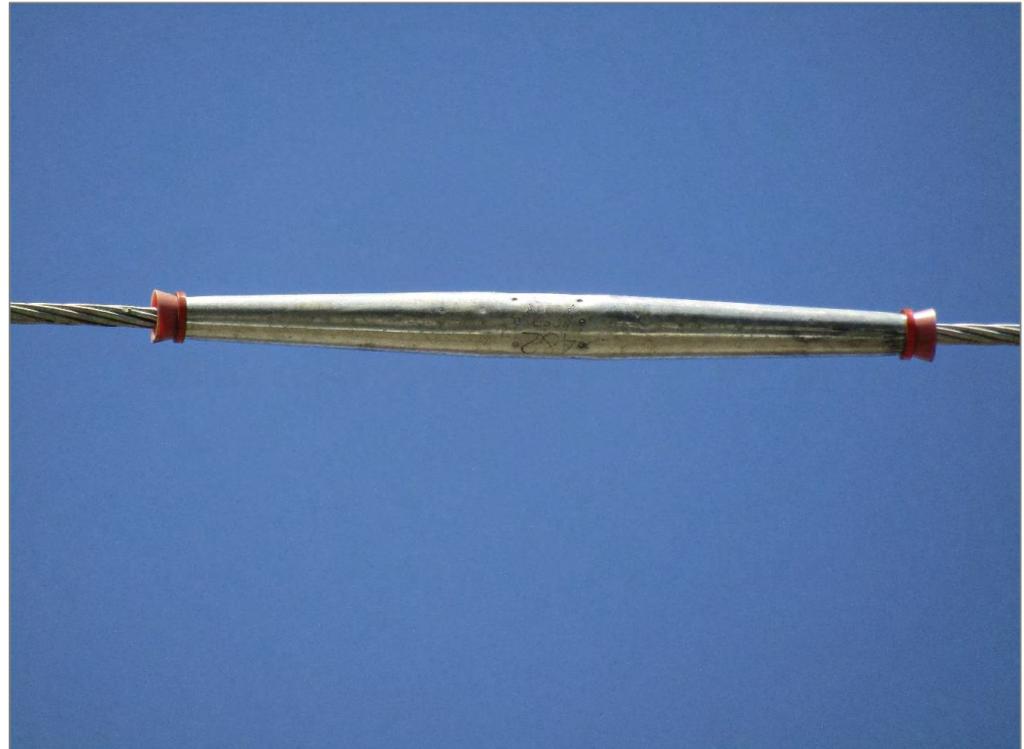
- Automatic splice used in slack spans between GOAB and Duke meter pole
- Compression slice required
- Automatic splices are prohibited in slack spans because they require tension and can vibrate loose

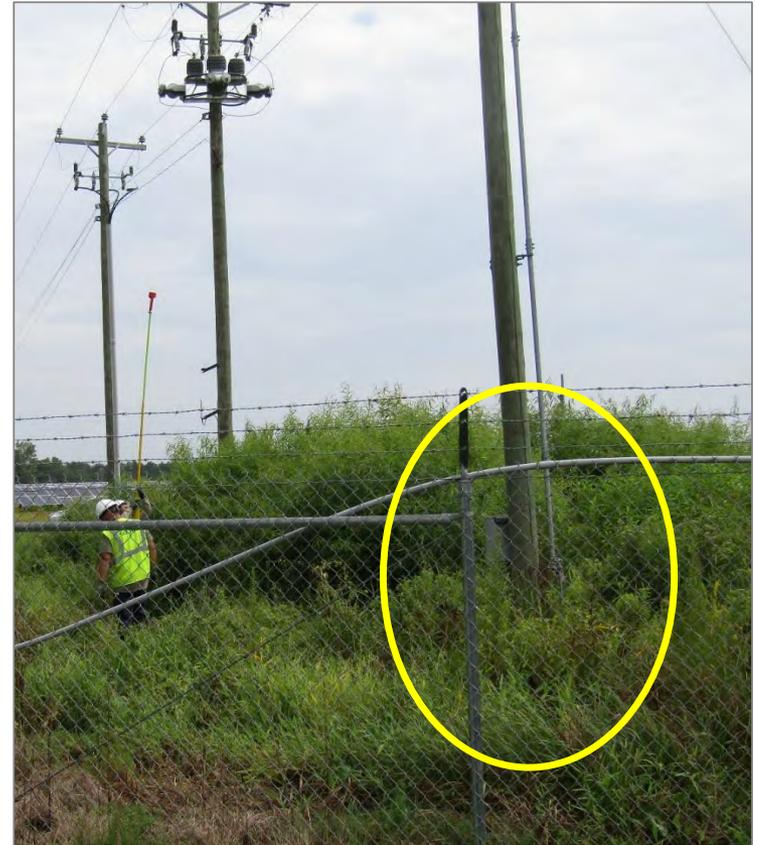
Reliability & Power Quality Issues – GOAB Pole Vegetation Management

- Overgrown vegetation makes safe operation of the GOAB control rod difficult
- Overgrowth at this site concealed a cut GOAB pole ground conductor, making operation of the GOAB switch unsafe
- Overgrown deep ruts and large groundhog holes, making navigation at the point of interconnection dangerous

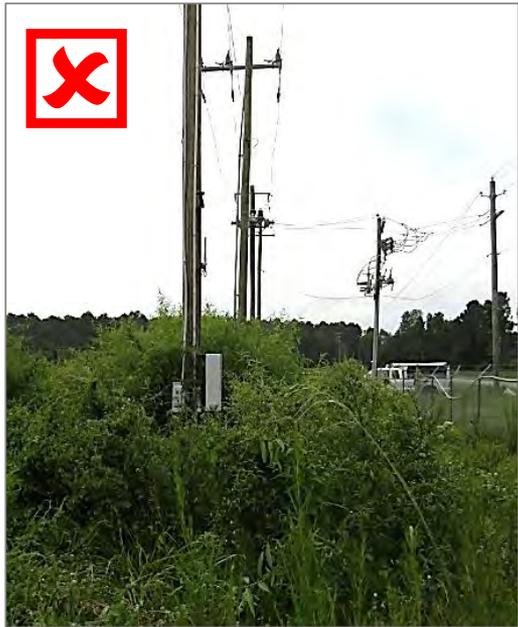
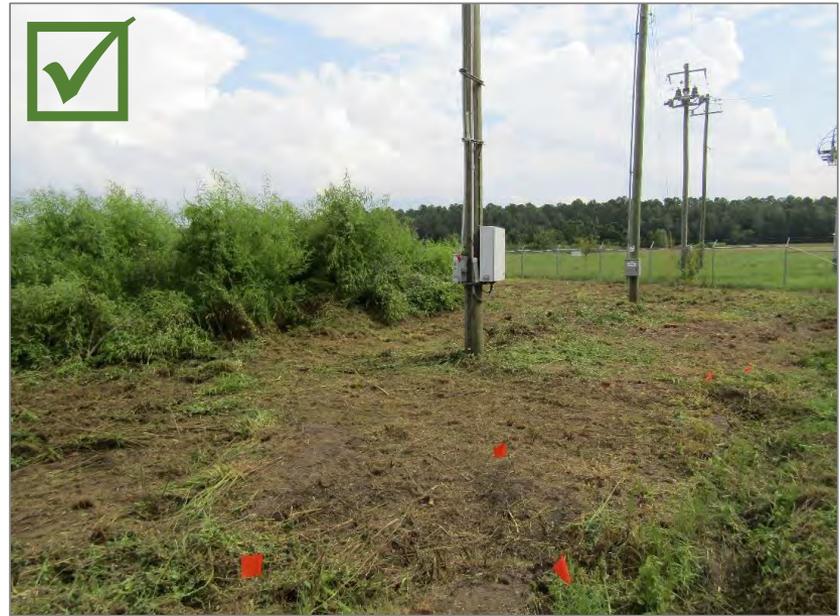
Overgrown vegetation at the customer meter pole was cut by O&M staff during inspection visit, revealing hazardous deep ruts and large groundhog holes.

NESC 012, 120A, 121A and 218A1; DE Legacy Carolinas Dist. Manuals, Line Clearance, 1.8 -
Brush Cutting

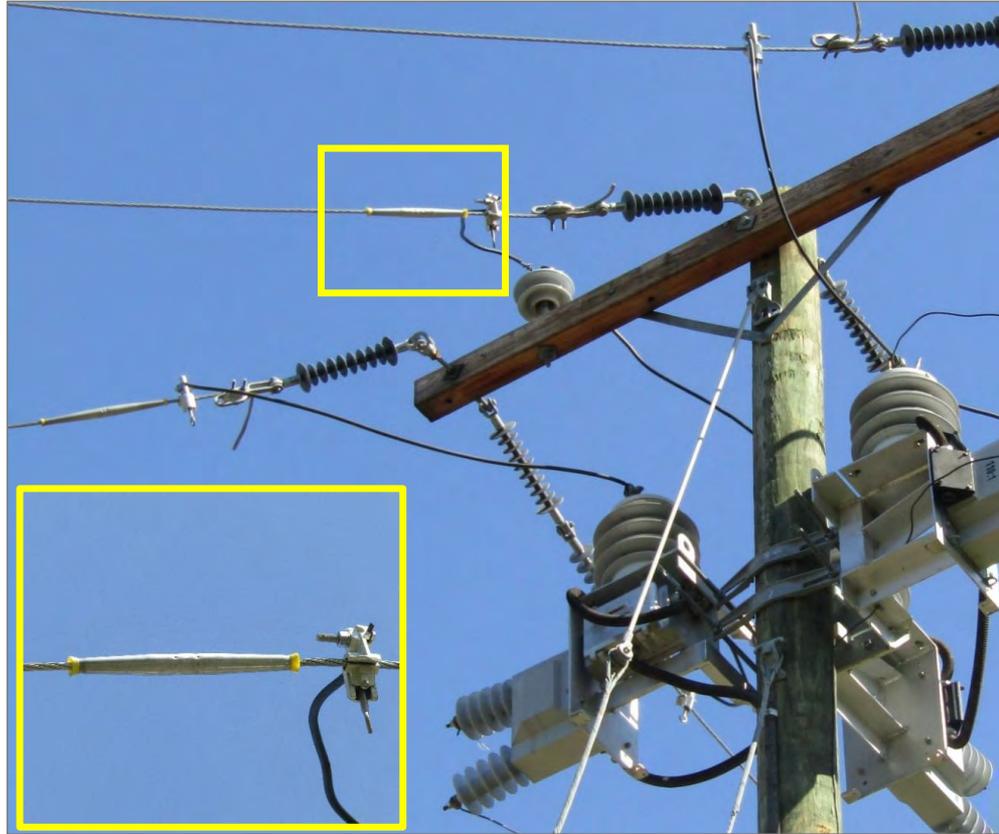
- Automatic splices in slack span instead of compression splices
- Splices within 1 ft of pole line hardware
- Splices must be min. 10 ft from hardware on new construction and min. 2 ft for repair work

NEC 110.3(B); Duke 04.02-102 and 04.09-120; RUS 1728F-803 Conductor Installation Specifications

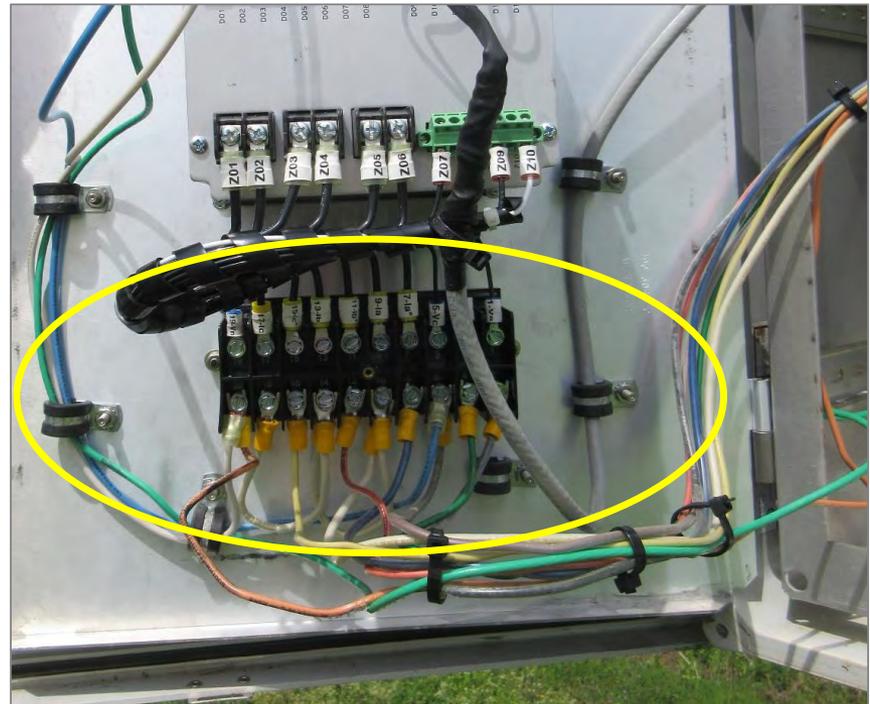
- 12 AWG solid copper field wiring used on hinged door mounted meter test switch
- All crimp-on fork terminals were loose on field installed solid wiring
- Crimp terminals are only listed for stranded wiring
- Several terminals came loose when door was opened due to stiff wire and loose connections
- Stranded wire is required for flex hinged door wiring

NEC 110.3(B), 110.14(A), 110.23 and 400.3

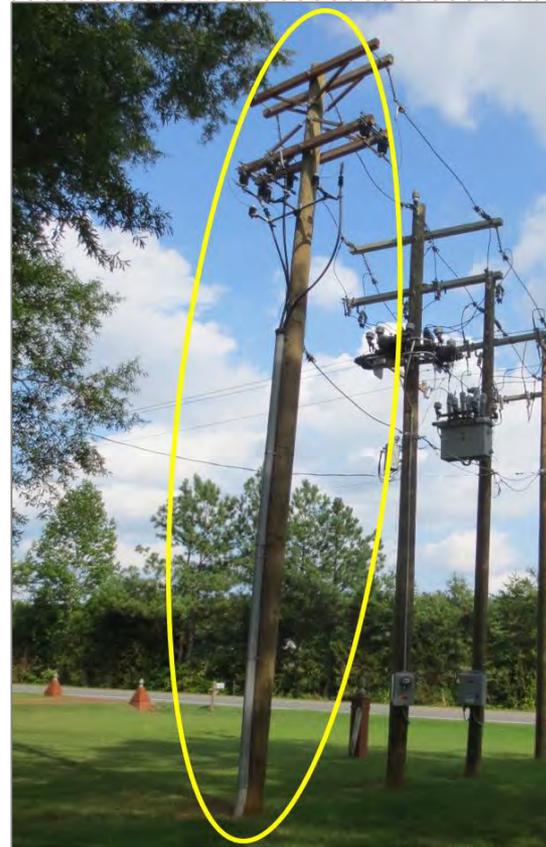
- Summer riser ampacity of 1/0 AWG AL MV cable is 160 Amps
- Facility rated current is 232 Amps

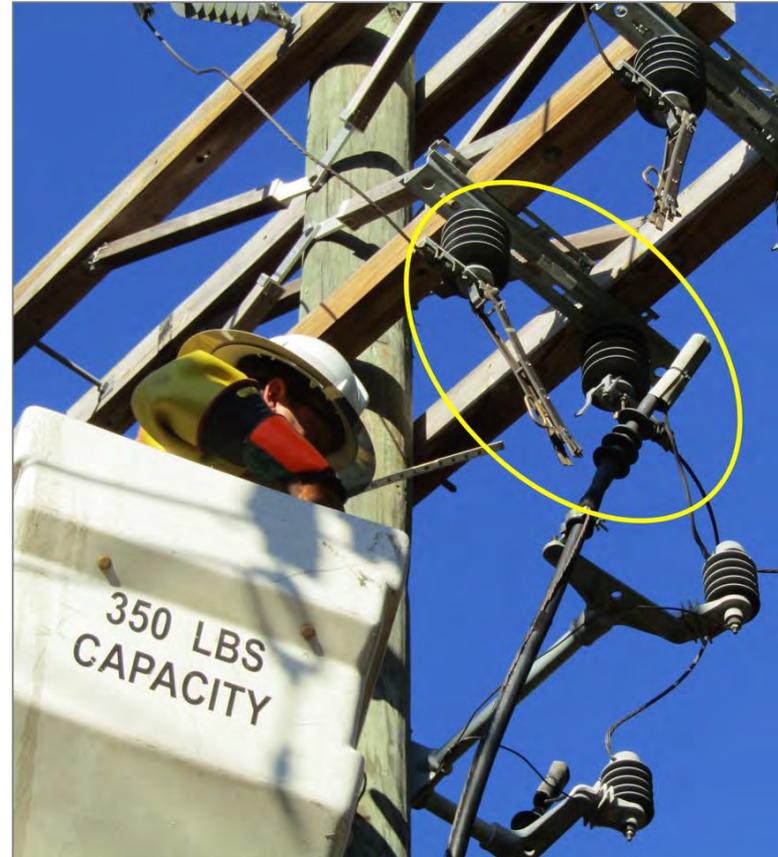
Unsafe Disconnect Switches

- 6 inches phase-to-phase clearance when opening switch
- 9 inches phase-to-ground clearance when opening switch
- NESC requires 14 inches phase-to-phase and 12 inches phase-to-ground minimum on 12 kV system

NESC Tables 235-1 and 235-5; DEC-DEM Distribution Standards Manual-Part 1 – 10003DUK and 88420DUK; Duke 21.05-100

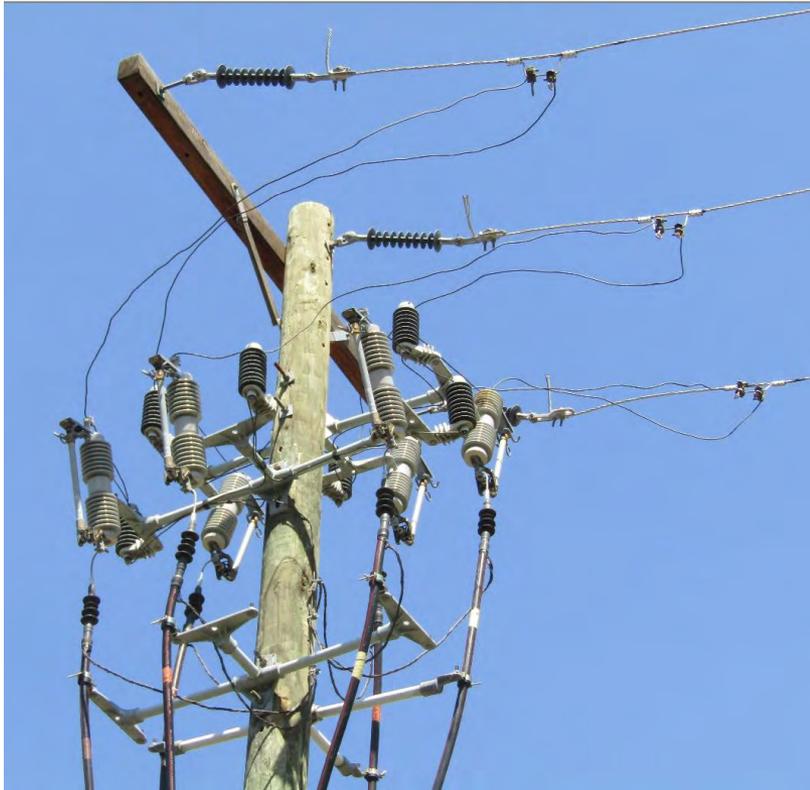
Insufficient Clearances

- Non-standard and incorrect framing of double-riser pole causes clearance problems
- Many instances of insufficient phase-to-ground clearances less than NESC horizontal and vertical requirements of 14 and 18 inches respectively
- Incorrect positioning of arresters above energized parts will result in phase-to-ground faults if arresters blow
- Bare copper jumpers and missing animal guards exacerbates the problems

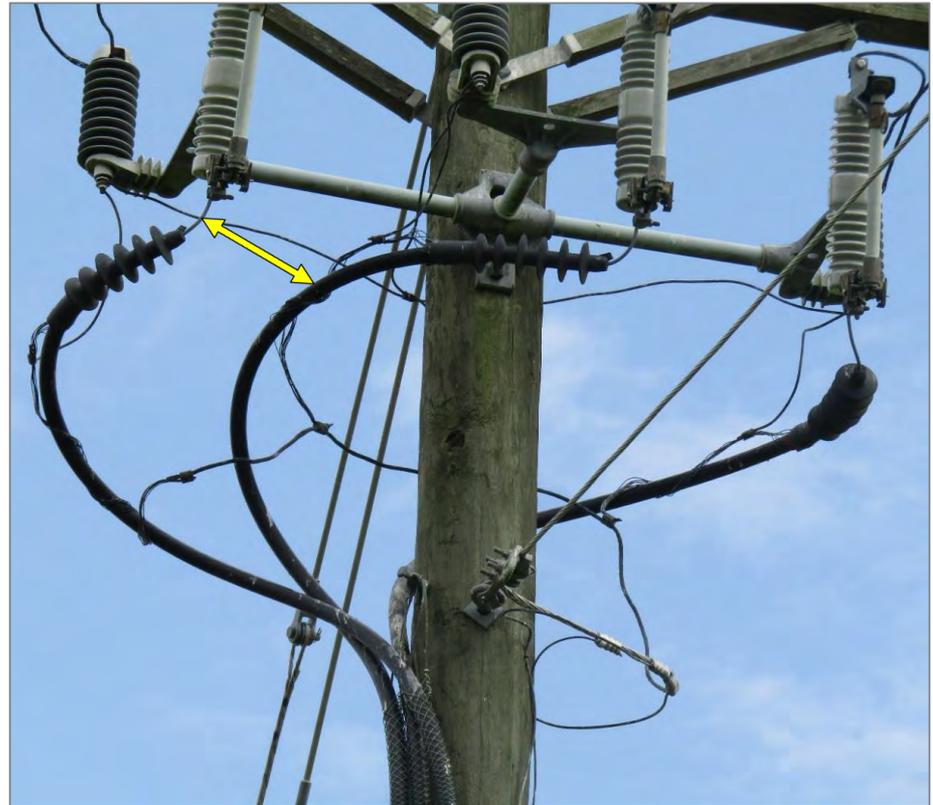
- Terminators installed horizontally instead of vertically
- Insufficient phase-to-ground clearance between termination and concentric neutral of opposite phases
- Orientation results in buildup of pollution on the terminators, leading to premature failure

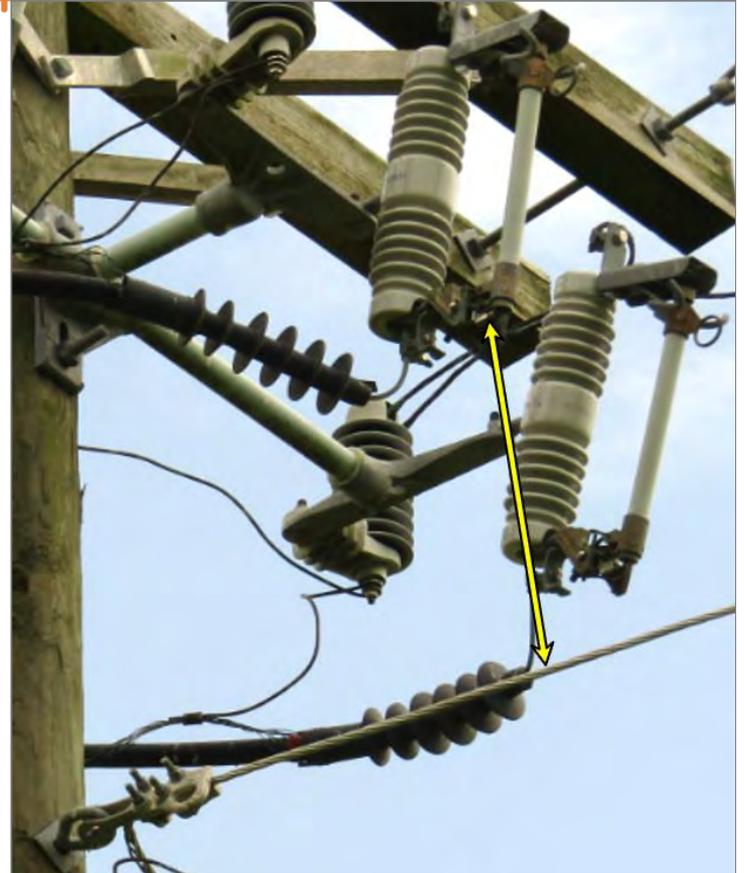
Reliability & Power Quality Issues – Riser Pole System Neutral Elevation

- System neutral installed too high
- Results in insufficient phase-to-ground clearance when cutout is opened
- Likely to cause a flashover when the middle phase cutout is open
- Requires terminators to be incorrectly installed horizontally

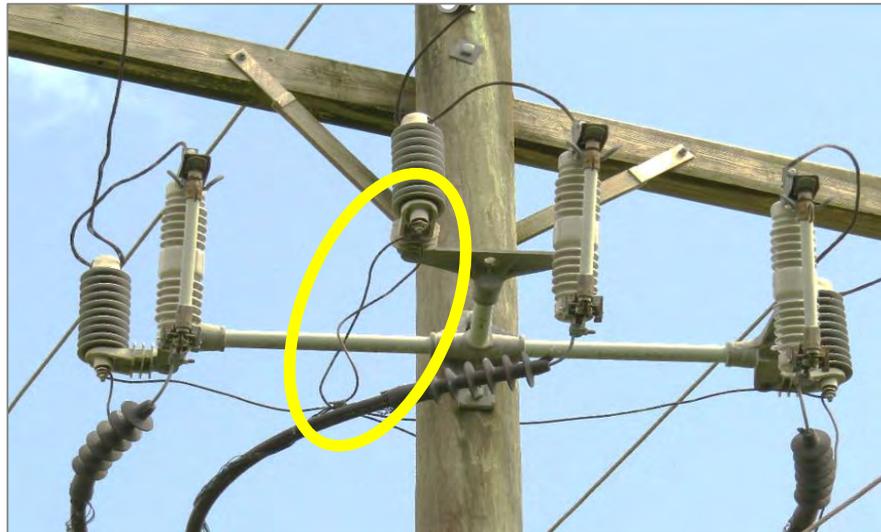
The lightning arrester ground leads are incorrectly connected to both the neutral bus and to the MV cable concentric neutrals. If an arrester fails it is likely to cause a phase-to-ground fault.

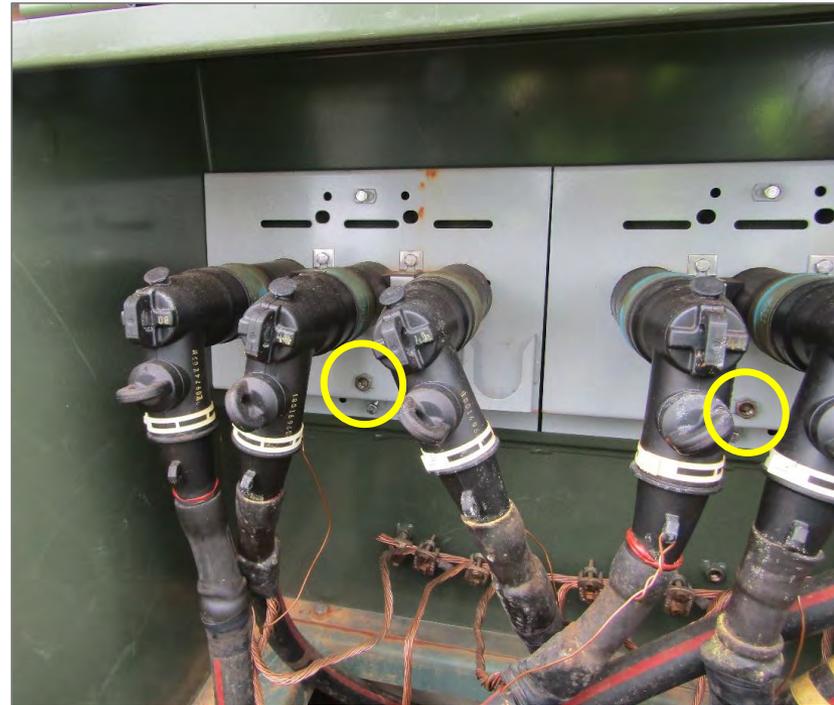
- Missing ground lugs and ungrounded junction plates in MV junction enclosure
- Results in a buildup of static charge on semi-conductive junction bodies, which presents a safety hazard to personnel
- May cause premature failure of junction due to corona discharge

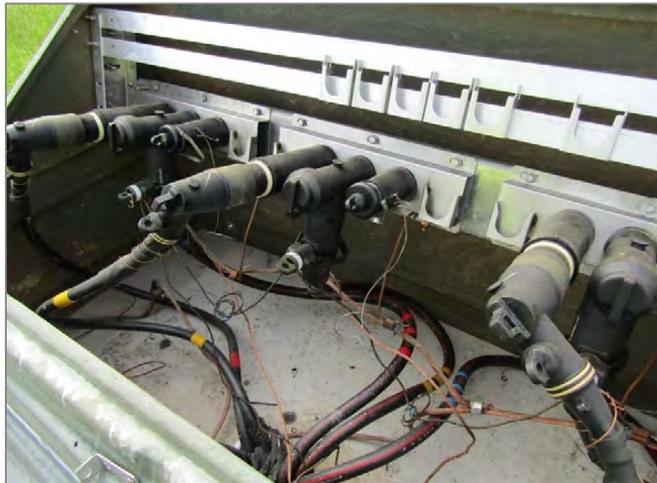
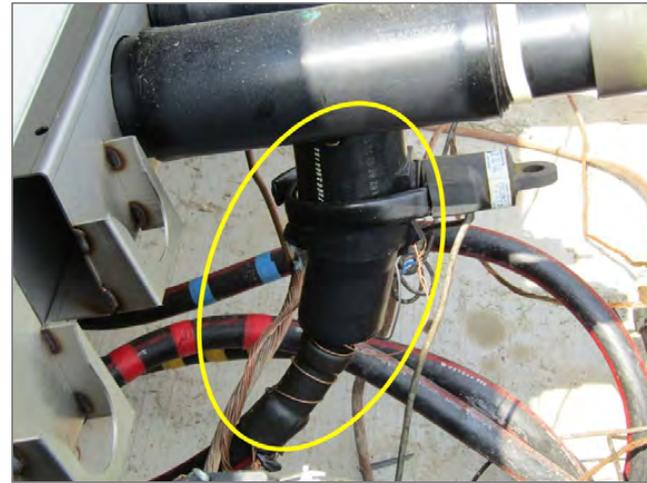
Excess cable length results in insufficient bending radius and deformation of the T-bodies. This can lead to premature cable and elbow failure.

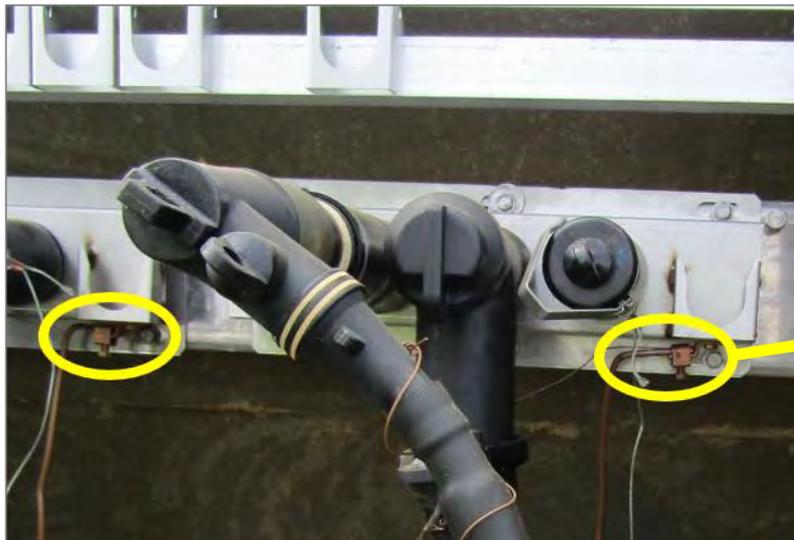
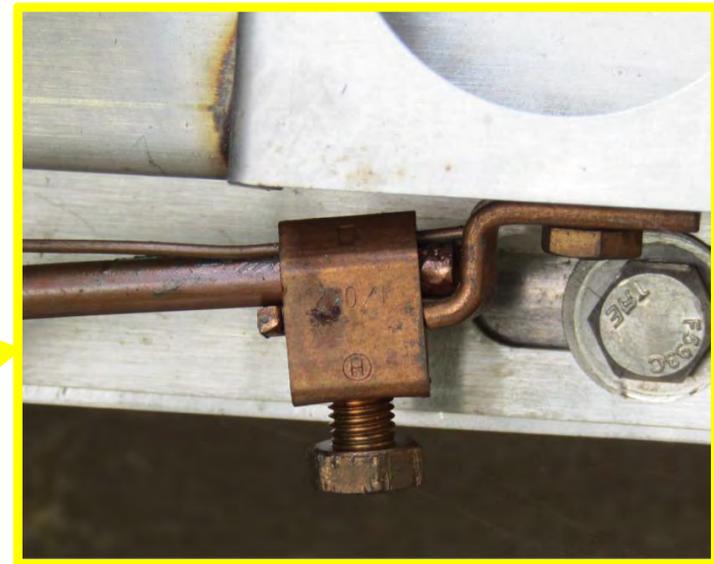
Improper Grounding

Two wires are installed in a lug that is only designed to accept one wire, so neither wire is ensured to maintain a good connection.

NEC 110.3(B) and 110.14(A)

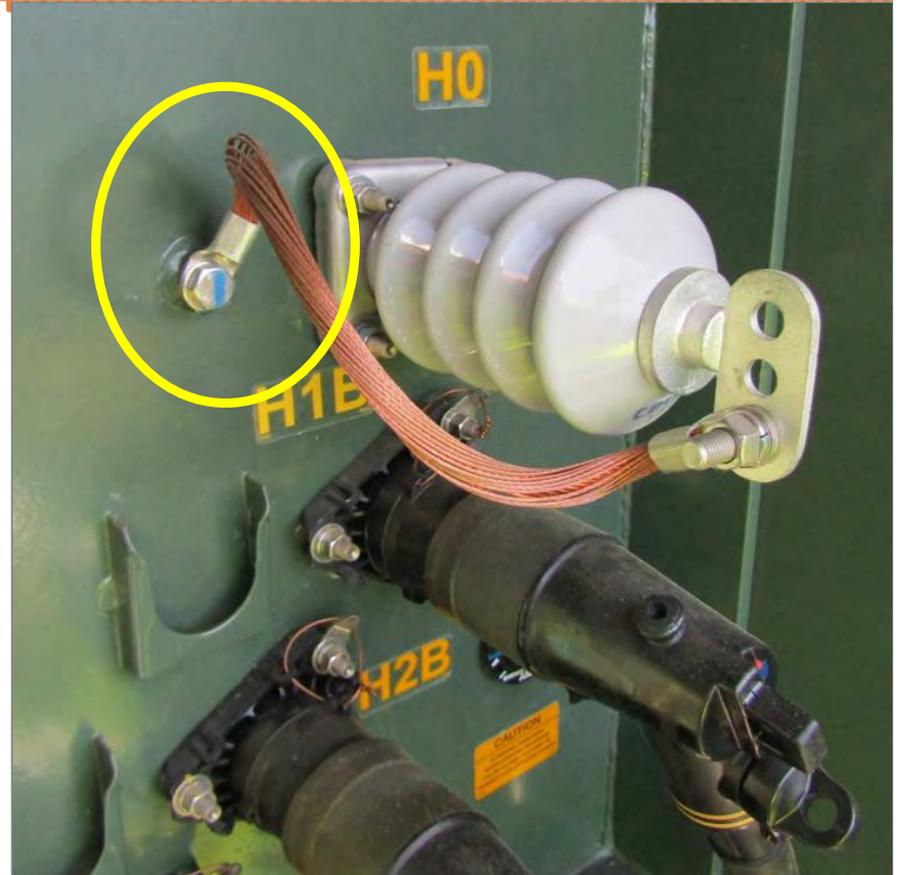
- H0 bushing not directly connected to transformer ground loop
- H0 bushing only grounded through the transformer tank
- Requires neutral current to flow through steel tank to return to MV cable neutrals

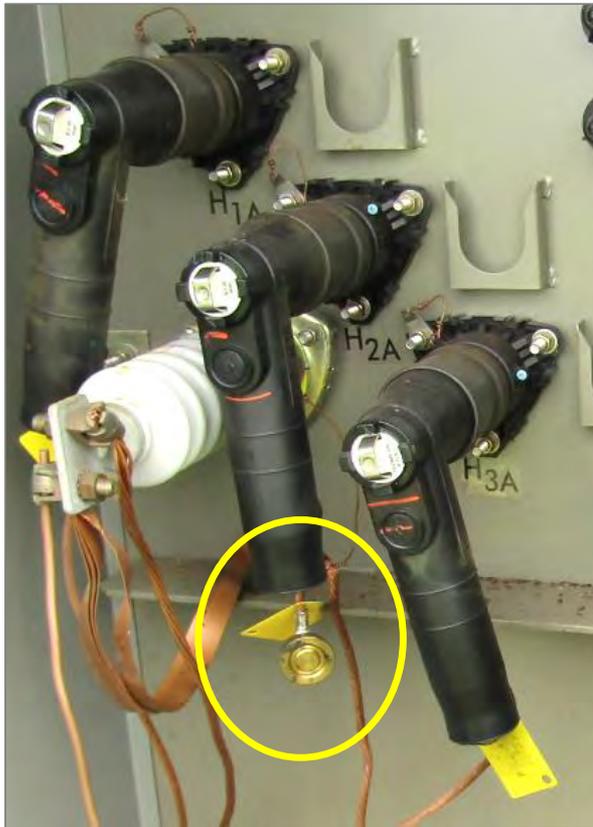
Blown Lightning Arrester

- Blown lightning arrester in MV transformer
- Interior of blown arrester body remains energized and is open, resulting in an uninsulated accessory
- Open arrester body is subjected to moisture and is prone to carbon tracking
- Creates a safety hazard for O&M personnel

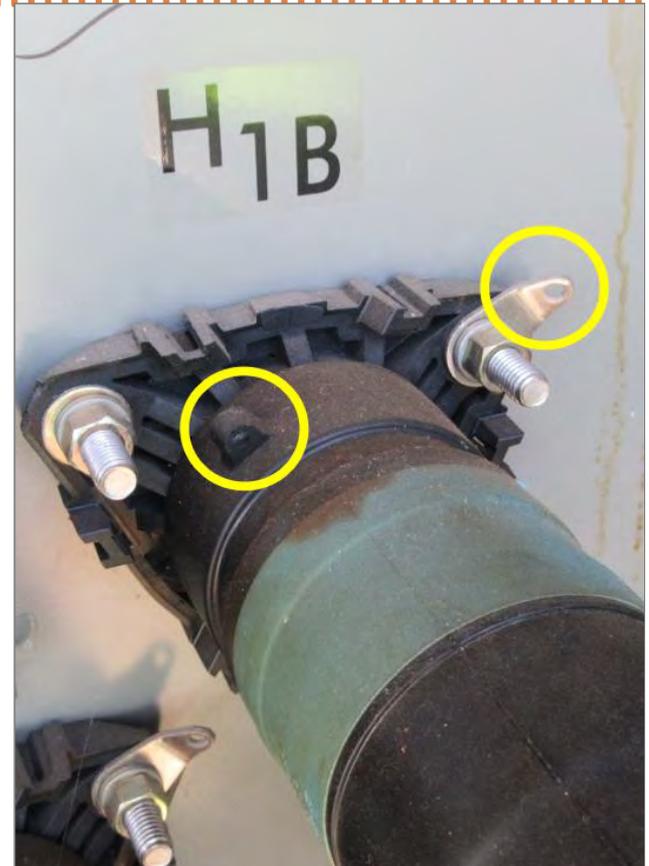
Missing Elbow and Bushing Drains

- Missing electrostatic drain ground wires on transformer bushing inserts, cable elbows and elbow arresters
- Results in a buildup of static charge on bushing accessories, which presents a safety hazard to personnel
- May cause premature failure of accessories due to corona discharge
- Electrostatic drain wires must be 14 AWG bare solid copper

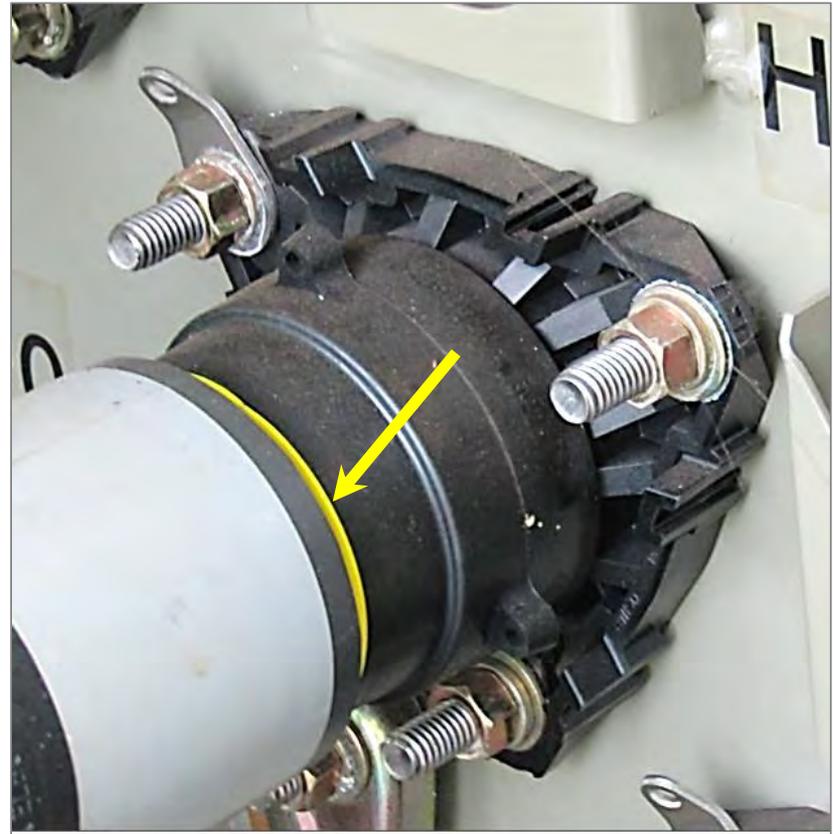
- The colored latch indicator ring is visible on MV cable elbows and arresters that are not fully seated on the bushings
- Loose elbows allow moisture and dust intrusion and carbon tracking, creating the risk of a flashover
- A full maintenance check is required on these elbows to clean and seal the bushings with silicone grease

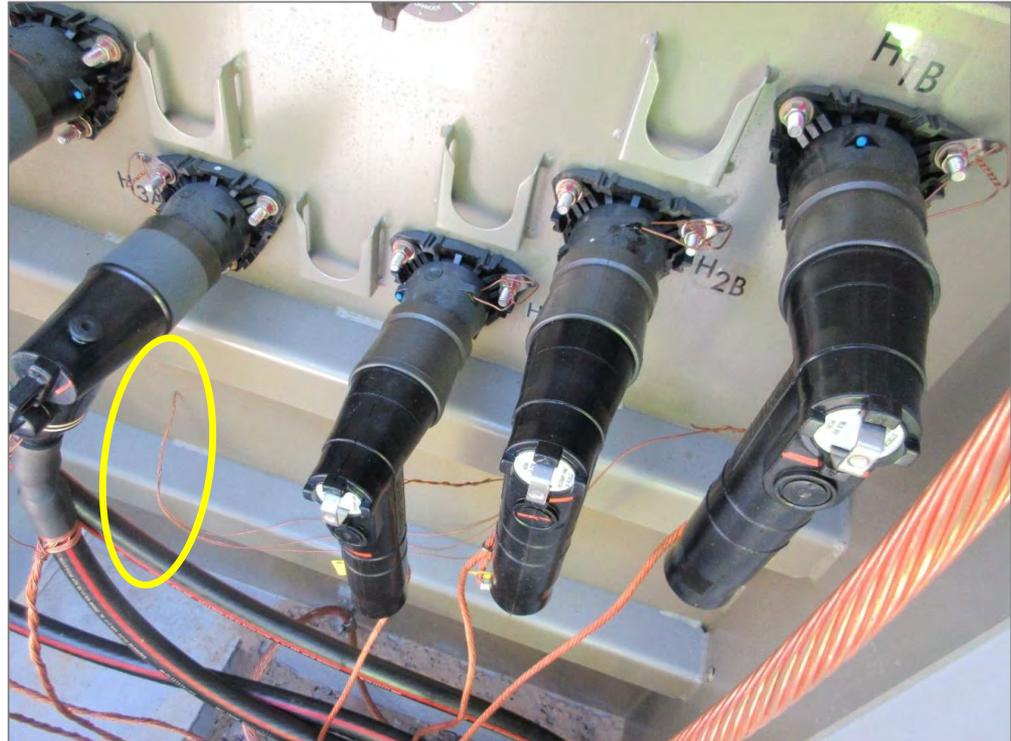
Disconnected Electrostatic Drains

The electrostatic drain wires for the transformer lightning arresters are twisted together but not connected to ground, creating a shock hazard for O&M personnel.

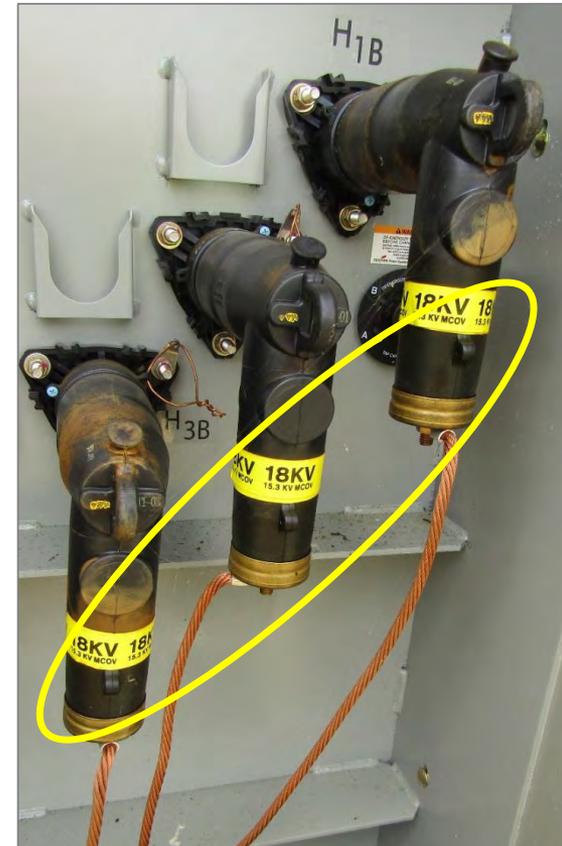
Missing Arrester Drains

- Missing electrostatic drain ground wires on lightning arresters grounding eyelets
- Results in a buildup of static charge on bushing accessories, which presents a safety hazard to personnel
- May cause premature failure of accessories due to corona discharge
- Electrostatic drain wires must be 14 AWG bare solid copper

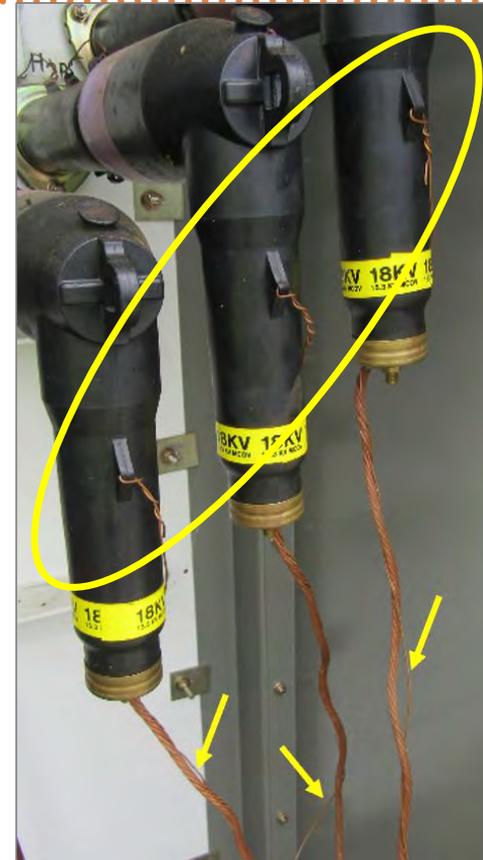
Electrostatic Drain Routing

- The 14 AWG arrester electrostatic drain wires are wrapped around the full length of the 2 AWG ground lead
- When an elbow blows, the high velocity ejection of the MOV blocks and brass ground lead cap will likely tear the drain wire away from the elbow eyelets, leaving the elbow ungrounded
- This creates a shock hazard for O&M personnel

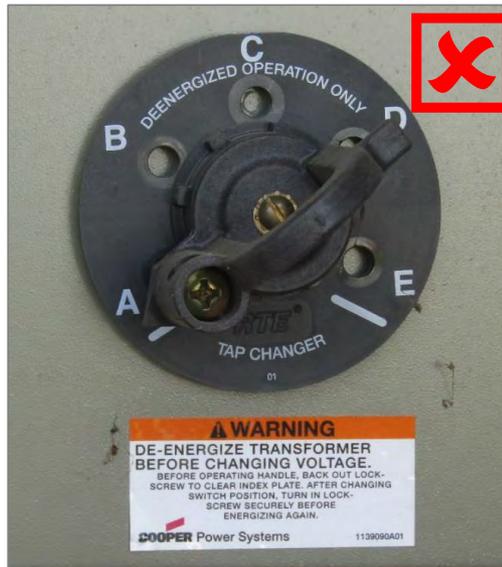
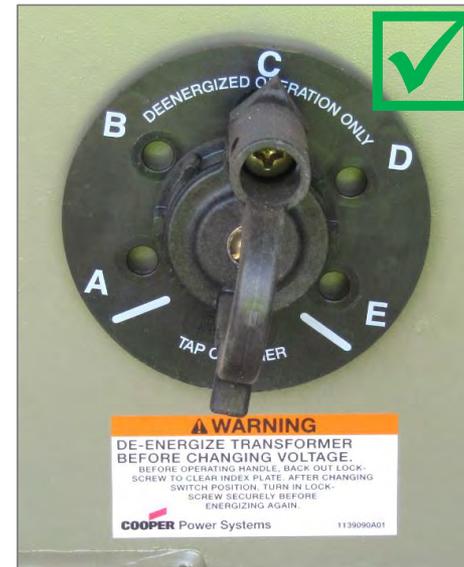
Transformer tap changer not set to nominal voltage tap C. Causes inverter settings to be out of compliance with the site Interconnection Agreement and IEEE 1547.

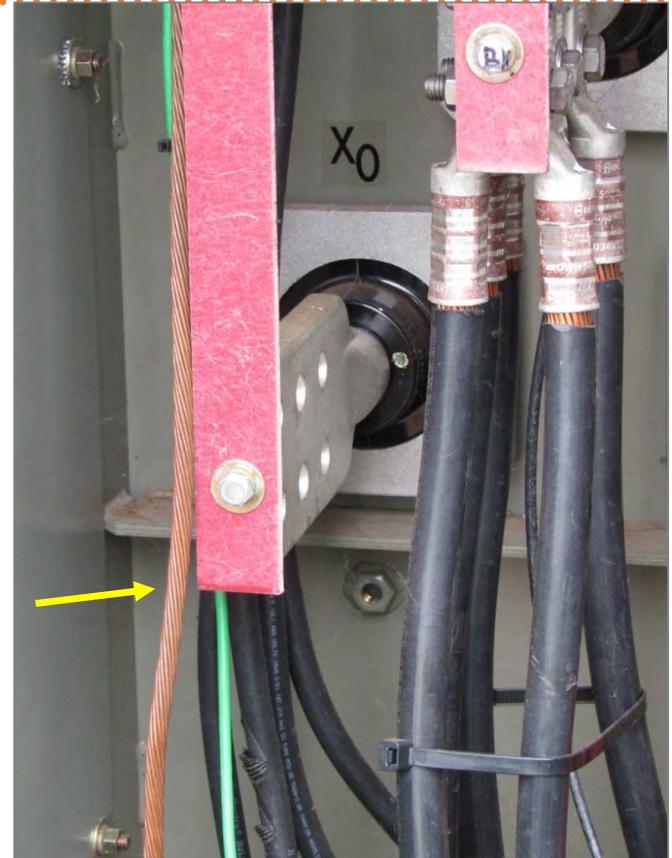
- The 4/0 AWG bare copper GS bushing ground jumper is not secured away from the intentionally ungrounded X0 bushing
- The bare copper jumper may inadvertently contact the X0 bushing, causing improper inverter operation and possible inverter damage

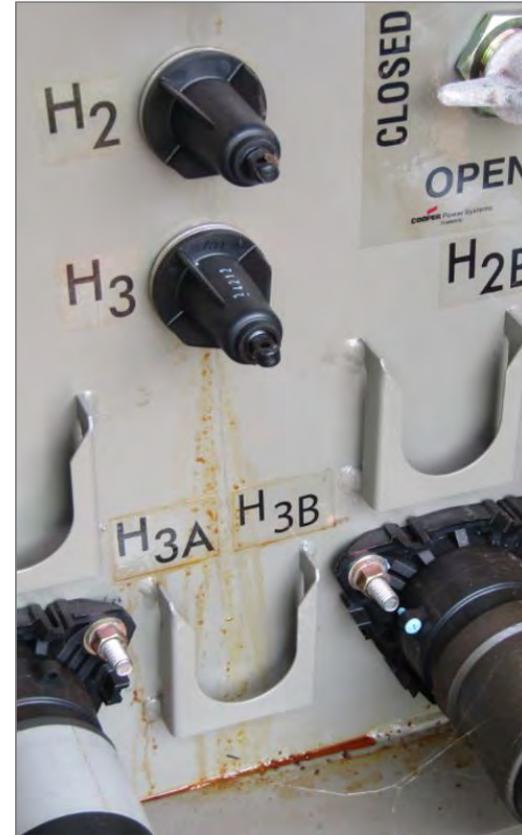
- Under-oil arrester switch with a leaking seal
- Oil leak must be monitored and repaired as necessary to prevent soil contamination and transformer damage
