**RE: Duke Energy Carolinas, LLC's and Duke Energy Progress, LLC's
Comments in Support of Inspections for Legacy Solar Generating
Facilities
Docket No. E-100, Sub 101**

- Present the technical findings from the nine sites in the 2018/2019 periodic inspection pilot
- Provide examples of safety, reliability and power quality issues to look for in a self-inspection
- Not a comprehensive list of all items that could be found in a self-inspection
- Not a training on the self-inspection program details. The self-inspection program is still under development through the 2021 pilot process.

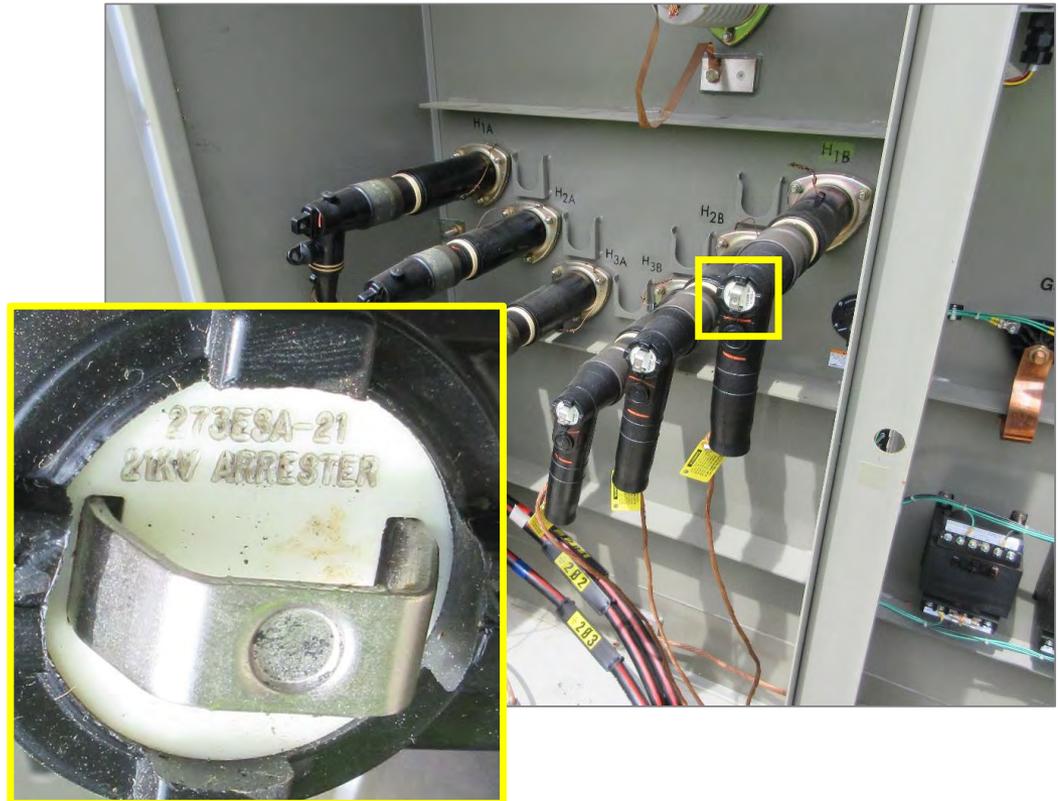
- 21 kV (17 kV MCOV) arresters installed on 23 kV transformer
- 18 kV (15.3 kV MCOV) arresters are required for adequate system protection

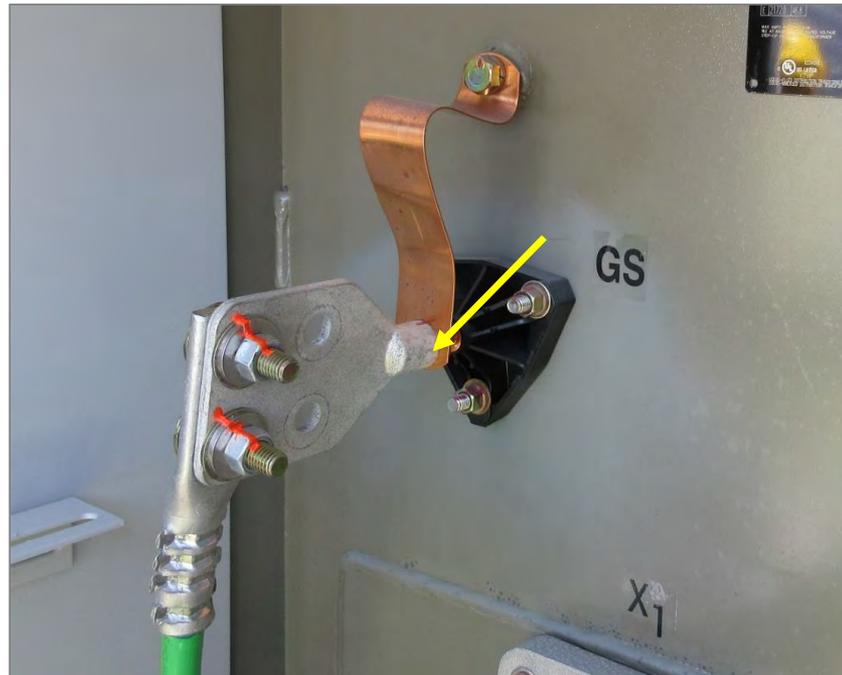
Loose Transformer Spade

Loose ground shield (GS) bushing jam nut and spade

NEC 110.3(B) and 110.14(D); Duke 27.02-112

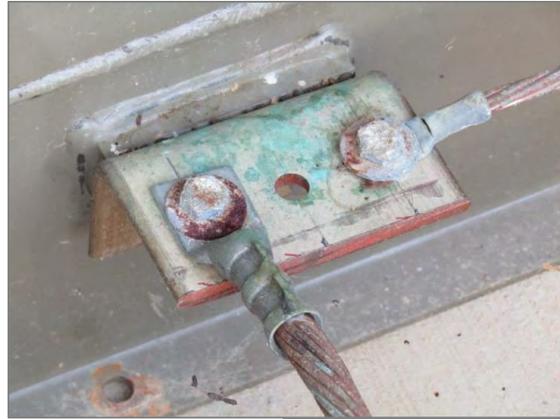
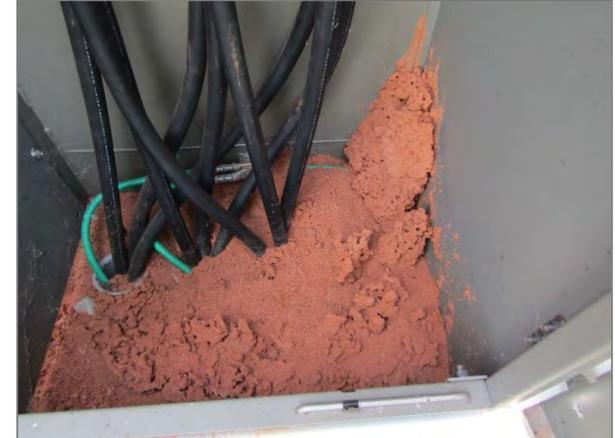
- 3/8-inch zinc-plated steel hardware is undersized and has insufficient corrosion protection
- Transformer ground pads are threaded for 1/2-inch bolts
- 1/2-inch bronze tank ground lugs, 1/2-inch silicon bronze bolts or 1/2-inch stainless steel bolts are required for transformer grounding due to highly corrosive conditions of condensation, flooding and soil contact (e.g. fire ant mounds)

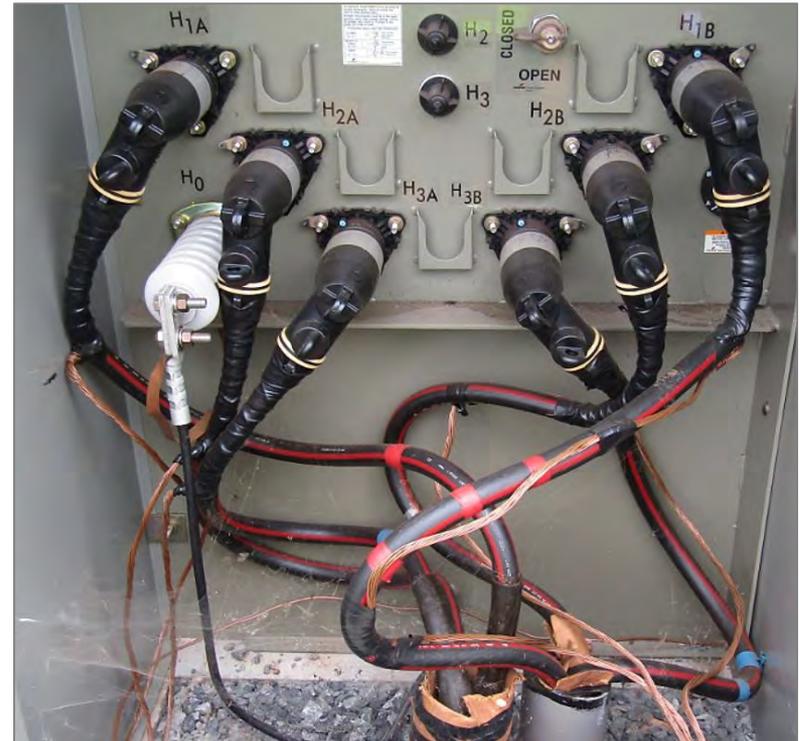
- MV cable bending radius as little as 4 times cable diameter
- Minimum bending radius is required to be 12 times cable diameter
- Tight bend can lead to premature cable failure due to insulation damage and separation of shield layers within the cable
- Cables like the ones shown at right may have irreversible damage due to having been bent so tightly

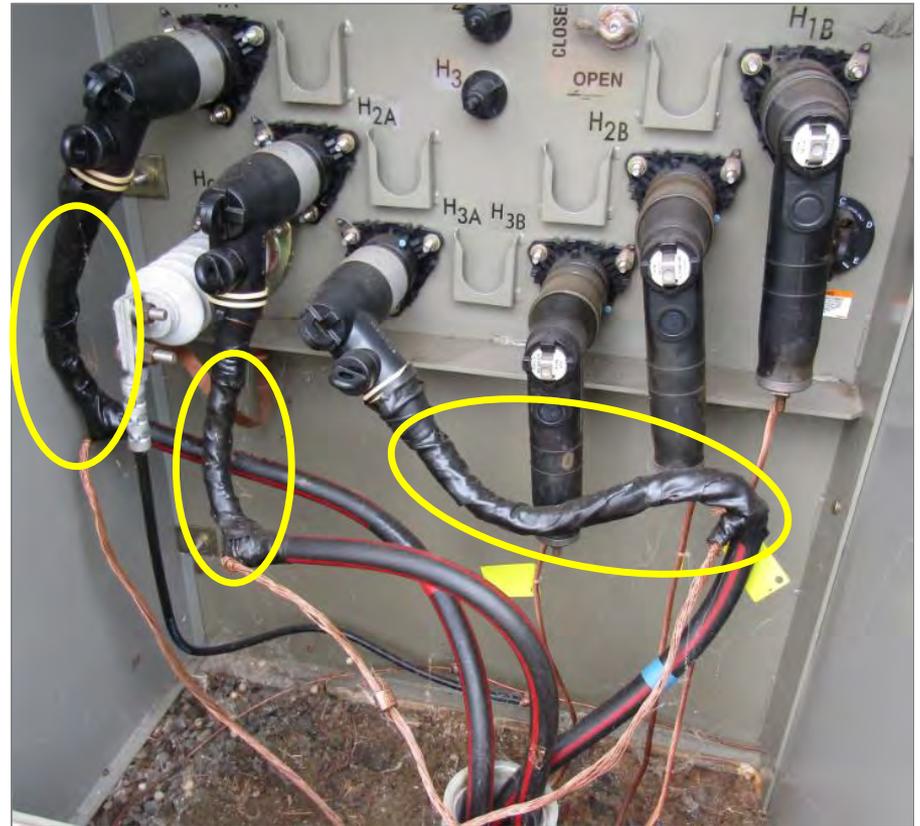
- In addition to insufficient bending radius, these poorly terminated MV cables have an excessive length of cable jacket and concentric neutral removed
- In a fault condition, large neutral currents may flow on cable semiconducting shield layer, causing a cable fire

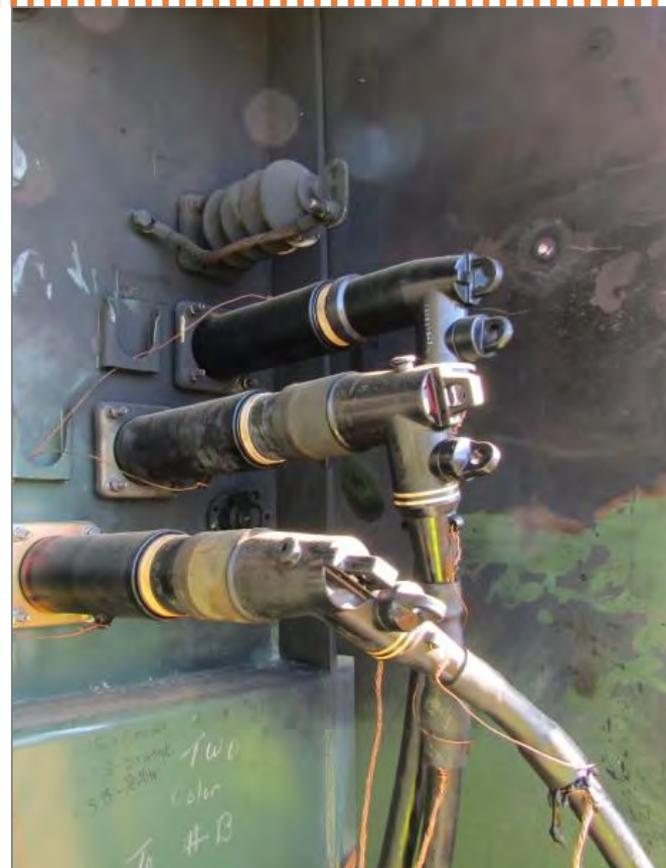
Inferior Blown Elbow Repair

A blown elbow repair had the following deficiencies:

- Residual soot and debris not cleaned can damage components from carbon tracking
- Burned paint not repaired, allowing the steel enclosure to rust
- Soot covered safety labels not cleaned
- The 15 kV replacement elbow is sufficient for the 12 kV system but does not match the other 25 kV class elbows on site

NEC 110.12, 110.12(B) and 328.14; RUS 1728F-803 General Construction Specifications;
RUS 1728F-806 section 1(b)

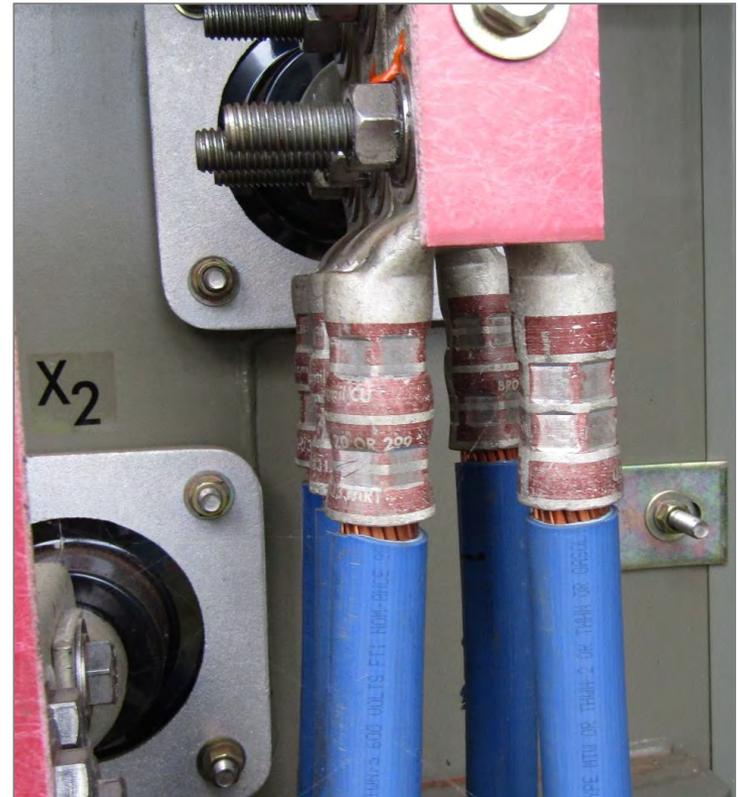
- Compression lugs have an insufficient number of crimps
- Lugs only have 2 crimps but 4 crimps are required
- 4 brown color bands indicate 4 crimps are required with the standard crimping die used for these connectors

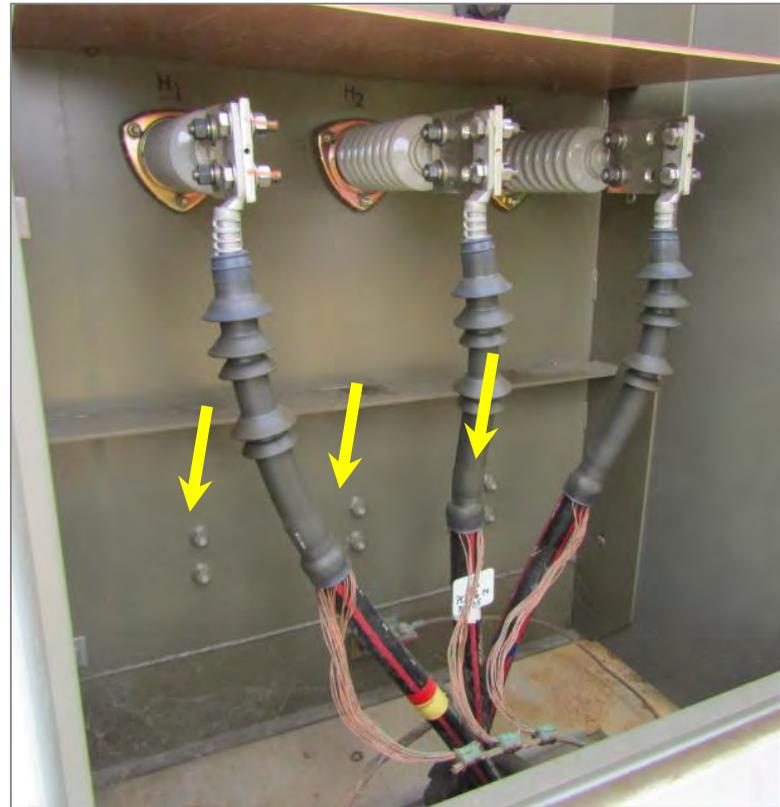
Missing Lightning Arresters

- The transformer at the end of the line in the underground feeder does not have lightning arresters installed on the live front primary bushings
- Switching and lightning voltage surges will double and reflect back up the line on the MV cable
- This increases potential for overvoltage and equipment damage

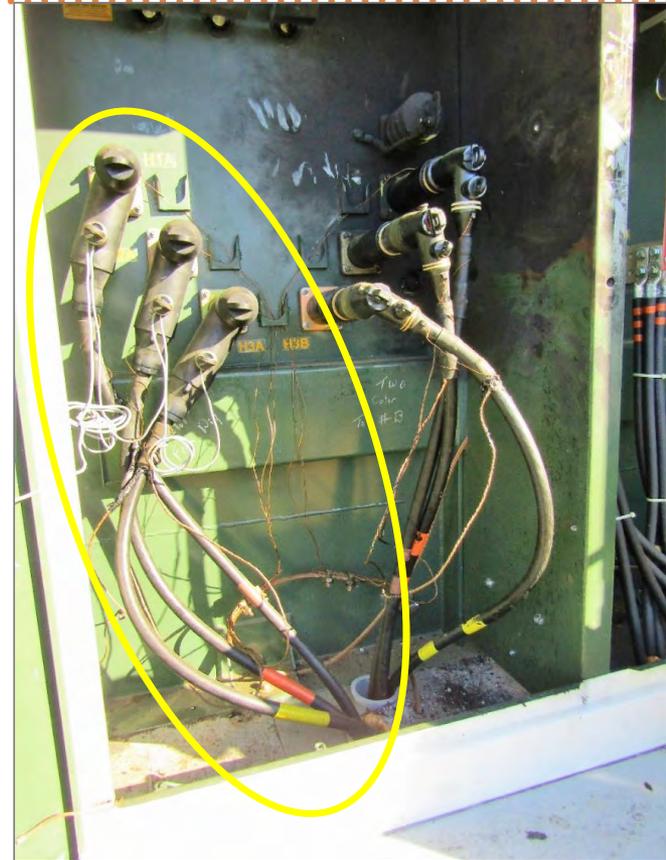
- 1/0 AWG AL MV cables are directly buried and have an ampacity of only 222 Amps
- Facility rated current is 232 Amps
- The cables are frequently overloaded for many hours per day and may fail prematurely

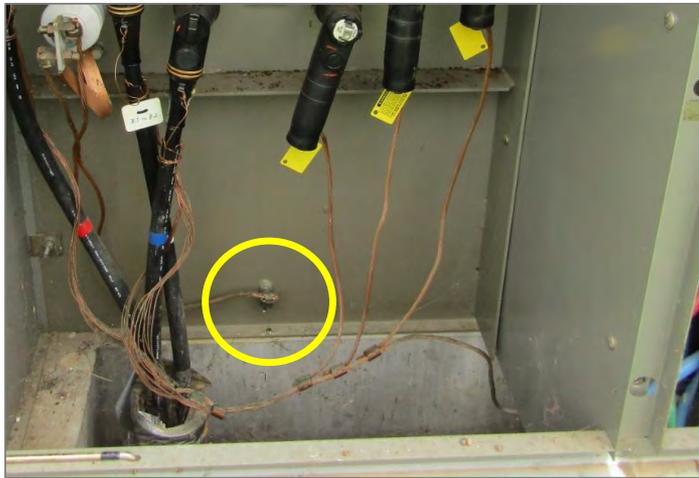
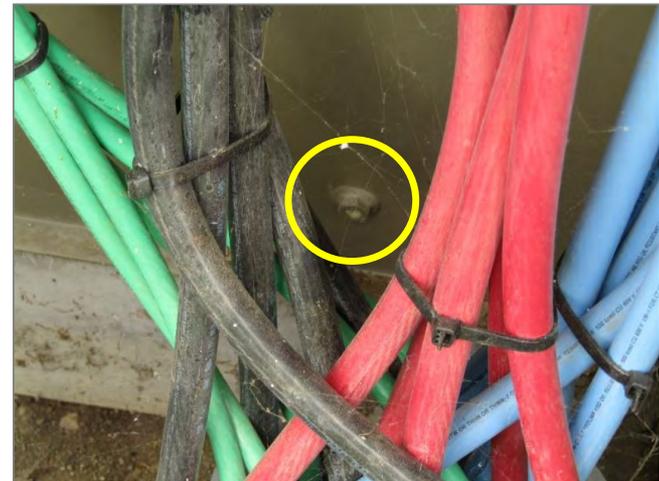
Missing Ground Connection

- Ground bus only connects to ground pad in primary compartment
- Ground bus is not connected to ground pad in secondary compartment

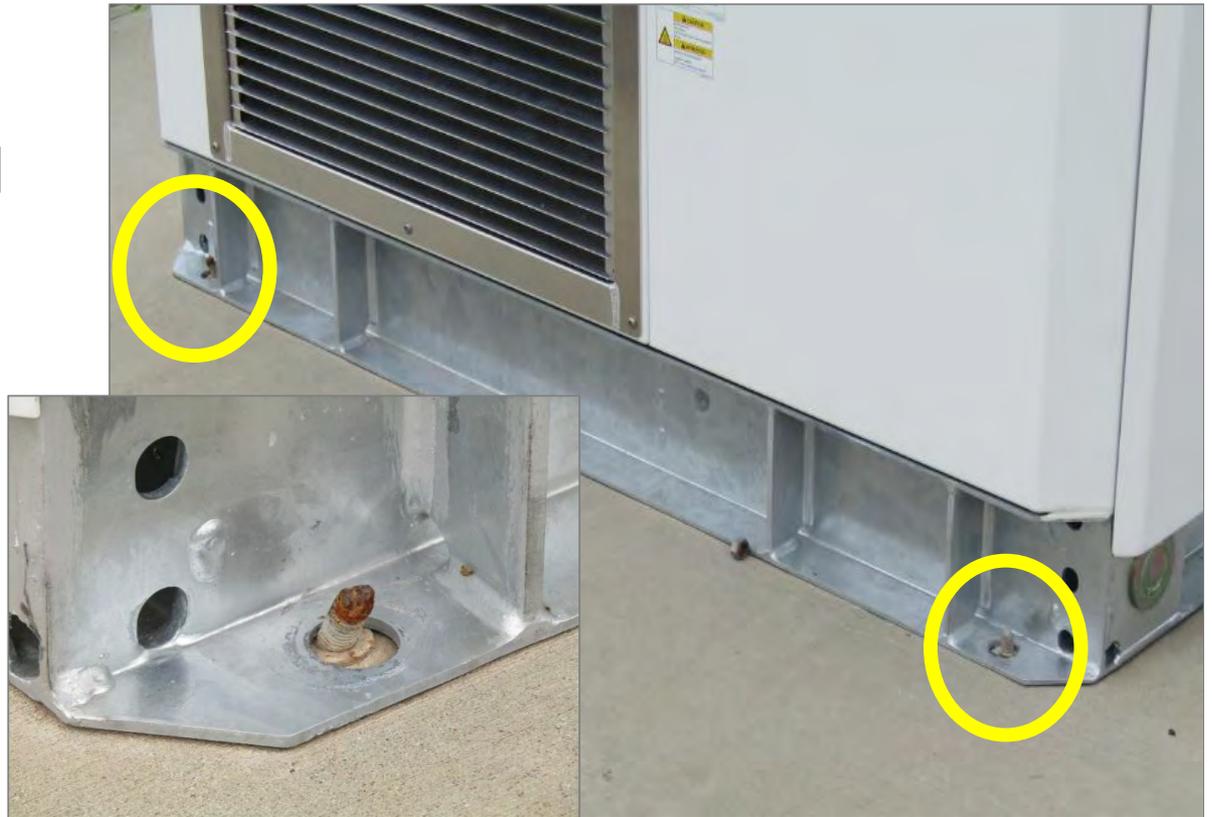
Replacement inverter not secured to pad after flooding destroyed two previous units.

NESC 180A1; NEC 110.3(B) and 110.13(A)

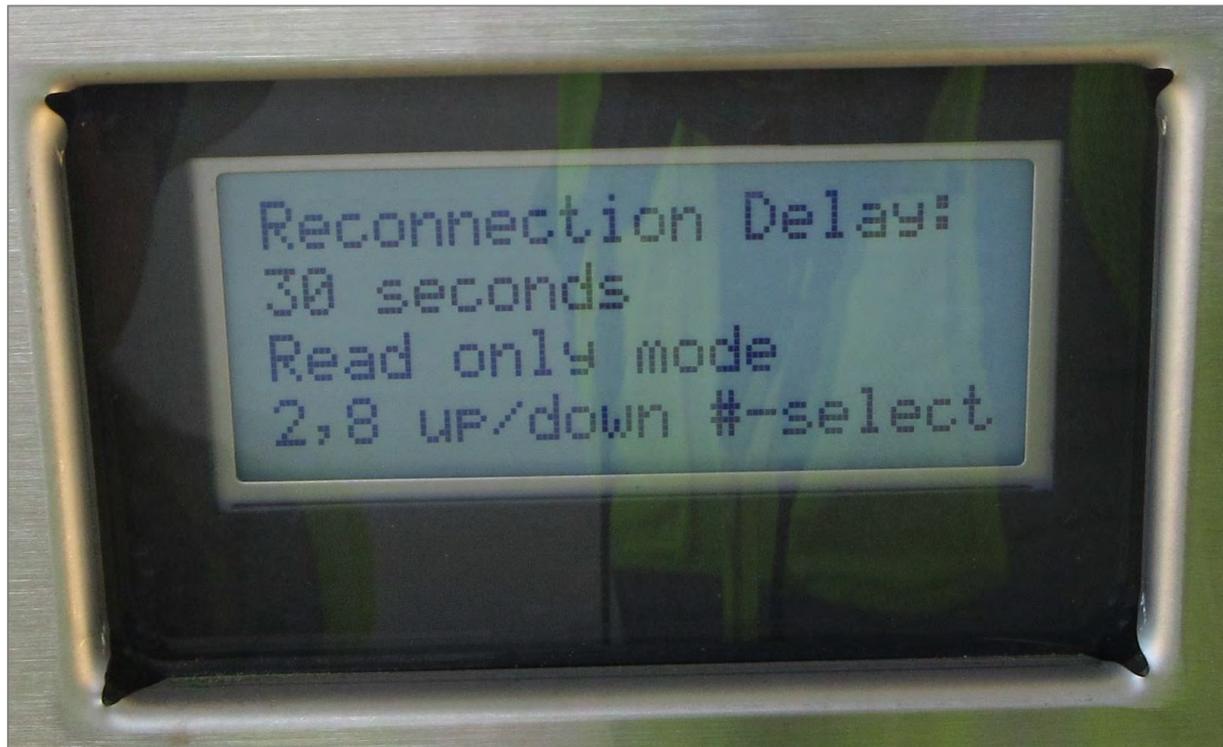
Reconnect timer set to 30 seconds instead of required 300 seconds.

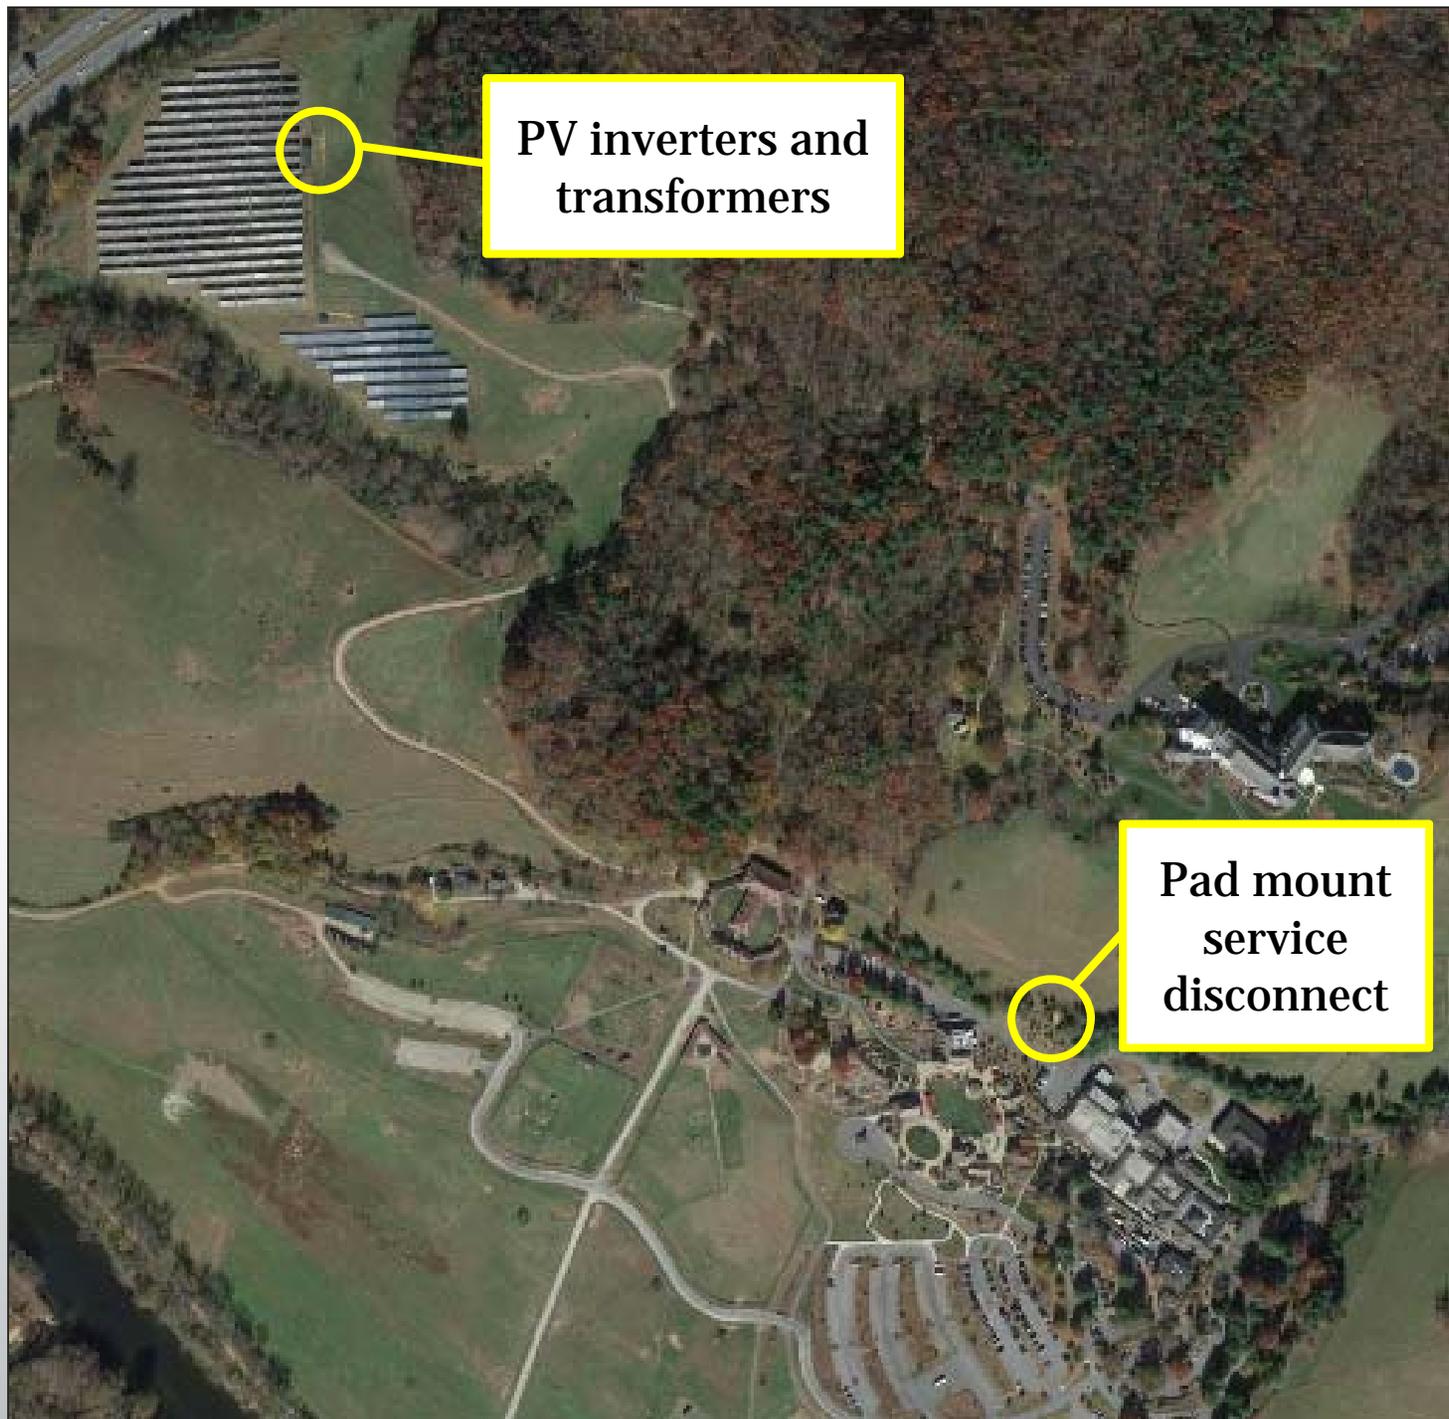
Missing Service Disconnect

- 2 of the 15 sites do not have a customer owned service disconnect located at the PV site, creating unsafe situations
- 1 of these 2 does have a customer owned service disconnect, but it is located $\frac{1}{2}$ mile away at a poorly marked pad-mount disconnect switch

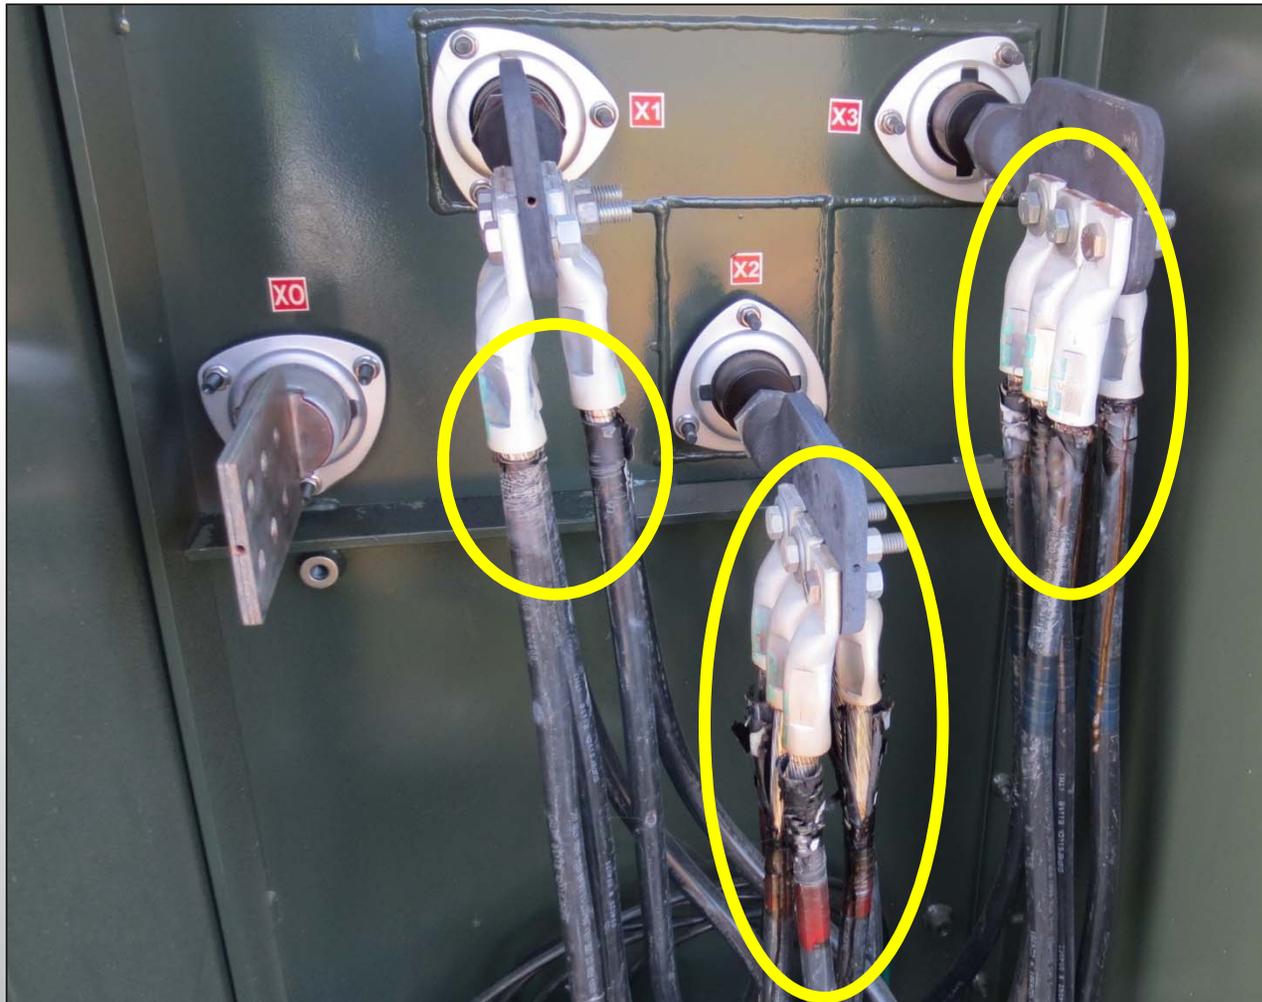
- At one site, owner and contractor were not aware they owned the transformers
- They didn't have keys to open the transformers
- It took two hours, three trips to a hardware store, a broken bolt cutter and a battery powered angle grinder to open the transformers
- When they did get the transformers open...

- Insulation was burned off the secondary conductors within one transformer

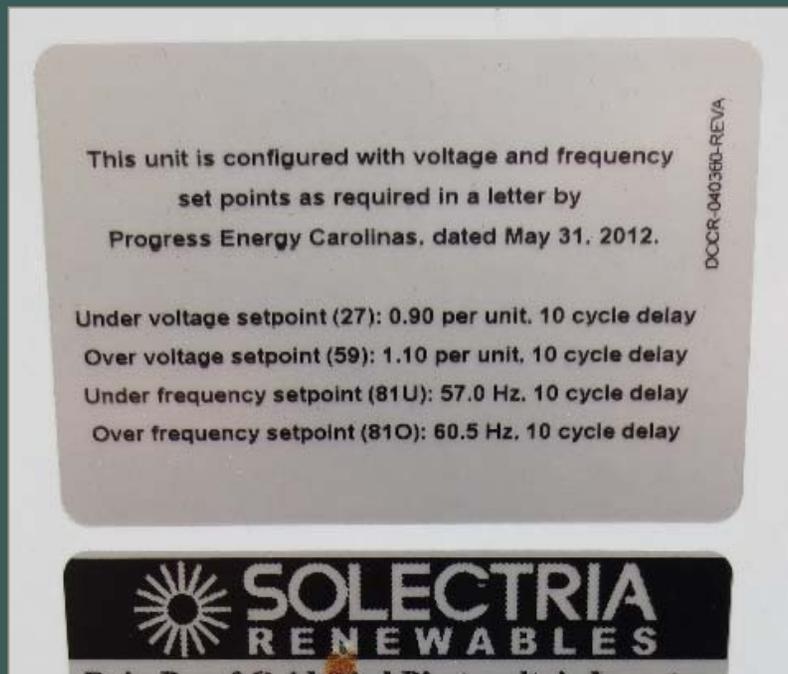
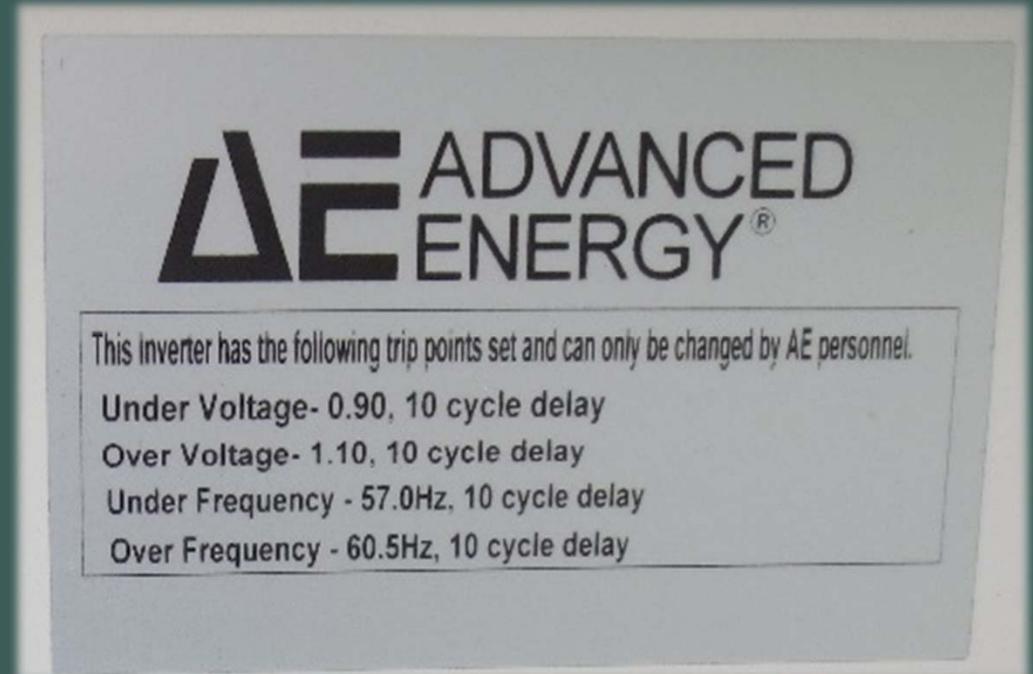
However, we found the actual inverter internal settings did not agree with those specified on the labels
