Century Engineering Evaluation Feb. 28, 2022

Eagle Creek Subdivision Vacuum Sewer Collection System Independent Engineering Evaluation

February 28, 2022

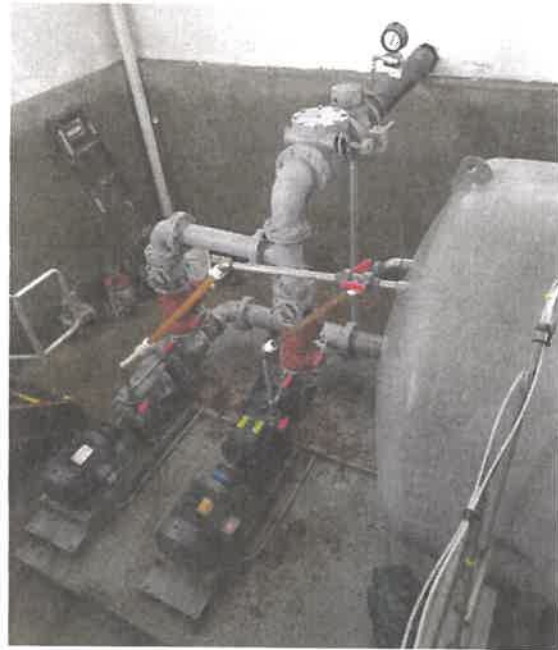
Inside the vacuum sewer receiving station building is the main vacuum tank. There is a robust coat of gray paint on the tank exterior, however, it had been recently reported the interior is in poor condition. The Engineer was not able to verify this. What was observed was an extremely messy and cruddy vacuum tank pit with water, sewage and oil on the floor, old broken and worn-out parts, rusty pipes and pump platforms, broken ladders, and loose wires.

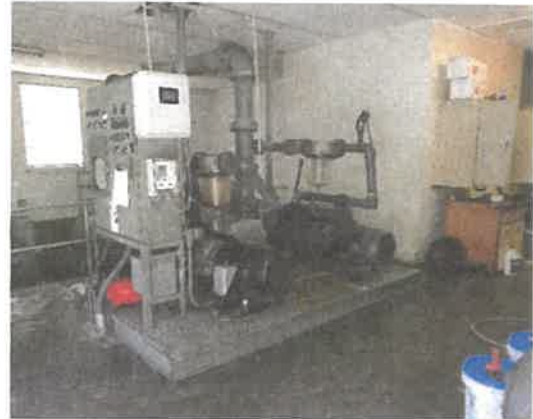
The vacuum pumps are located on the main floor of the vacuum sewer receiving building. The vacuum pumps are mismatched and one of the motors is scuffed. The pump platform is rusted, and loose and uncapped wires are strewn about. Oil and water are on the floor.

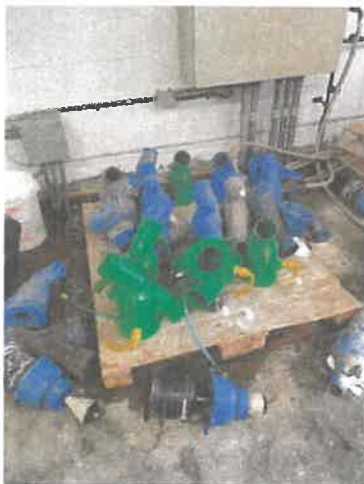
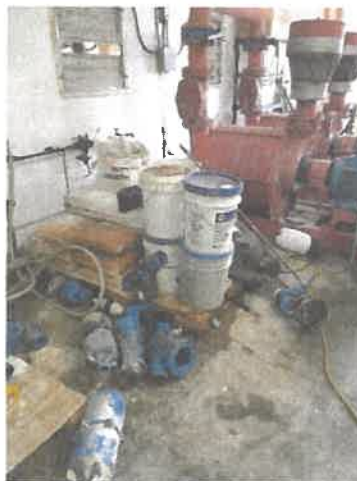
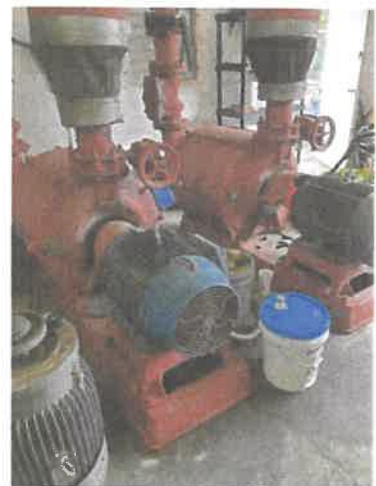
The main room in the vacuum sewer receiving station houses the electrical controls, the aeration blowers for the wastewater treatment plant, spare chemicals, vacuum sewer valve pit spare parts, the ultraviolet disinfection lights, and two cabinets for small parts. The condition of the room and equipment is trashy. There are buckets of unknown fluids lying around, there is a spare blower motor which may or may not be operable. Chemical bags are torn open and improperly stored. There is water on the floor. The spare vacuum valve pit assemblies are strewn in a heap, and it is unknown if any are operable or not.

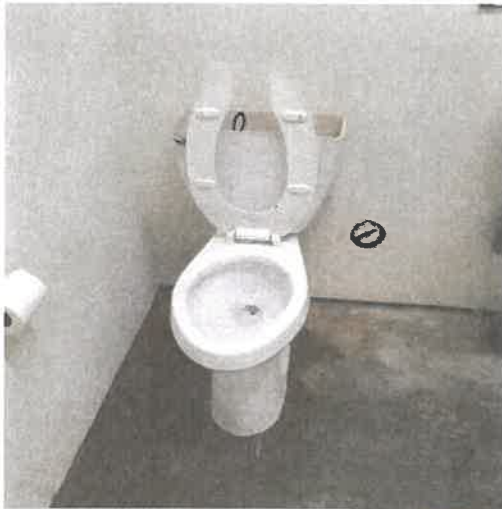
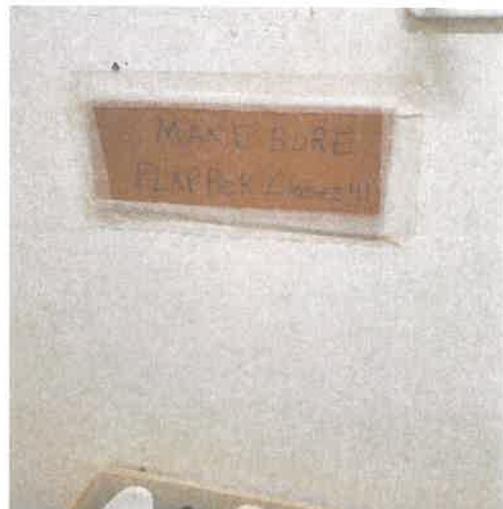
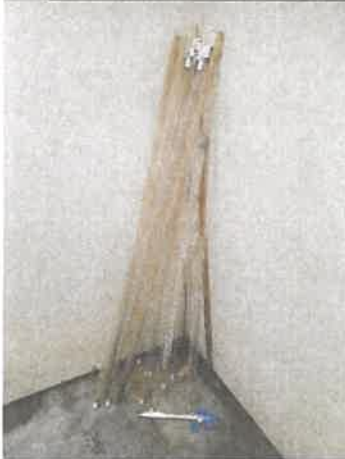
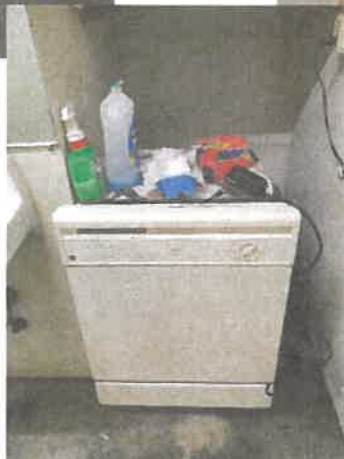
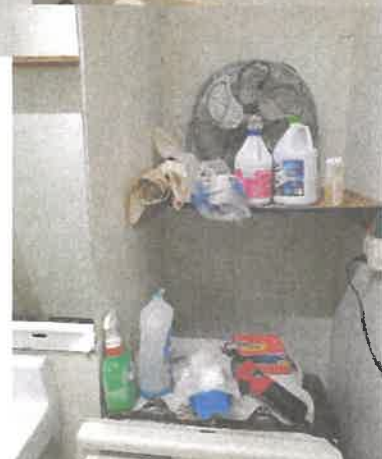
The bathroom is as dilapidated as the vacuum sewer tank pit area and main vacuum building blower and vacuum pump operating room. There is water on the floor. The toilet doesn't work properly and there is a sign on the wall above which says, "Make sure flapper closes." Spent and broken ultraviolet light tubes are stacked in one corner. For some reason there is a disconnected dishwasher in the bathroom that has junk lying on top of it. There is a spare blower motor placed behind the dishwasher. Above the dishwasher is a shelf with junk and a fan that doesn't work and a roll of original construction drawings that is old and so washed out that it is unreadable.

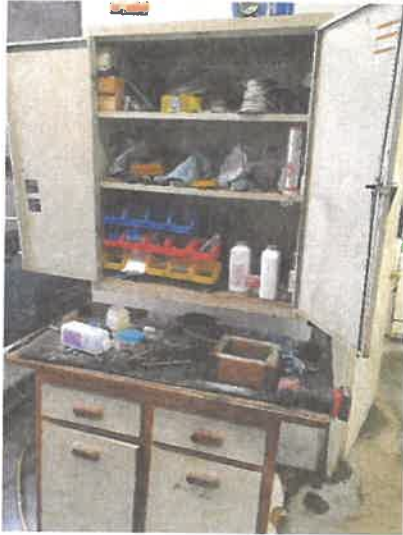
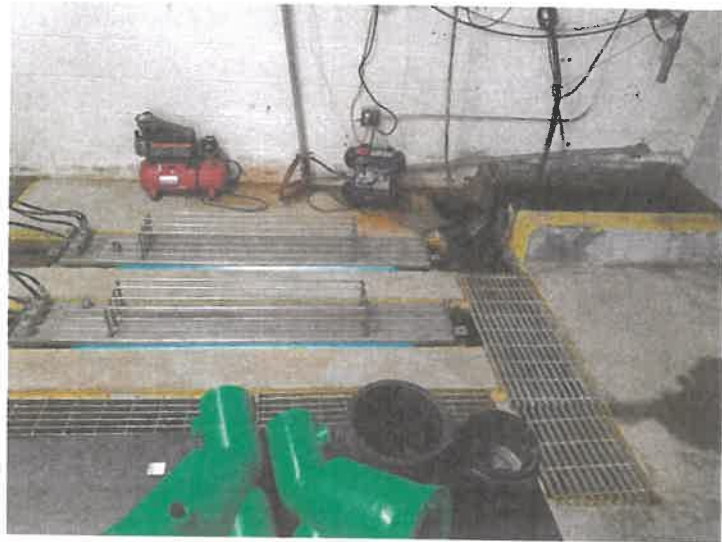
Also located in the main room in the vacuum sewer receiving station are two small cabinets and the ultraviolet disinfection lamps. The cabinets have oily junk stacked on them and the cabinet doors hang open. The ultraviolet lamp area has unsecured electrical equipment and wires strewn around in the wet environment.

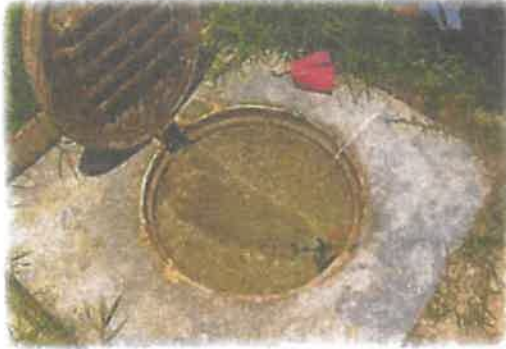
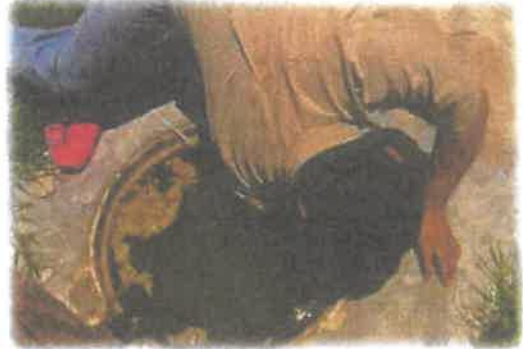
View of an Airvac Collector Tank in operation, general condition of the upper chambers.

ý The collecting tanks, their rims and covers presented structural damage from the beginning, by not considering the damage caused by the high salinity in the environment and soil.

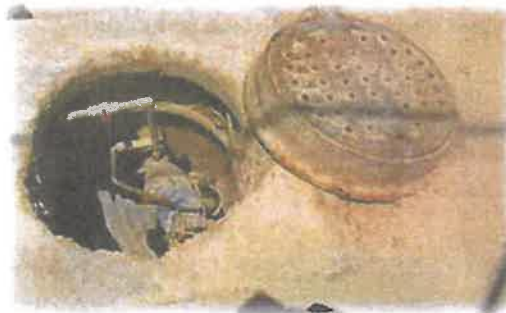
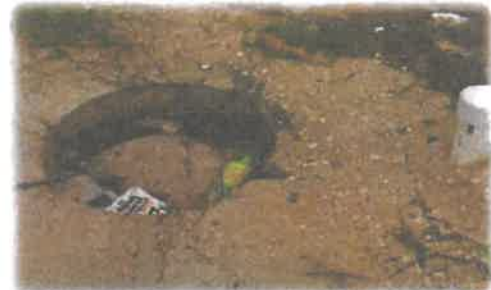
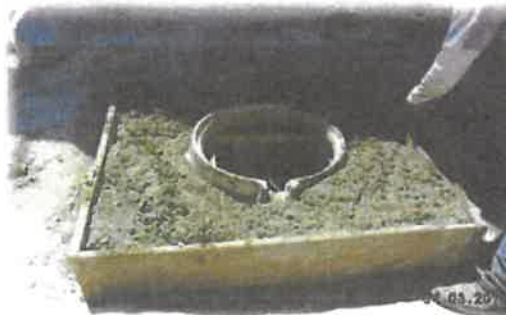
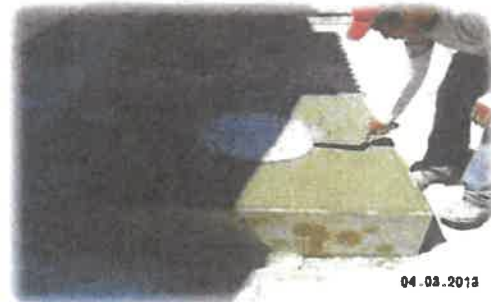
As mentioned at the beginning, the topographical characteristics of the island defined the system to be used, but in this case it is also a point against; since it presents many movements (settlements) and that normally the water table is barely 60 cm.

65 of the 85 collector tanks presented failures in the 12 years of operation, most of them have already been repaired with their own resources, it was started by the most critical ones such as those observed.

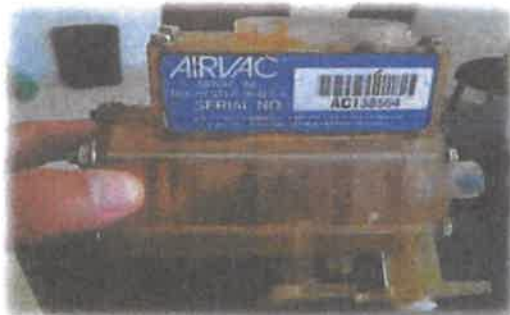
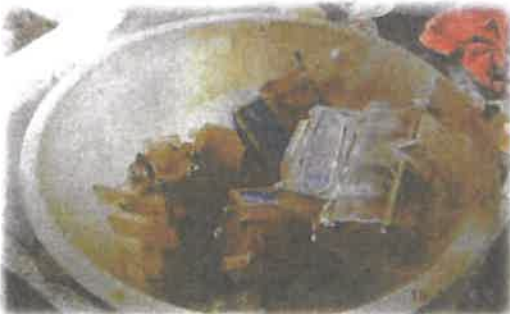
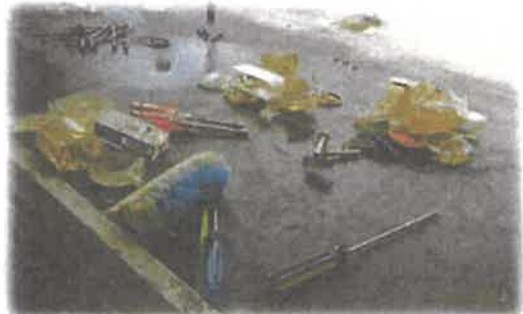
This number of Collecting Tanks that are losing automation due to lack of spare parts is increasing annually, in 2013 there were 10 tanks, in 2014 it increased to 14 of them, this 2015 as indicated before it rose to 20. This also increases operating expenses and number of incidents with service users.

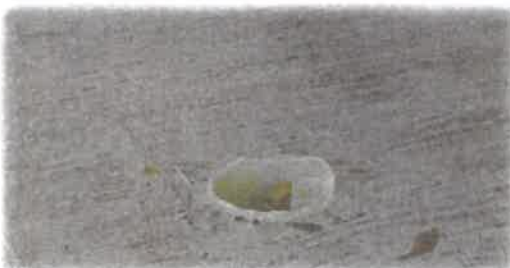
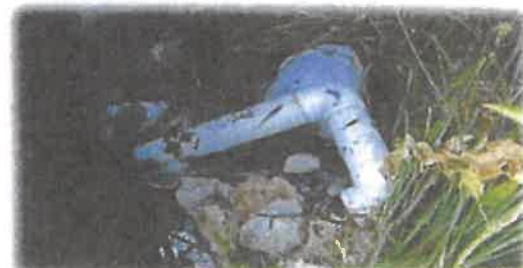
In addition to this lack of spare parts, we must consider the two complementary elements that make these tanks work properly, which are the vents of the Airvac valves and the gravity lines that frequently suffer damage that affects their correct operation.

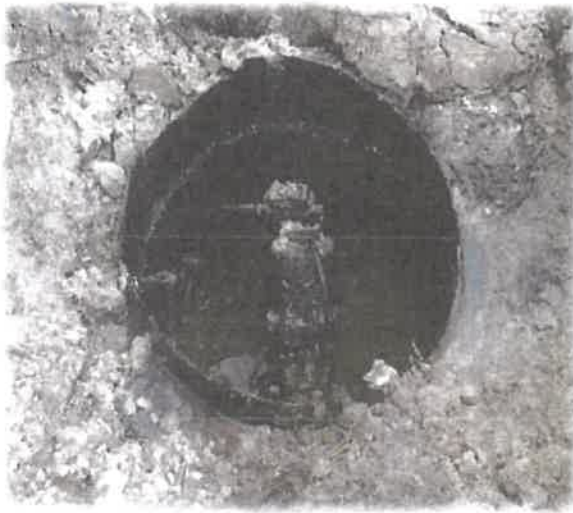
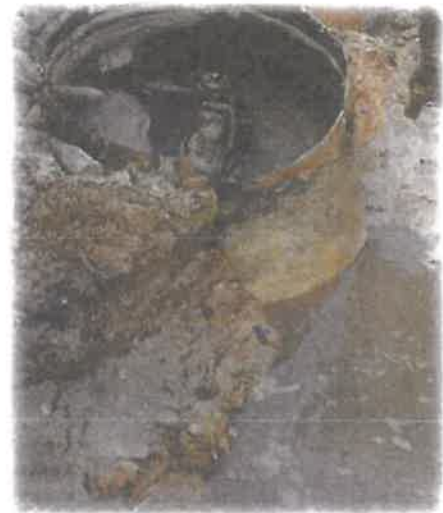
In February of this year, a collection tank from the company **Viatek** was received as a test donation, which was installed to replace an Airvac fiberglass tank that had critical damage to its structure, as it had large cracks that allowed the passage of sewage to the top and were already contaminating the water table.

Airvac collector tank in poor condition, with serious leaks of sewage into the subsoil and water table.

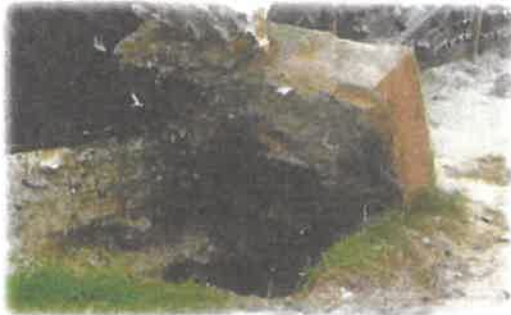
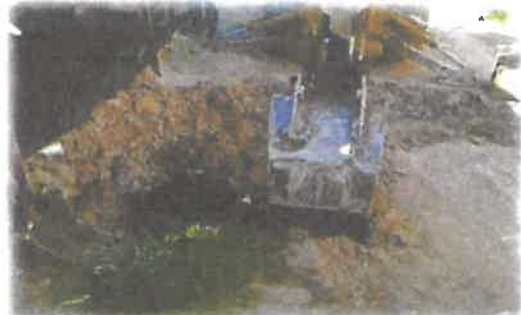
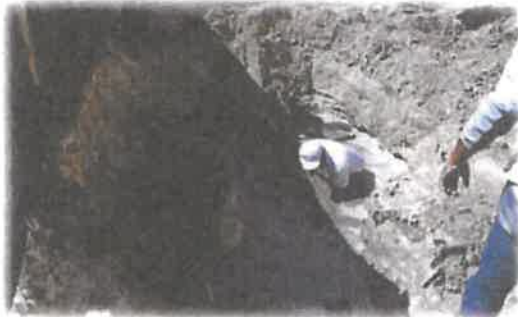
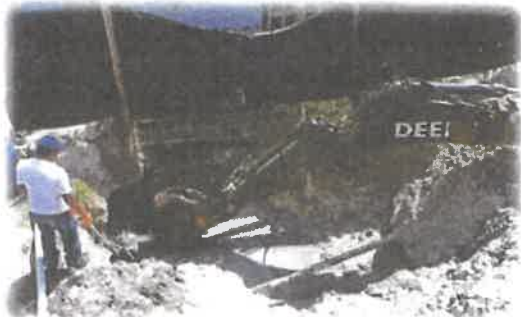
Excavation process, to reach the adequate depth of connection of the gravity lines, it was necessary to open a circumference of approximately 4.00 mt due to the landslides of the sand.

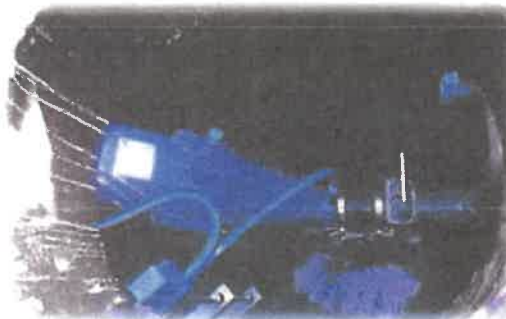
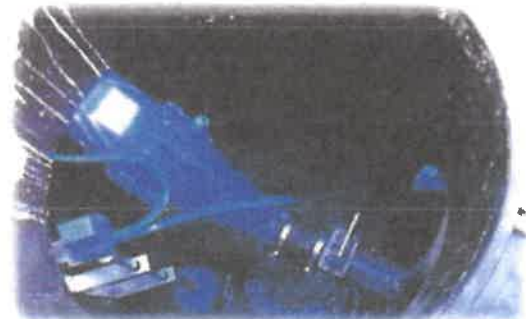
First activation, the VIAVAC/Vacuflow system worked satisfactorily immediately after installation. It was observed to work on three occasions, raising and lowering the float without any problem.
