### **INFORMATION SHEET**

COMPANIES: Duke Energy Carolinas, LLC

DESCRIPTION: Application of Duke Energy Carolinas, LLC, for Approval of Renewable Energy and Energy Efficiency Portfolio Standard Cost Recovery Rider

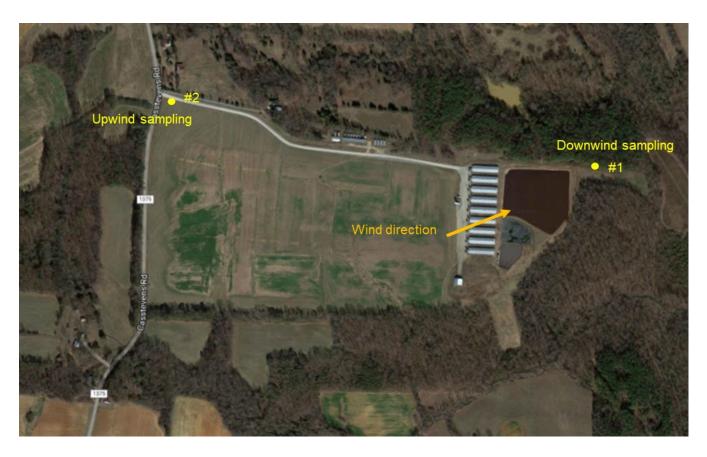
Figure 5. Aerial view of the facility and location of the monitoring points for odor for the March 14, 2019 sampling.

The location was about 50 yards downwind of the little hunting hut. The arrows indicate the prevailing wind direction the day of the sampling.

Sampling took place at about noon. It was an overcast mild day (60° F) with moderate to strong wind (sustained 3.7 m/s with gusts at 4.5 m/s). Several measurements for wind speed and direction were taken. The predominant wind direction and sampling points for odor were selected as shown in Figure 5.

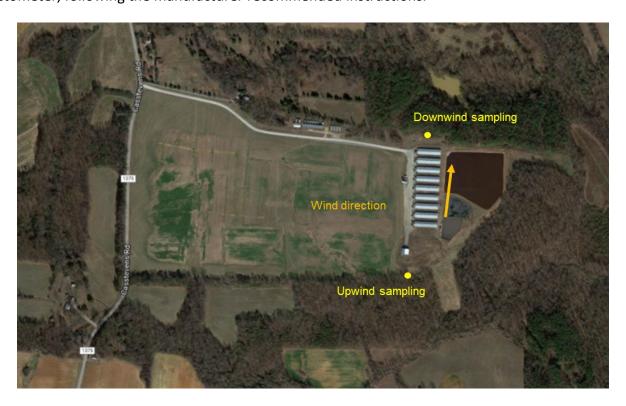
Figure 6. Aerial view of the facility and location of the monitoring points for odor for the June 26, 2018 sampling. The arrows indicate the prevailing wind direction the day of the sampling.

Sampling took place at about 9:15 am. It was a nice clear day, somewhat cool for the season (78° F) with very variable wind, from no wind to mild gusts of 2 m/s. Several measurements for wind speed and direction were taken. The average wind speed was 1.3 m/s, the predominant wind direction and sampling points for odor were selected as shown in Figure 6.

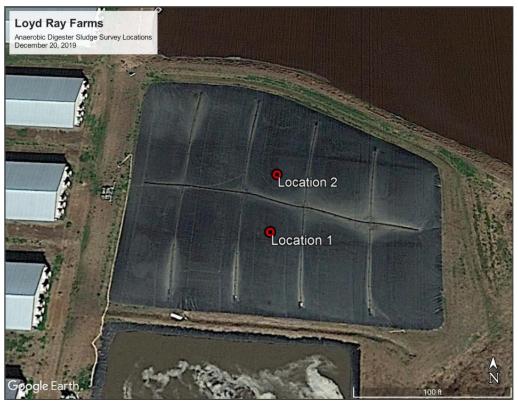
Marvin Cavanaugh and Ben Cauthen of Cavanaugh & Associates, P.A. completed a sludge survey of the anaerobic digester on December 20, 2019. Sludge depth was measured from the two centermost digester vents at the locations depicted below. The depth at Location 1 was measured as 2' and the depth at Location 2 was measured as 2'-6".

Figure 4. Loyd Ray Farms anaerobic digester sludge survey locations from December 20, 2019.

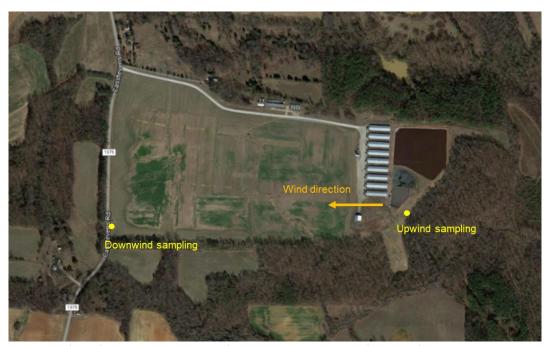
Figure 5. Aerial view of the facility and location of the monitoring points for odor for the September 27, 2019 sampling. The arrows indicate the prevailing wind direction the day of the sampling.

Sampling took place at about 11:40 am. It was slightly overcast day, temperature was  $80^{\circ}$  F with very variable wind 1.2-2.5 m/s and average at about 2 m/s. The predominant wind direction and sampling points for odor were selected as shown in Figure 1.

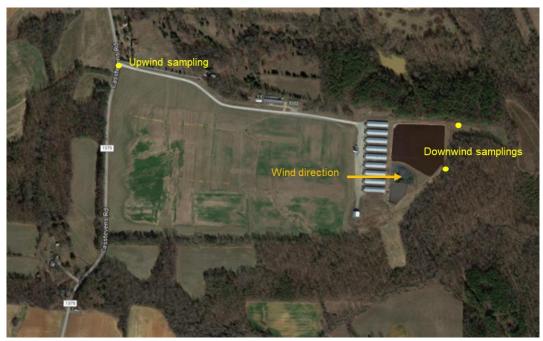
Figure 6. Aerial view of the facility and location of the monitoring points for odor for the December 31, 2019 sampling. The arrows indicate the prevailing wind direction the day of the sampling.

Sampling took place at about 10:30 am. It was a nice cold (50° F) clear and windy day. The wind was strong with steady winds of 4 m/s and gusts of up to 10 m/s. Several measurements for wind speed and direction were taken. The average wind speed was about 6 m/s, the predominant wind direction and sampling points for odor were selected as shown in Figure 2.
