UTILITY STREAM CROSSINGS: WHOSE PROBLEM IS IT AND WHO'S PAYING?

Jana Stewart, P.E., ARCADIS
Rebecca Cramer, P.E., ARCADIS

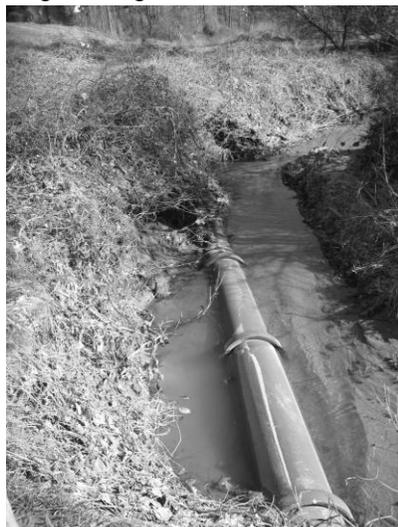
Figure 1. Exposed Pipe in Streambed

Depending on the sewer crossing type, it can be affected differently by erosion. A buried sewer crossing is impacted by transport of sediment from over the top, see Figure 1. Aerial sewer crossings are impacted by erosion of the streambed, bank incising, and erosion around the pipe supports. Figure 2 is an example of where both the pier has been undermined by erosion and the bank has been incised. This exposes more pipe in the streambank and increases the length of unsupported pipe. Figure 3 shows a location where the stream bed has eroded to the point where the length of unsupported pipe has become too long and a temporary solution has been applied to give added stability.

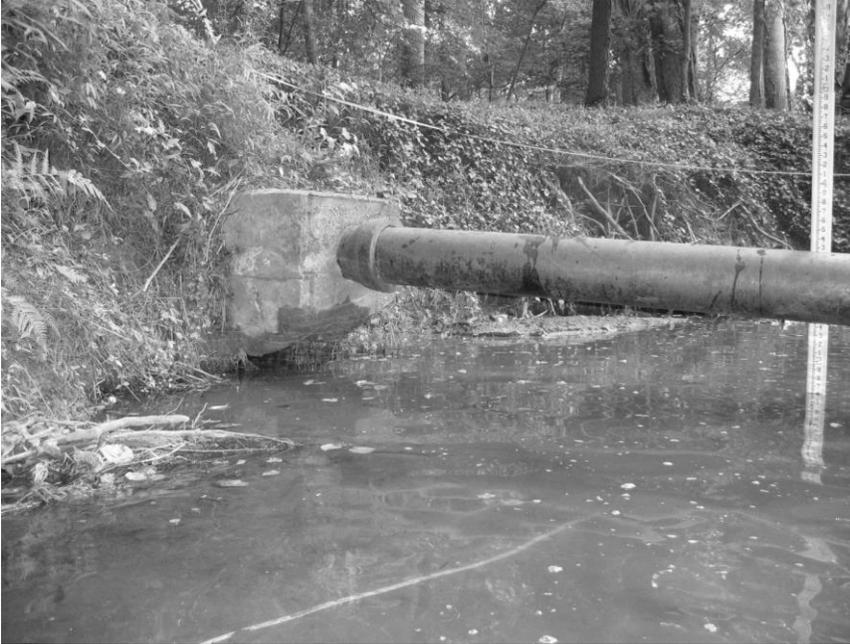
Figure 2. Scour Under a Support

The Winston-Salem Case study for stream bank stabilization included six locations in various tributaries throughout the City. One site within this area was Buena Vista Branch. Figure 2 is a photo of this area, consisting of a scour hole at the bottom of an exposed pier along the left bank of an aerial sewer line crossing. The stream was stable both laterally and vertically except for a washed out area which left the concrete pier suspended above the ground and water. Improvements consisted of replacing the existing pier, adding two j-hook boulder vanes along the left bank at the outside of the stream bend, and excavating the vertical banks to decrease bank slope. Container plants and live stakes were installed.

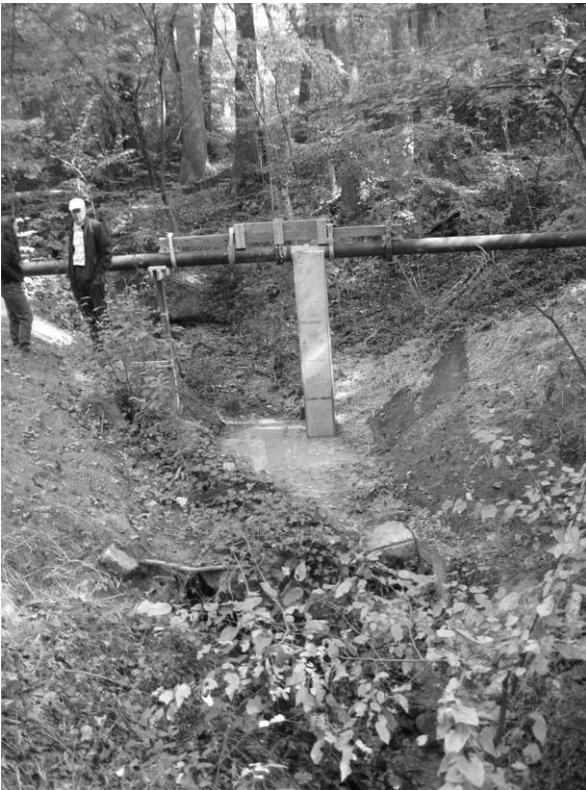
Figure 3 Bank Scour Causing Un-supported Lengths of Aerial Pipe

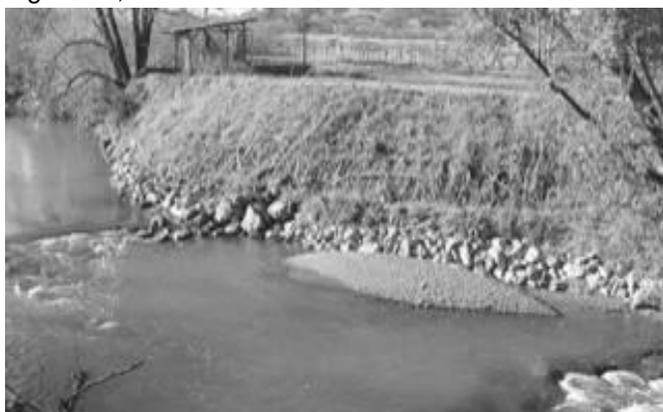
Figure 11. Streambank Using a Boulder Toe for Stabilization

Important techniques in utility work are the soil lift and the boulder toe. A soil lift is a vegetated “lift” or slope of soil. In order to stabilize this the soil “lifts” are wrapped in liners (NRCS, 2007). This is illustrated in Figure 9. Boulder toes are also a good way to stabilize a stream bank (see Figure 10). In this case, boulders are imbedded into the stream bed and are stacked in such a way as to allow a stable and fairly upright streambank. An example of a boulder toe installation is included in Figure 11. In both cases, a streambank is stabilized. It is less than a natural state, but if done properly, it will stabilize in an area where there isn’t sufficient space to lay back the streambank to a more natural state.

The Ardmore stream restoration was another project driven by and funded by the Stormwater Utility Fund. In this case there was incising of the stream banks in a confined area with no ability to bench or lay back the streambeds. When Stormwater reviewed this condition, they realized that some parallel water/sewer utilities could become exposed, if the incising was allowed to continue. To avoid this, the Stormwater Department coordinated their work with the Water/Sewer Department and by using soil lifts and boulder toes, were able to stabilize an incised streambank in a very tight area and protect the nearby utilities.

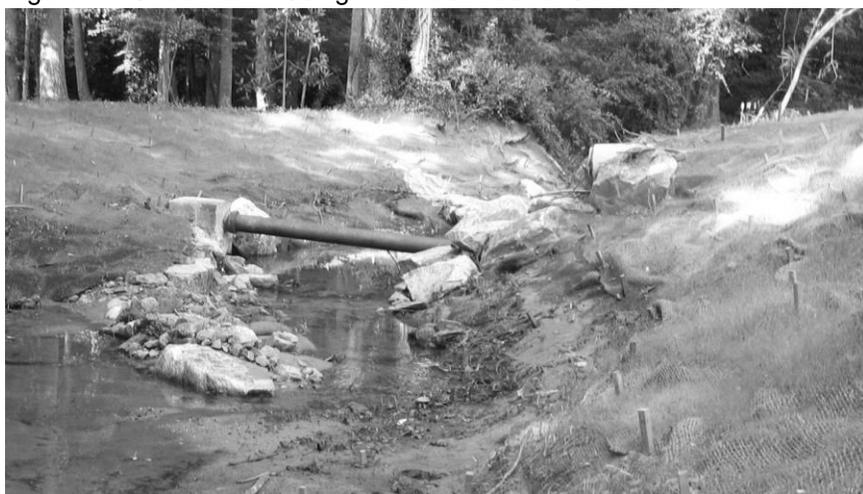
Figure 12. Buena Vista Ranch, During Reconstruction

Figure 12 shows the reconstruction process and illustrates that the banks have been laid back and stabilized with matting and, downstream of the aerial crossing, a j-hook structure has been built upstream and downstream. These improvements have stabilized the velocity in the stream and reduced erosion around the pier. This also allows a pool to form under the aerial utility to better enable debris to move downstream without negatively impacting the aerial pipe. Figure 13 is the final product. With these improvements, it is not expected that erosive properties will damage the structure again and the stream has been returned to a natural state.

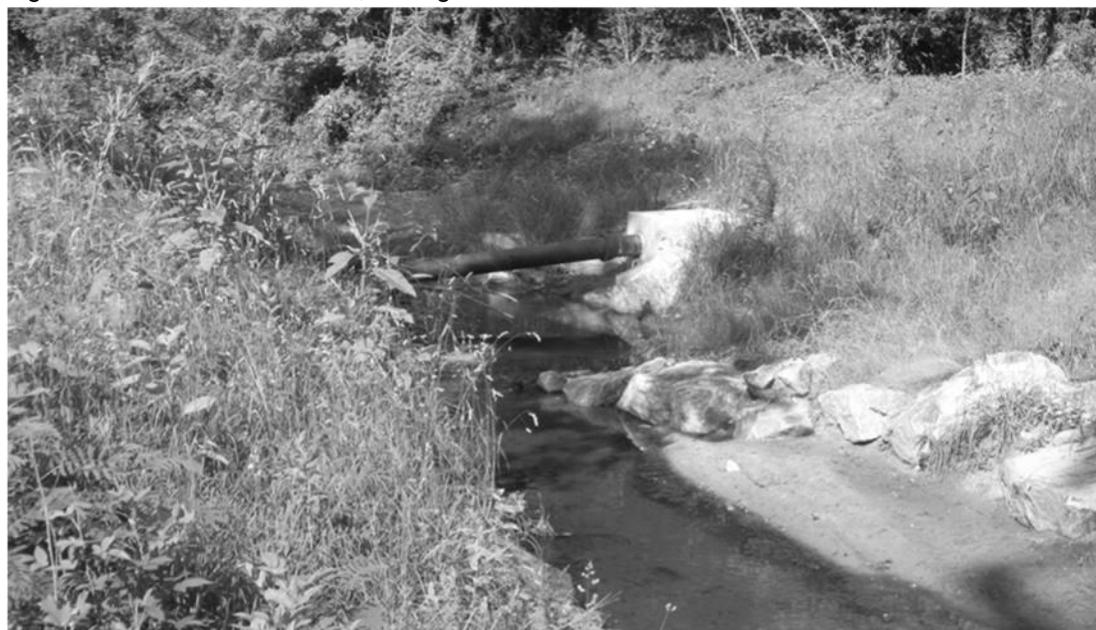
Figure 13. Buena Vista After Reconstruction
