STATE OF NORTH CAROLINA  
UTILITIES COMMISSION  
RALEIGH

BLUE RIDGE ELECTRIC	)	
MEMBERSHIP CORPORATION	)	
Petitioner,	)	
	)	
v.	)	DOCKET NO. EC-23, SUB 50
	)	
CHARTER COMMUNICATIONS	)	
PROPERTIES LLC,	)	
	)	
Respondent.	)

RESPONSIVE TESTIMONY

MICHEAL MULLINS

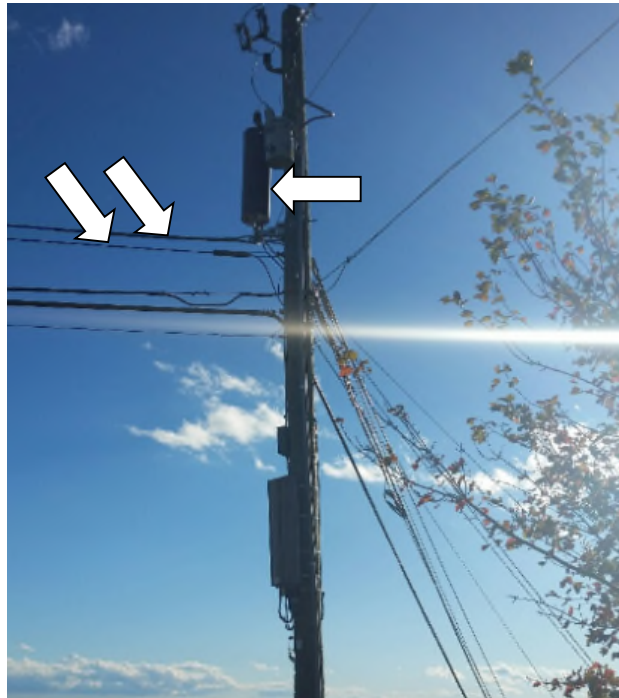
3 **Photo 3**

1 Photo 3 is another Blue Ridge pole showing its use of the safety space. This pole  
2 is numbered 05-07-165.

4  
5 There is more than 30 inches on this pole from Charter's attachment (the second  
6 from the bottom) and the bottom of Blue Ridge's transformer. But it is clear that  
7 Blue Ridge is maximizing its use of all of this space by placing a large cylindrical  
8 antenna extending well below the transformer and multiple fiber optic wires  
9 below that, as marked on the photo with arrows. This pole also has multiple Blue  
10 Ridge risers and several large boxes attached below the lowest communications  
11 attachment. I note this equipment because they pose a number of climbing  
12 obstructions (what Blue Ridge calls a "mess" when discussing Charter) on a pole  
13 that cannot be accessed by bucket truck.

9 A. It is perplexing to me because Blue Ridge typically places many more facilities  
10 than Charter in the climbing space on a pole. For example, photo 3 above shows  
11 a pole that is not accessible by bucket truck with multiple Blue Ridge risers on all  
12 sides of the pole and several large boxes that would make the pole very difficult,  
13 if not impossible to climb. Blue Ridge creates these conditions on other poles as  
14 well. Photos 4 and 5 on the following page show a pole on Main Street, off  
15 Highway 321 in Blowing Rock. The pole is tagged as an AT&T pole. But its  
16 climbing space is full of Blue Ridge equipment, including large boxes, multiple  
17 risers, an antenna, and lots of wires. It is another case of Blue Ridge taking a  
18 normal practice—one that it uses far more than Charter—and making it seem as if  
19 Charter is a bad actor.

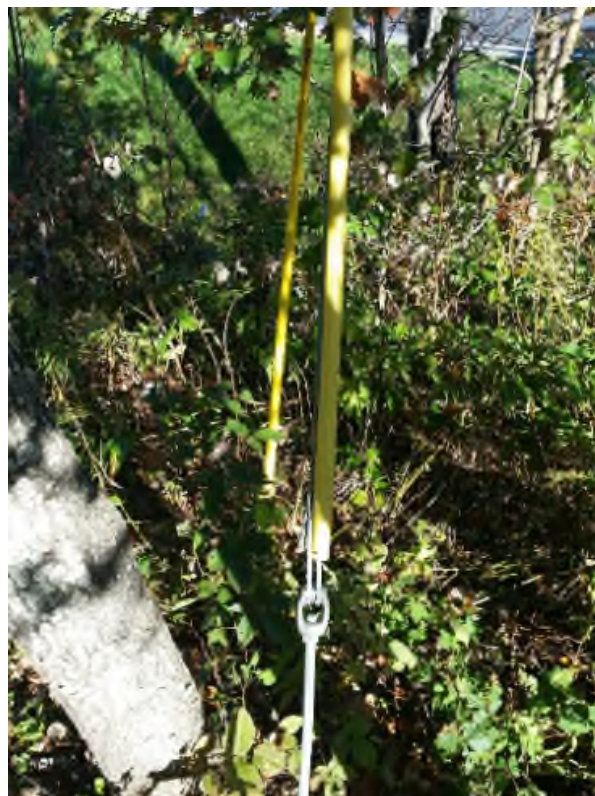
10 **Photo 6**

1 there were the full complement of safety space on this pole. The second photo  
2 shows Charter's facilities within 13 inches of the top of Blue Ridge's riser. Here,  
3 again, Blue Ridge has not provided any information about when each party placed  
4 its facilities. If Blue Ridge placed its transformer and riser after Charter, then it  
5 should have installed a longer riser to avoid creating this issue in the first place.  
6 *Exhibit LL-16D*. Mr. Layton says that Charter's attachment is not guyed in the  
7 first photo. This is not accurate. In fact, Charter's guy follows Blue Ridge's guy.  
8 Photo 6, below, shows Charter's guy in the background and Blue Ridge's guy in  
9 the foreground.

11  
12 In fact, other attachments are not guyed, including what appears to be Blue  
13 Ridge's own fiber optic attachment. It is also possible that Blue Ridge's guy at

1 the top of the pole is on the wrong angle or is over-tensioned. I say that because  
2 Blue Ridge's guy remains taught, and I would expect it to have slack in it if the  
3 pole were bowed because of the attachments in the middle. The second photo  
4 shows a pole where Charter has had an attachment for decades. I know this  
5 because Charter's attachment is 500 cable, which we have not used for at least 20  
6 years. We do not have information about when the transformer was placed. But  
7 we know that it was either placed after Charter made its attachment, or this  
8 condition has existed for decades without complaint by Blue Ridge. Charter is  
9 guyed on this pole, but it could be tightened. Charter has guys on other poles  
10 along this road, so any issues with guys likely exist because of the age of this  
11 construction.

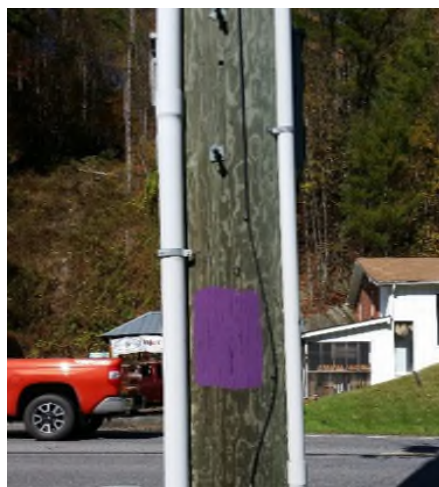
17 **Photo 7**

12 *Exhibit LL-16E.* The photo here simply says "terrible mess on pole from  
13 Charter," without additional detail. Blue Ridge asserts there is no climbing space  
14 on this pole because of Charter. But to the extent there is no climbing space, or a  
15 "terrible mess," it is because of Blue Ridge. Photo 7 shows multiple Blue Ridge  
16 risers that obstruct the climbing space, even without any Charter facilities.

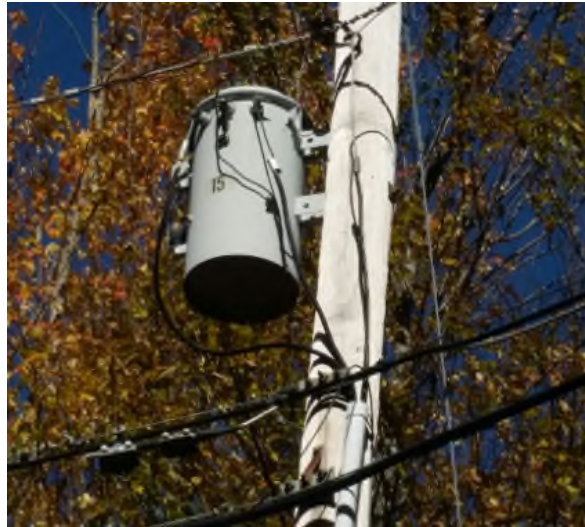
**Photo 8**  
**(Pole No. 10-09-085)**

Photo 8 shows a situation where Charter framed its attachment decades ago with plenty of space below the neutral. It is likely that Blue Ridge installed the transformer and riser after Charter. The home this transformer serves appears to be of recent construction, and the transformer drip loops are so close to Charter's bracket—indeed even appearing to touch it—that Charter's contractors simply could not have safely installed its attachment like this. It appears Blue Ridge could have maintained 30 inches below the transformer had it placed the transformer closer to the neutral and ran a longer riser. In any event, Charter cannot lower its attachment here until the phone company lowers first.

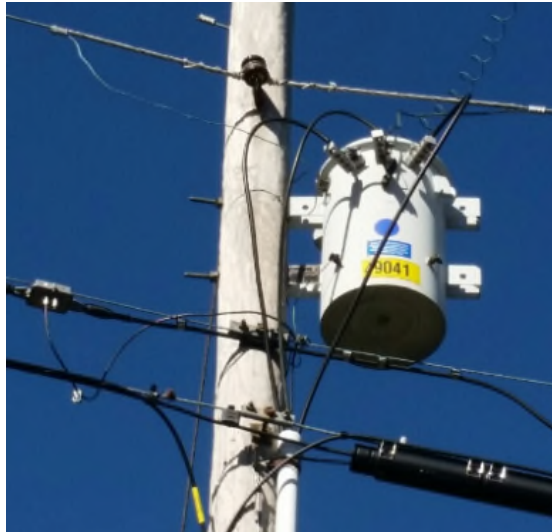
**Photo 9**  
**(Pole No. 16-08-038)**

Photo 9 similarly shows a pole where Charter has been attached for decades and was initially framed with plenty of separation between the neutral and Charter's wire. It is clear that Blue Ridge installed its transformer after Charter because the drip loops coming from the transformer actually wrap in front of Charter's attachment and behind the phone attachment as they feed into a riser that is too short. Charter's contractors could not have installed their strand and then run the coax through the small space between the pole and the drip loops. The house served by this transformer also appears to be recent construction. In fact, the house next door is new construction, and Blue Ridge has hung a transformer with this same configuration on the next pole over. Charter cannot lower its facilities until the phone company lowers theirs.

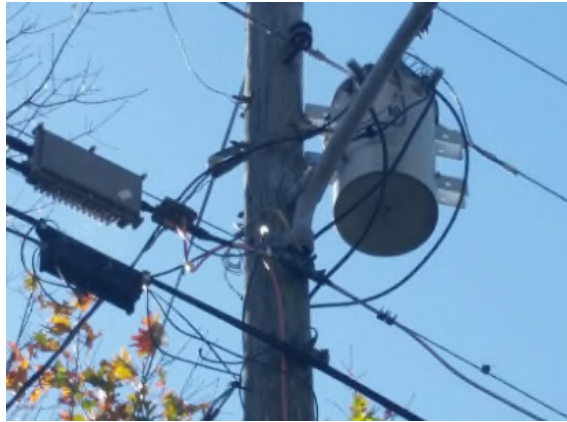
**Photo 10**  
**(Pole No. 16-08-038)**

Photo 10 shows an old pole where Charter has been attached for decades. I measured the facilities and Charter was initially framed 51 inches below the neutral, but it appears Blue Ridge placed a transformer here without notice to us. Again, Charter must wait for telephone (which may also be too close to the transformer) to lower before it can move its facilities.

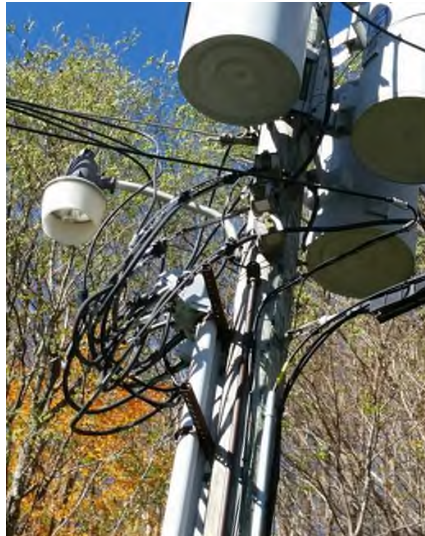
**Photo 11**  
**(Pole No. 07-02-005)**

Photo 11 shows a pole with a mess of transformers and triplex wires on a pole Charter has been attached to for decades. Charter is framed 40 inches below the neutral, and nearly has 30 inches below the transformers. The biggest problem here is the tangle of Blue Ridge's wires feeding into the risers, and it is entirely Blue Ridge's creation. We dead-end at this pole with a down guy on the side opposite of the one pictured in Photo 11, indicated by an arrow in Photo 12 on the following page.

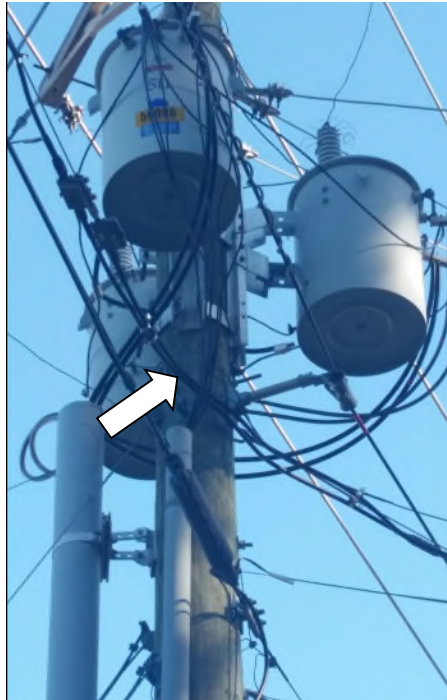
**Photo 13**  
**(Pole No. 05-07-263)**

Photo 13 shows another one of the “immediate hazards” identified by Mr. Booth that is actually Blue Ridge’s creation. Charter’s attachment is marked with an arrow. Blue Ridge has its own fiber on a cross-arm that is bolted immediately above Charter’s attachment. I can tell Blue Ridge created this condition because Charter’s attachment is tucked behind the drip loop extending from the transformer in the foreground. There is simply no way Charter could have installed its bolts, strand, and wires in this configuration. Blue Ridge’s risers are also too short. This appears to be a newer pole (serving a newer commercial building). It is possible Blue Ridge moved us into this spot when it replaced the pole. Again, there is nothing Charter can do on its own to safely fix this.

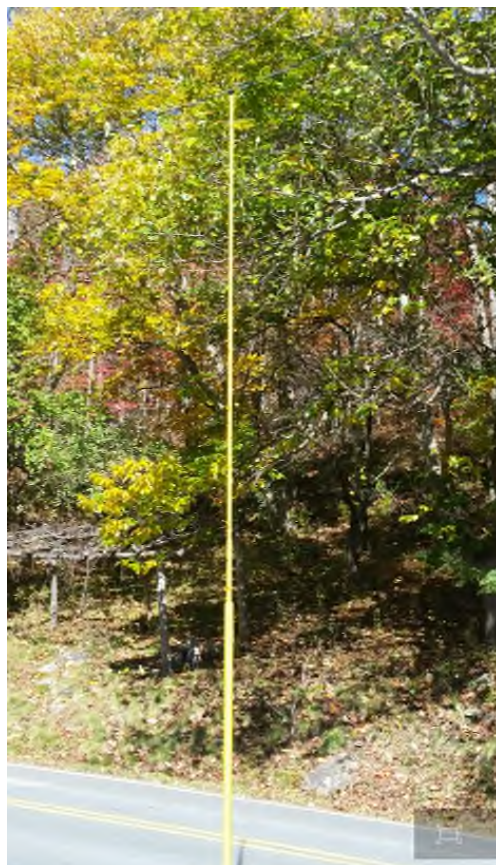
12 **Photo 15**

5 A. Yes. Perhaps the most dangerous condition I observed was not one on Mr.  
6 Booth's list. It was a Blue Ridge wire hanging very low across Seven Devils  
7 Road. This is a winding two lane road that runs down the side of a mountain,  
8 with no shoulder to speak of, a steep drop on one side and the mountain face on  
9 the other. The wire was a feeder for a streetlight placed on a pole on the opposite  
10 side of the road. Blue Ridge's wire only had 14 feet and 3 inches of clearance  
11 over the road. The wire is depicted in Photo 15 below.

1 After observing this condition, I contacted Blue Ridge to let them know about it.
