BEFORE THE NORTH CAROLINA UTILITIES COMMISSION

DOCKET NO. E-7, SUB 1229

**DUKE ENERGY CAROLINAS, LLC
RENEWABLE ENERGY AND ENERGY EFFICIENCY
PORTFOLIO STANDARD (“REPS”)
COMPLIANCE REPORT**

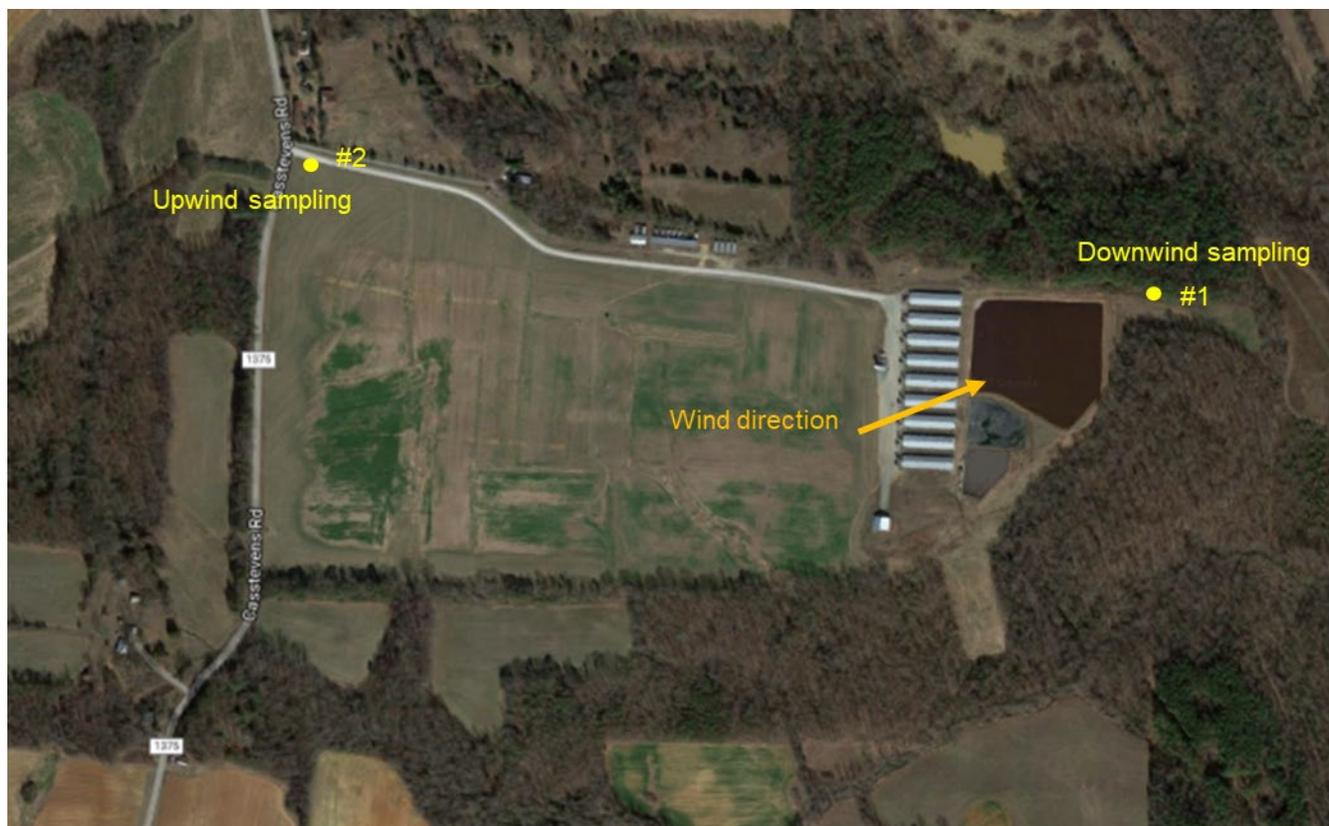
Figure 5. Aerial view of the facility and location of the monitoring points for odor for the March 14, 2019 sampling. The location was about 50 yards downwind of the little hunting hut. The arrows indicate the prevailing wind direction the day of the sampling.

Odor was monitored by Marc Deshusses. Odor panelist rules were listed in an earlier report and are not repeated here. Odor was monitored using a Nasal Ranger (<http://www.nasalranger.com/>) field olfactometer, following the manufacturer recommended instructions.

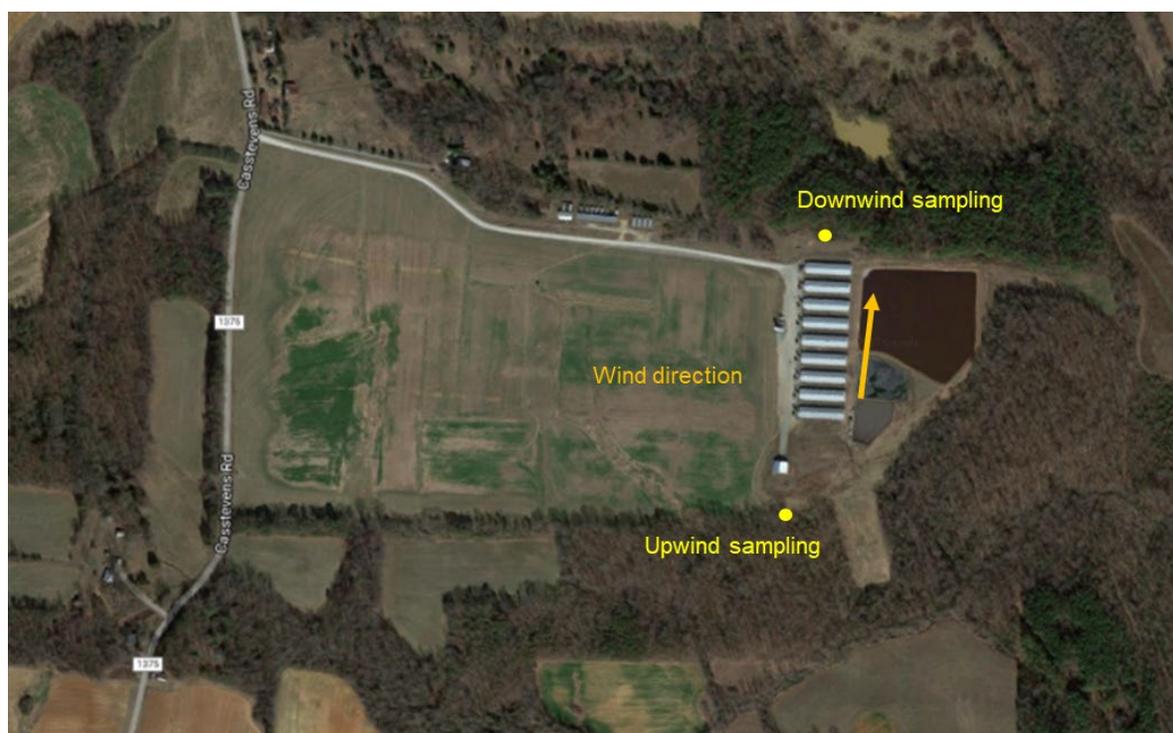
Figure 6. Aerial view of the facility and location of the monitoring points for odor for the June 26, 2018 sampling. The arrows indicate the prevailing wind direction the day of the sampling.

Odor was monitored by Marc Deshusses. Odor panelist rules were listed in the previous report and are not repeated here. Odor was monitored using a Nasal Ranger (<http://www.nasalranger.com/>) field olfactometer, following the manufacturer recommended instructions.

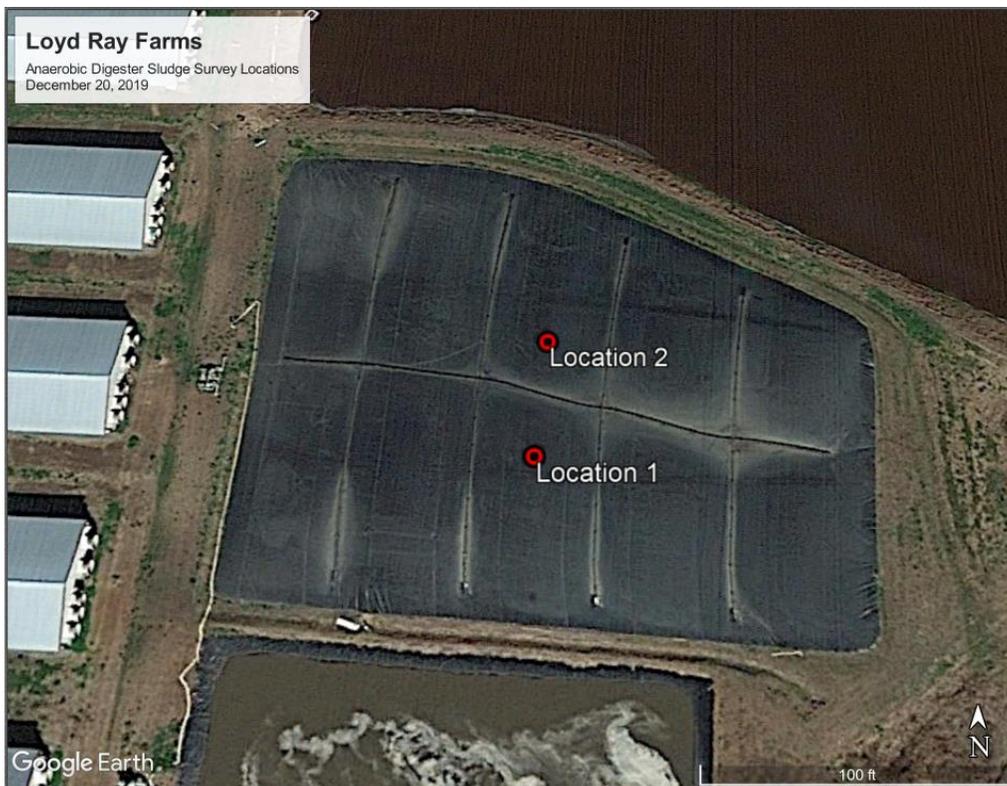
Figure 4. Loyd Ray Farms anaerobic digester sludge survey locations from December 20, 2019.

Marvin Cavanaugh and Ben Cauthen of Cavanaugh & Associates, P.A. completed a sludge survey of the anaerobic digester on December 20, 2019. Sludge depth was measured from the two centermost digester vents at the locations depicted below. The depth at Location 1 was measured as 2’ and the depth at Location 2 was measured as 2’-6”.

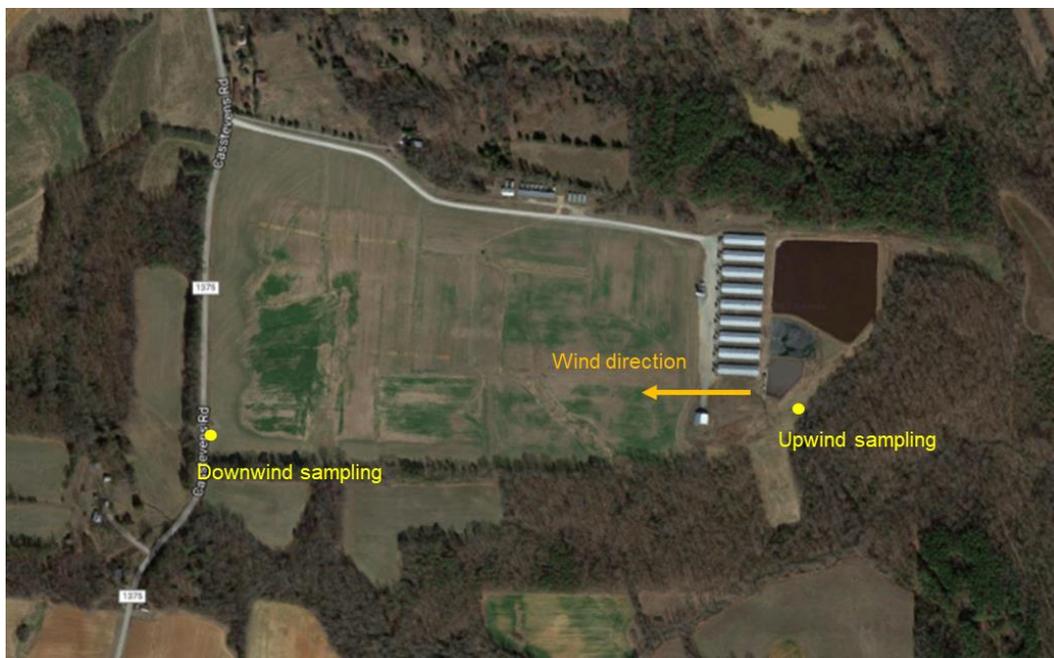
Figure 5. Aerial view of the facility and location of the monitoring points for odor for the September 27, 2019 sampling. The arrows indicate the prevailing wind direction the day of the sampling.

Odor was monitored by Emma Fulop and Matthew Arsenault. Odor was monitored using a Nasal Ranger (<http://www.nasalranger.com/>) field olfactometer, following the manufacturer recommended instructions.

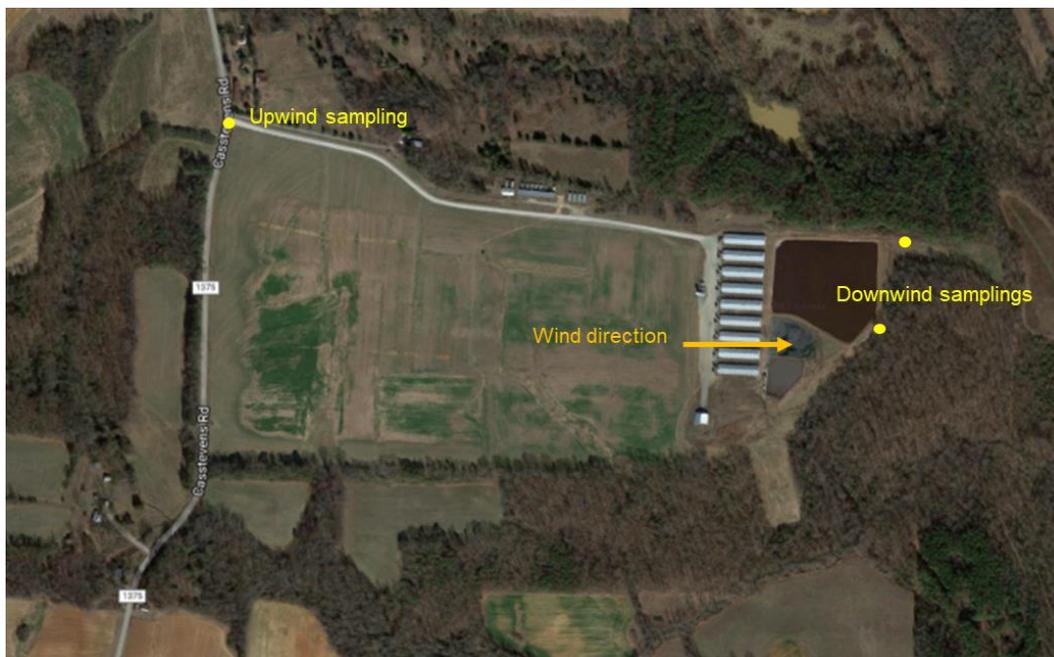
Figure 6. Aerial view of the facility and location of the monitoring points for odor for the December 31, 2019 sampling. The arrows indicate the prevailing wind direction the day of the sampling.

Odor was monitored by Marc Deshusses. Odor panelist rules were listed in the previous report and are not repeated here. Odor was monitored using a Nasal Ranger (<http://www.nasalranger.com/>) field olfactometer, following the manufacturer recommended instructions.
