Docket No. W-1333, Sub 0
Docket No. W-1130, Sub 11

BEFORE THE NORTH CAROLINA UTILITIES COMMISSION

REBUTTAL TESTIMONY
OF
MICHAEL J. MYERS
SECRETARY OF CURRITUCK WATER & SEWER, LLC
March 31, 2022

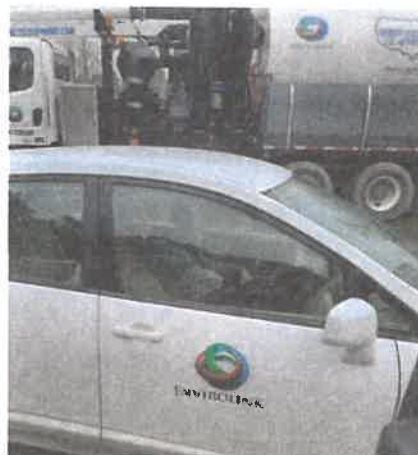
When the Engineer arrived at the vacuum sewer receiving station at 9:30 am on February 4, 2022, the one and only operator at the facility was asleep in his car. It took a few minutes of tapping on the window of the car to wake the operator.

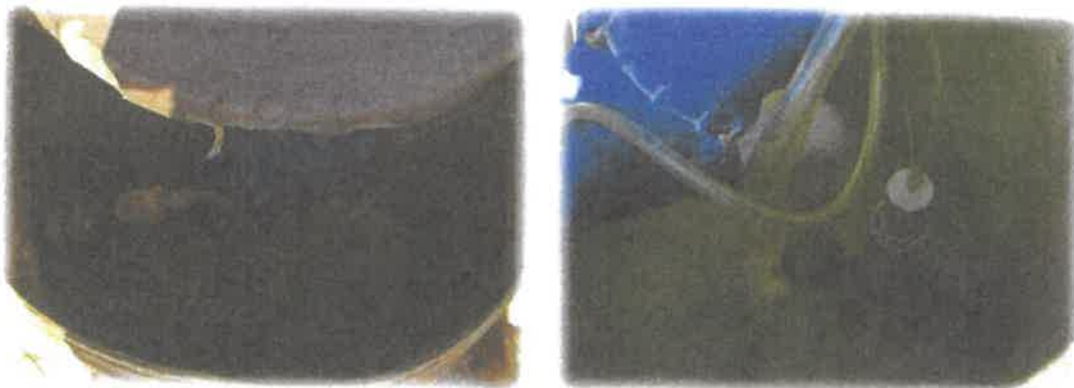
- The Airvac Valve System and its sensors DO NOT work under water, as the company offered at the time. The high presence of humidity during the rainy season enters the sensors, blocking their operation and the operation of the vacuum valve. in turn affecting the

View of a new Airvac Collection Tank during the construction of the System, optimal state of the upper chamber.

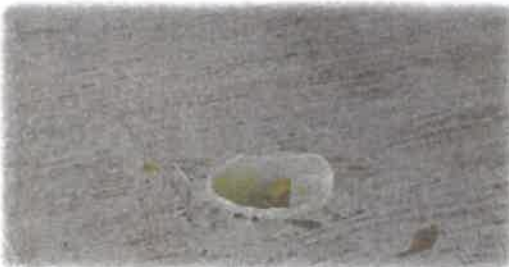
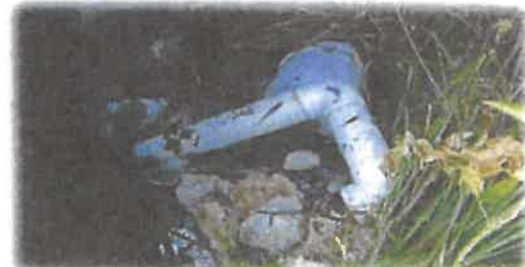
In addition to this lack of spare parts, we must consider the two complementary elements that make these tanks work properly, which are the vents of the Airvac valves and the gravity lines that frequently suffer damage that affects their correct operation.

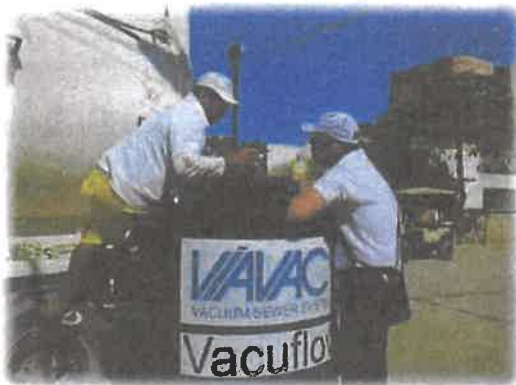
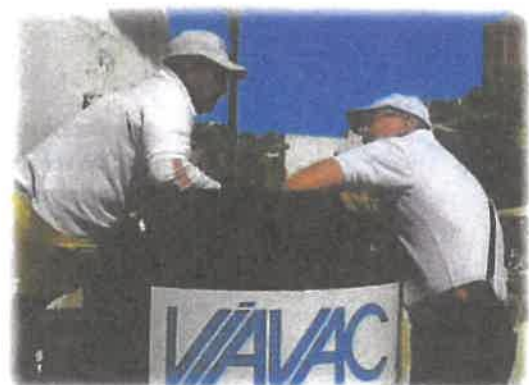
In February of this year, a collection tank from the company **Viatek** was received as a test donation, which was installed to replace an Airvac fiberglass tank that had critical damage to its structure, as it had large cracks that allowed the passage of sewage to the top and were already contaminating the water table.

Airvac collector tank in poor condition, with serious leaks of sewage into the subsoil and water table.

VIAVAC/Vacuflow collection tank supplied; its characteristics and operation were explained to the operating personnel. Immediately highlighting that they work without a vacuum sensor and external vents.
