Public Staff Late Filed Exhibit 2

Attachments to Company's Response to  
Public Staff Data Request 3-5 - Bremo

RE: Follow-up to pH incident at Dominion – Bremo Power Station

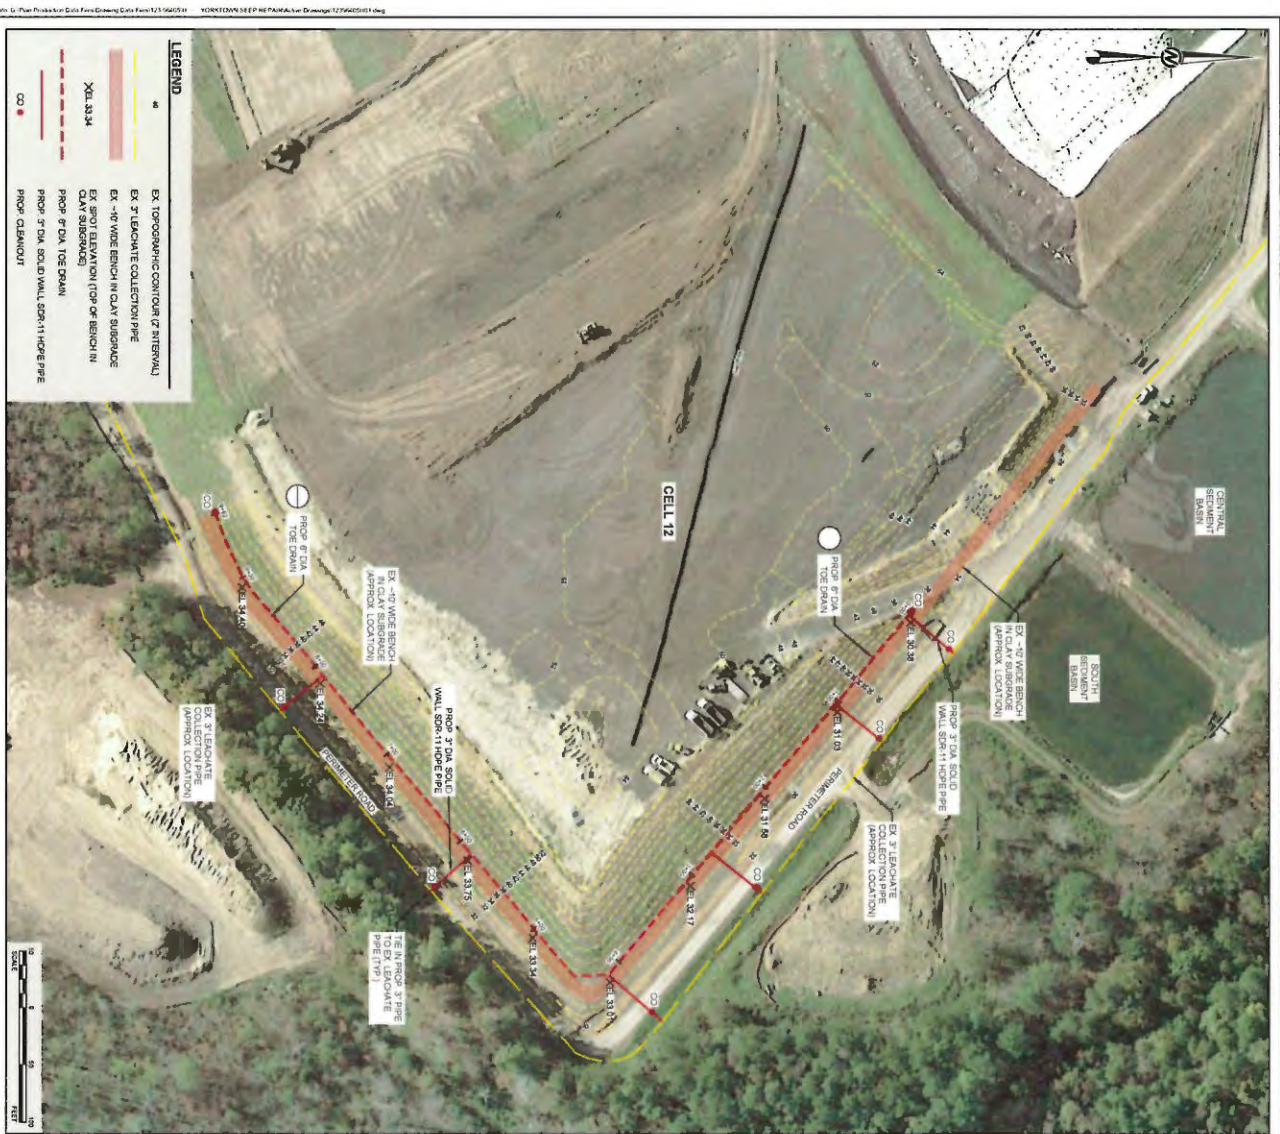
During the rain event, the berm failure occurred where the installed check dam was located. The perimeter ditch was filled to capacity with ash laden rainwater. A previously placed straw bale was in front of the culvert pipe leading from the Cell 12 check dam into the center sedimentation pond. The straw bale restricted flow into the culvert pipe and filled the perimeter ditch to capacity.

Improper construction of the check dam allowed for rapid erosion of the berm. Filter fabric provides a protective layer between the soil and rock. Filter fabric was not used in the installation of the check dam. In addition, two types of rock are necessary for proper construction. Only small gravel was used. Omitting class I rip rap allowed the flow to carry off the small gravel.
