# Due Diligence Assessment

Produced for Bald Head Island Transportation Authority

March 5, 2019

Bald Head Island Transportation Authority (BHITA) is performing due diligence on the Ferry Terminal and related waterfront structures at the Deep Point Marina (DPM) and Bald Head Island (BHI) sites in North Carolina. Moffatt & Nichol was contracted to carry out an above and below water inspection of these during the week of December 17-21, 2018. The purpose of the inspection was to assess the overall general condition of each structure, identify major deficiencies, and recommend needed repairs within a 10-year planning horizon.

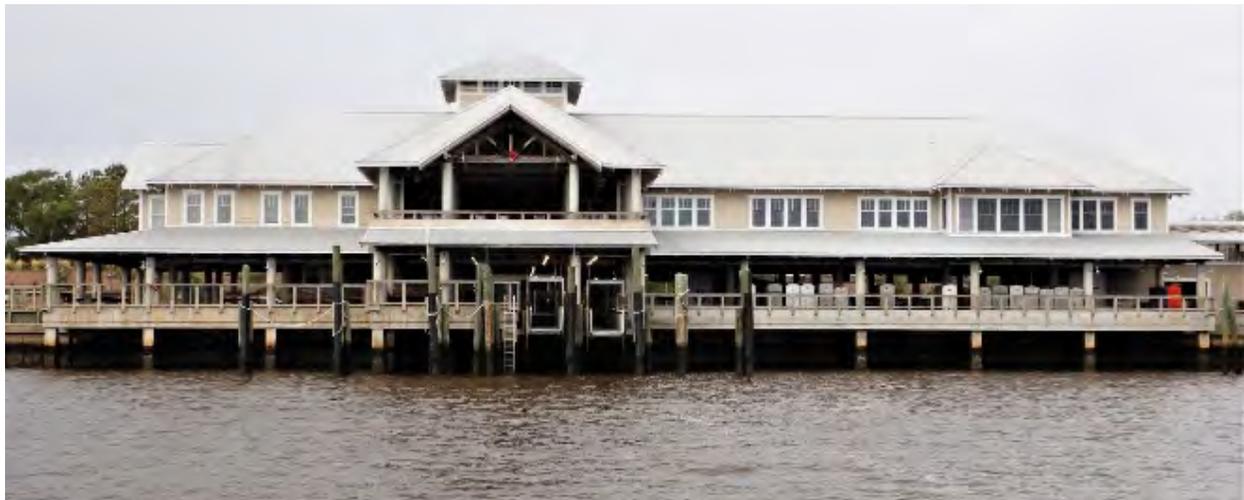
**FIGURE 2-1: DPM A-GATE PASSENGER LANDING ELEVATION VIEW (LOOKING WEST)**

The A-Gate Passenger Landing is a reinforced concrete dock supported by prestressed concrete piles. A series of timber pile dolphins are arranged along the berthing face to provide vessel breasting and mooring. Overall, the structure was found to be in good condition with no visible sign of damage or repairs needed.

Summary	
Construction	Concrete
Overall Condition	Good
Repair Priority	Low
Significant Defects	None
Recommendations	Routine Inspection & Maintenance
Recommended Repairs Estimate	\$0

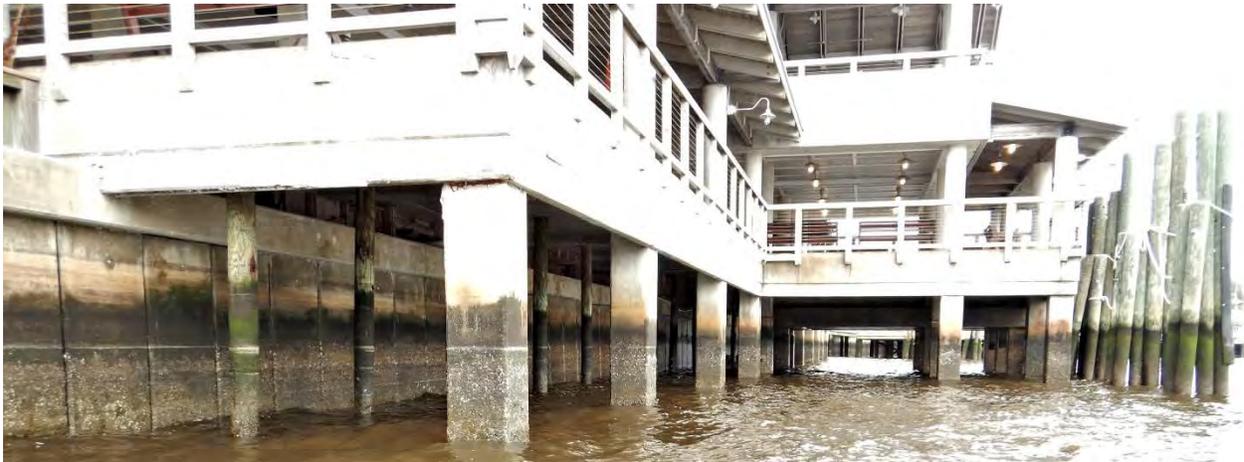
FIGURE 2-2: DPM A-GATE PASSENGER LANDING (LOOKING NORTH)

End view of concrete support piles, timber fender piles (right), and adjacent concrete bulkhead (left)

Seven of the 24 concrete support piles have been retrofitted with fiberglass and epoxy jackets, reportedly following original construction (pile driving). These were found to be in good condition with no signs of deterioration or damage. A series of timber piles along the bulkhead wall were installed to support construction loads and are no longer serving any function. The mudline along the bulkhead wall has been fortified at the south end with cut off sections of concrete pile laid sideways and rip rap stone at the north end between Bent 1 and Bent 5. See the marine pile plan layout (FIG-A1) in Appendix A for more detail.

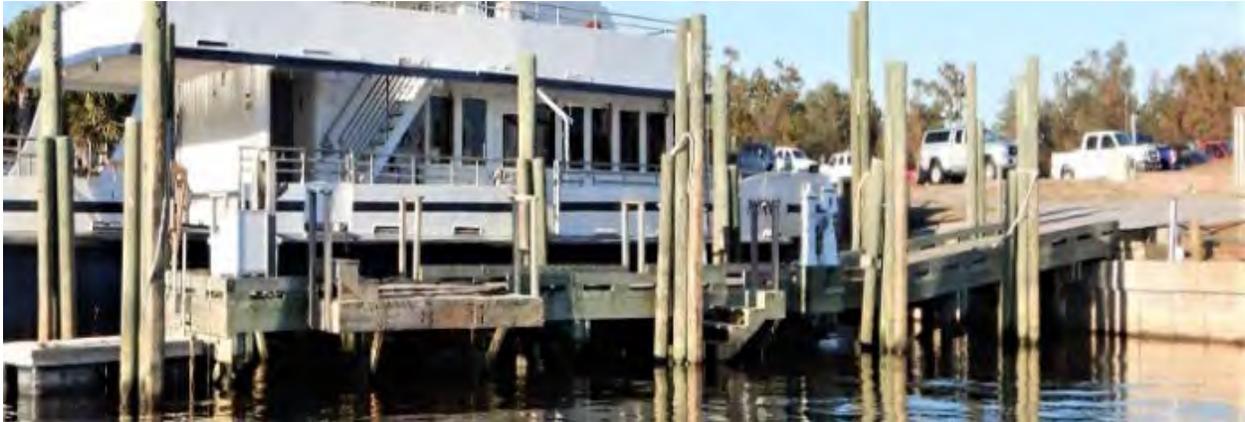
**FIGURE 2-5: DPM MAINTENANCE FIXED PIER ELEVATION VIEW (LOOKING WEST)**

Summary	
Construction	Timber
Overall Condition	Good
Repair Priority	Low
Significant Defects	Open bolt holes in piles.
Recommendations	Repair minor defects including bolt holes in timber piles and split bracing.
Recommended Repairs Estimate	\$1,000

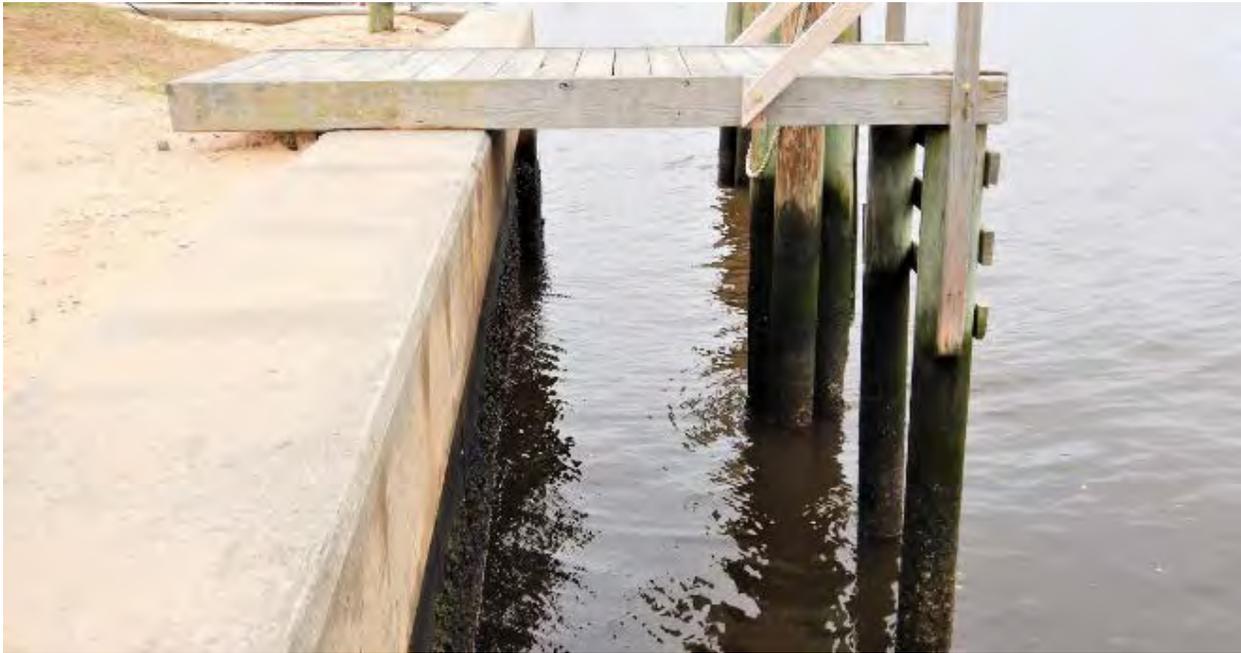
**FIGURE 2-8: DPM "G" BERTHING PLATFORM ELEVATION VIEW (LOOKING SOUTH)**

Summary	
Construction	Timber
Overall Condition	Good
Repair Priority	Low
Significant Defects	None
Recommendations	Routine Inspection & Maintenance
Recommended Repairs Estimate	\$0

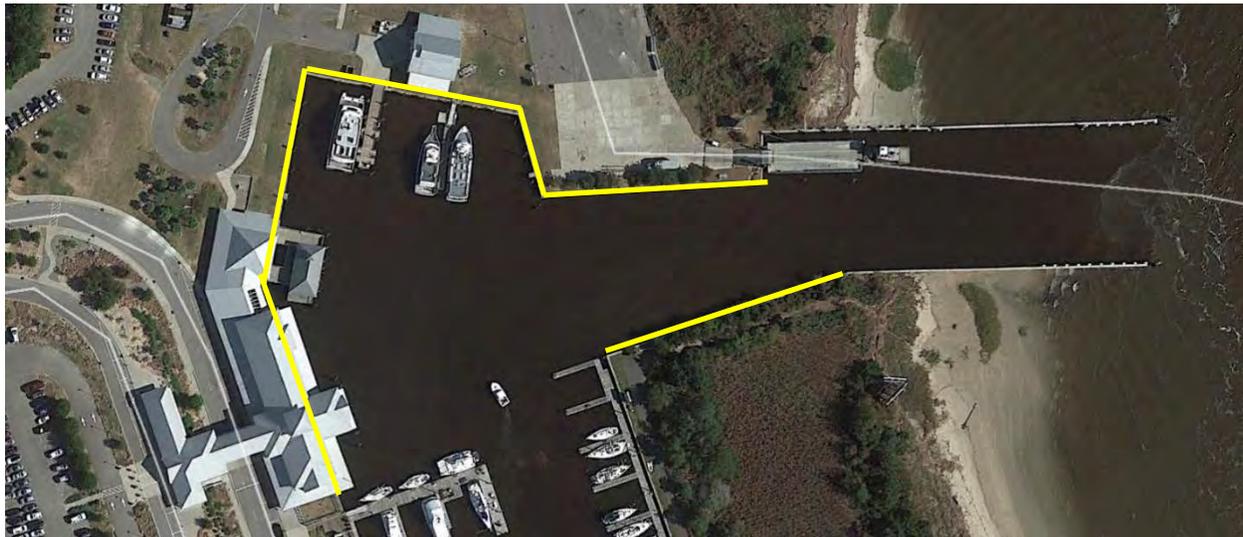
**FIGURE 2-10: DEEP POINT MARINA PLAN VIEW**

The shoreline at DPM is comprised of a concrete sheet pile bulkhead wall with a reinforced concrete cap. The limits of the bulkhead wall are shown in Figure 2-10. On the north and west perimeter of the marina, the bulkhead extends from the barge ramp around to just beyond the “A” Gate Ferry Terminal Building. The bulkhead wall along the south bank of the inlet channel is also included in this assessment. Segments to the south of the yellow highlighted walls in Figure 2-10 along the marina floating docks are not part of the scope for this assessment.

Summary	
Construction	Concrete Sheet Pile
Overall Condition	Satisfactory
Repair Priority	Medium
Significant Defects	Sinkholes behind the wall Minor spalls & cracks
Recommendations	<ol style="list-style-type: none"> <li>1. Repair/ fill sinkholes as needed</li> <li>2. Monitor the repair section adjacent to the barge ramp &amp; plan a permanent repair during the next major CAPEX cycle.</li> </ol>
Recommended Repairs Estimate	\$137,000

Ferry Terminal bulkhead wall scope limits highlighted in yellow

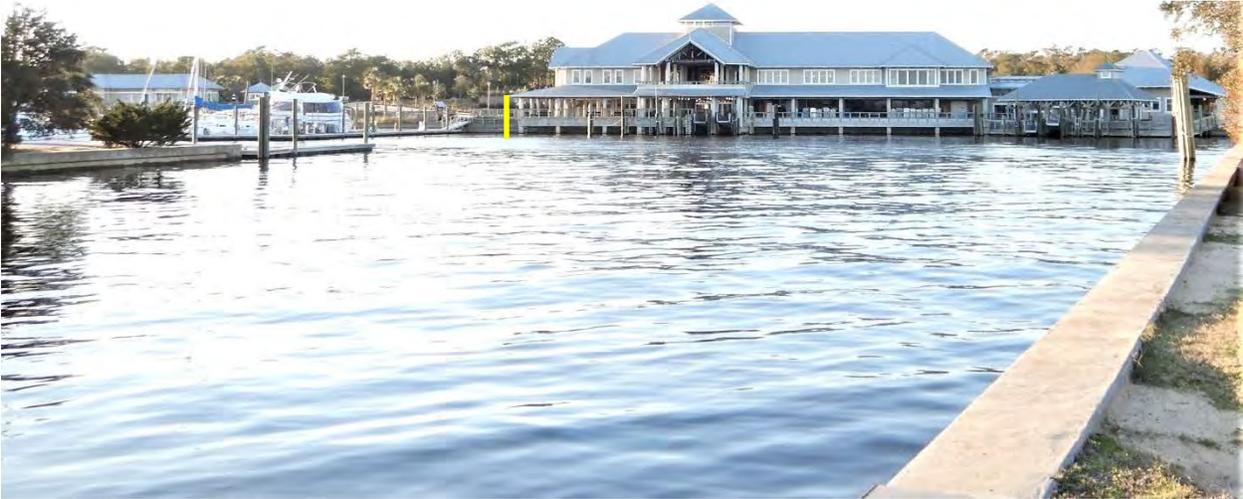
FIGURE 2-11: VIEW OF DPM (LOOKING WEST)

View of DPM bulkhead wall at marina inlet (foreground left and right) and end of scope limits between Ferry Terminal Building and A Dock (yellow, background center-left)

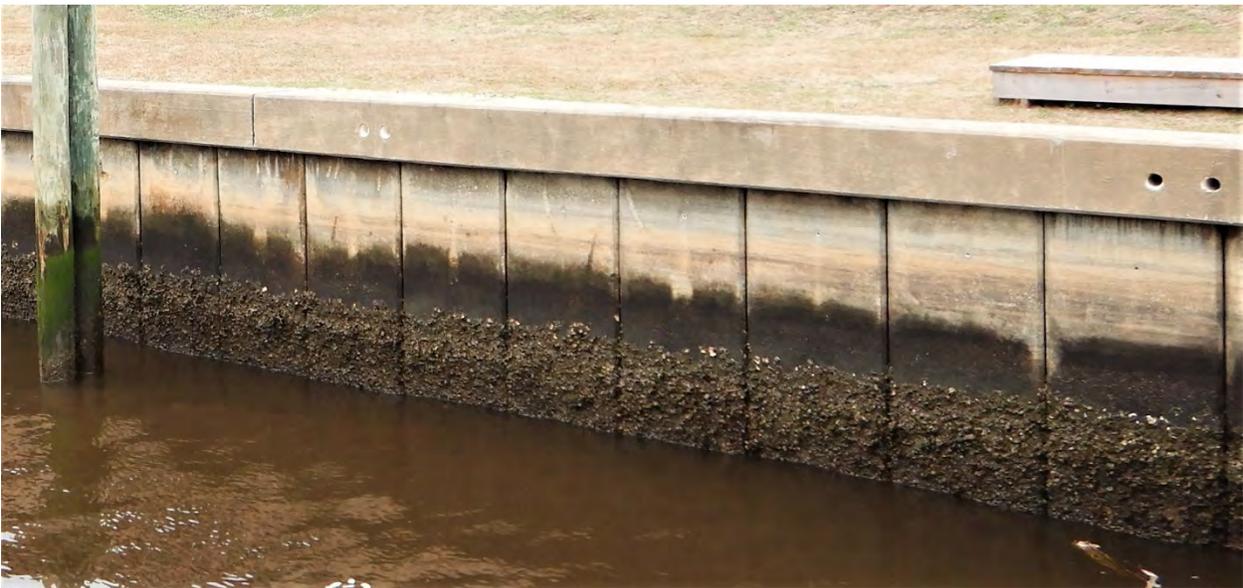
FIGURE 2-12: TYPICAL BULKHEAD WALL ELEVATION AT LOW TIDE

The DPM bulkhead wall is constructed of concrete sheet pile panels which interlock with a tongue-and-groove type fit and a reinforced concrete cap along the top of the wall, typically level with the adjacent sand fill/lawn. Inspection of the above water portion of the wall was performed during low tide. With the exception of the section adjacent to the barge ramp (see next section). The bulkhead is in overall good condition with isolated/localized spalls and cracks.

Location adjacent to "H" Berth and Maintenance Docks, looking West

The spalls and cracking in the sheets are typically along the groove side of the tongue-and-groove interlock, exposing the tongue from the adjacent sheet but not creating open voids. Areas behind the wall have loss of fill or “sinkholes” which are typical for this type of construction. Locations with minor fill loss and sinkholes can be addressed by regular maintenance with replacement sand/stone fill material when needed.

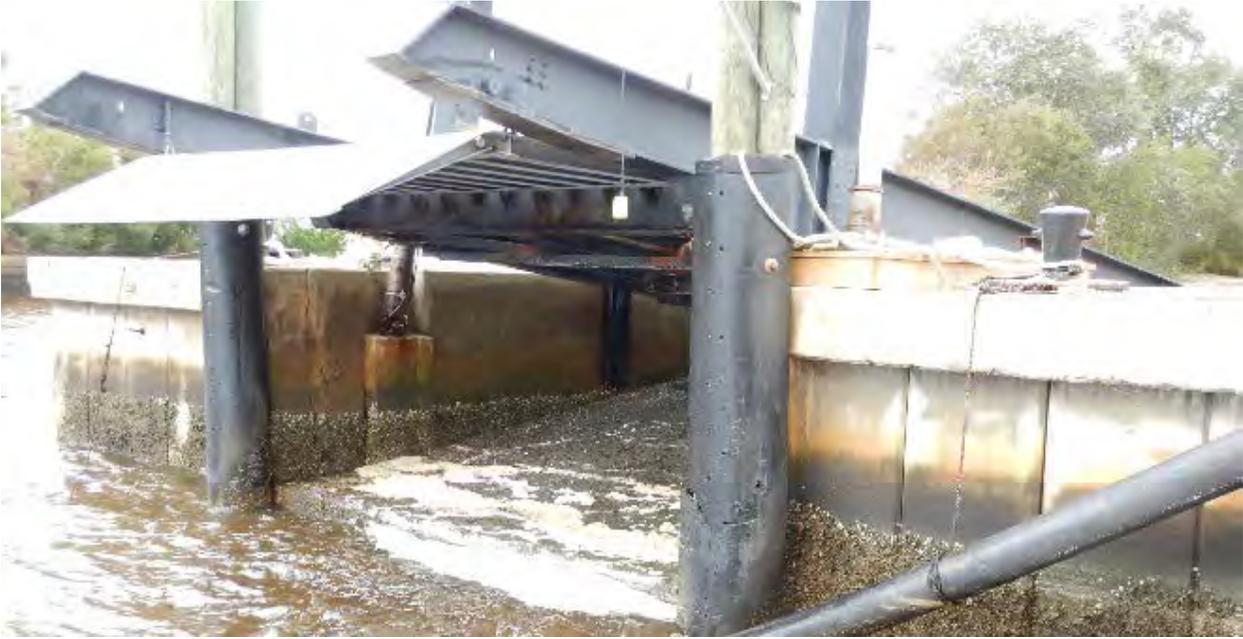
FIGURE 2-18: DPM BARGE RAMP ELEVATION VIEW (LOOKING SOUTHWEST)

Summary	
Construction	Steel Ramp with Concrete Substructure
Overall Condition	Satisfactory
Repair Priority	Medium
Significant Defects	Moderate corrosion of steel elements Crack in concrete substructure
Recommendations	<ol style="list-style-type: none"> <li>1. Monitor tension crack associated with bulkhead repair section.</li> <li>2. Monitor steel corrosion and plan refurbishment during the next major CAPEX cycle.</li> </ol>
Recommended Repairs Estimate	\$154,000

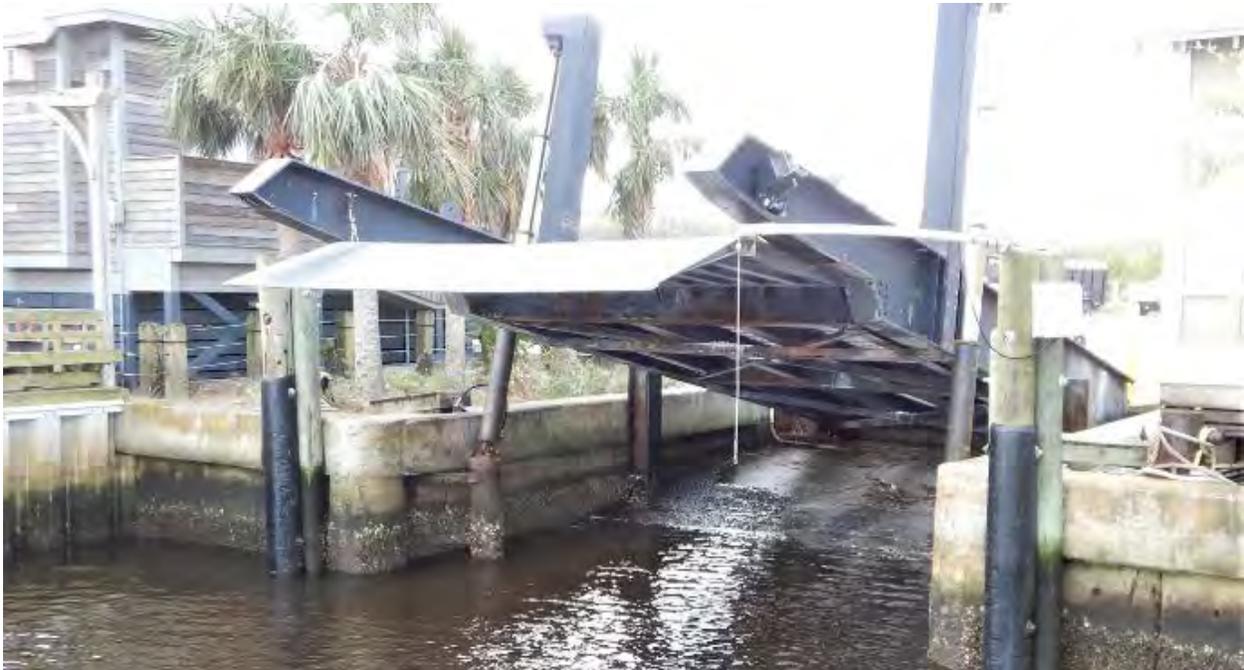
**FIGURE 2-20: BHI BARGE RAMP ELEVATION VIEW (LOOKING SOUTHEAST)**

Summary	
Construction	Steel Ramp with Concrete Substructure
Overall Condition	Satisfactory
Repair Priority	Medium
Significant Defects	Moderate corrosion of steel elements
Recommendations	Monitor steel corrosion and plan refurbishment during the next major CAPEX cycle.
Recommended Repairs Estimate	\$130,000

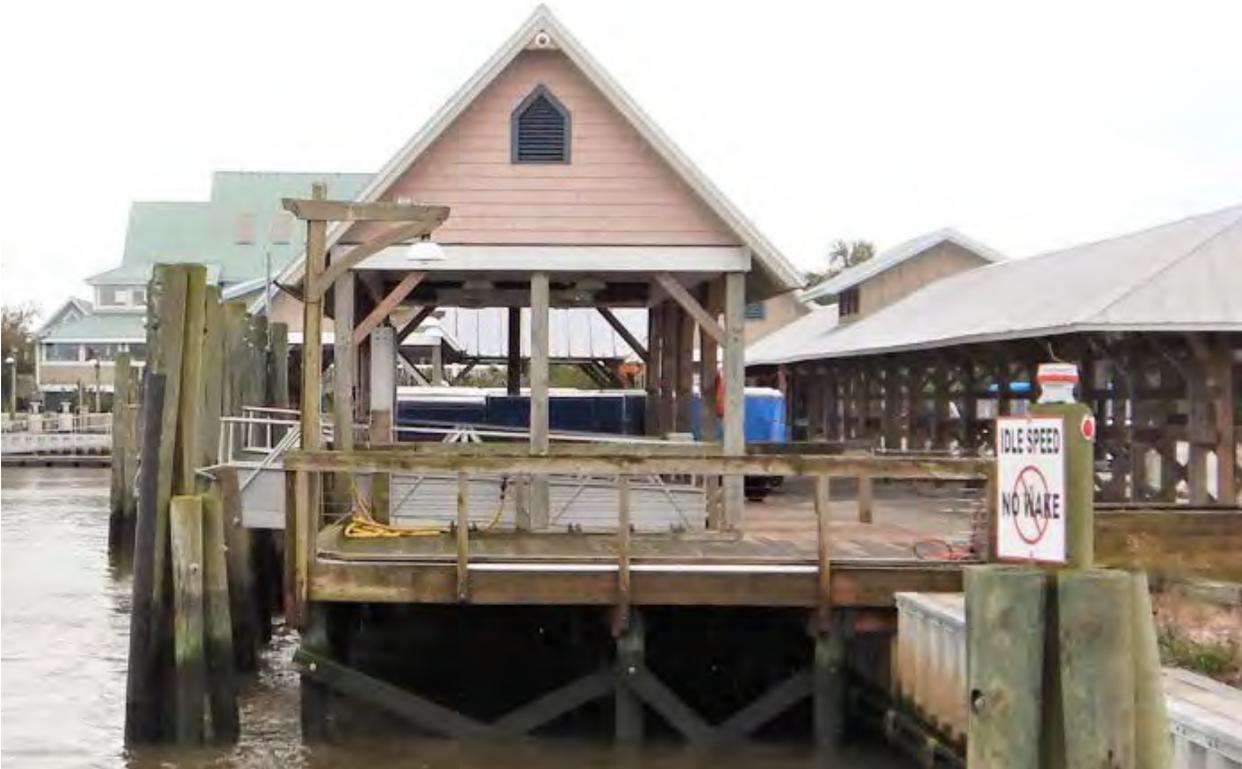
FIGURE 2-22: BHI CONTRACTOR LANDING END VIEW (LOOKING SOUTH)

Summary	
Construction	Timber
Overall Condition	Good
Repair Priority	Low
Significant Defects	Minor decay on 3 piles Open bolt holes and minor timber defects (abrasion/ check/ shake)
Recommendations	Routine Inspection & Maintenance Cover open bolt holes with epoxy
Recommended Repairs Estimate	\$10,000

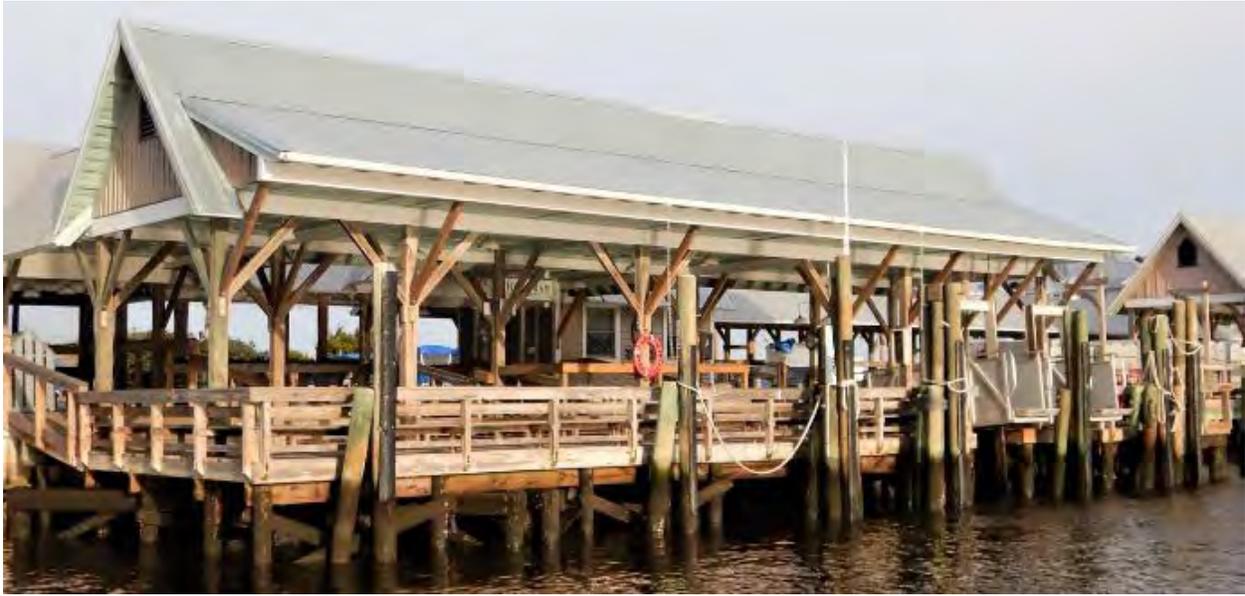
FIGURE 2-24: BHI PASSENGER LANDING ELEVATION VIEW (LOOKING WEST)

The BHI Passenger Landing is a timber structure supported by various types of piles/columns and timber substructure elements, either from the original construction or installed during its repair history. The original round timber piles (installed by pile-driving them into the subsurface) have been augmented by additional timber piles driven where access was available or by square columns jetted into the subsurface. These have been connected directly to the original timber framing stringers or with additional structural members to create “crutch bents” in order to support the loads from the deck and structure above. There are a series of timber pile dolphins along the berth face for vessel breasting and mooring.
