**RE: Duke Energy Carolinas, LLC's and Duke Energy Progress, LLC's
Comments in Support of Inspections for Legacy Solar Generating
Facilities
Docket No. E-100, Sub 101**

- Present the technical findings from the nine sites in the 2018/2019 periodic inspection pilot
- Provide examples of safety, reliability and power quality issues to look for in a self-inspection
- Not a comprehensive list of all items that could be found in a self-inspection
- Not a training on the self-inspection program details. The self-inspection program is still under development through the 2021 pilot process.

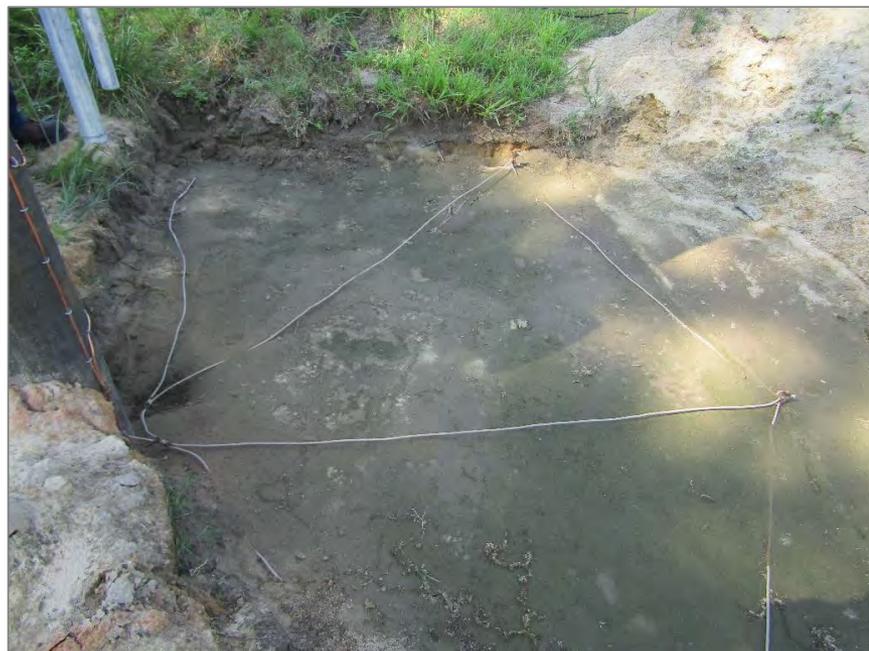
Missing GOAB Switch Ground Grid

Control rod operated GOAB switches must have a ground grid equivalent to **one** of the following:

- Duke Energy (FMO) standard 08.10-37
- RUS Bulletin 1728F-804 drawing H3.1
- RUS Bulletin 1728F-804 drawing H4.1

Duke Energy GOAB ground grid with 2 AWG bare solid copper wire grid loop and four ground rods

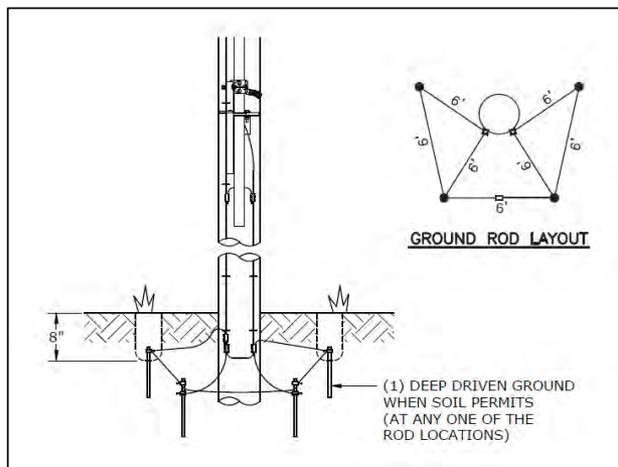
Duke Energy std. 08.10-37
four rods and 2 AWG solid
copper wire grid loop. One
20 ft. deep driven rod
required. Other three rods
8 ft. minimum

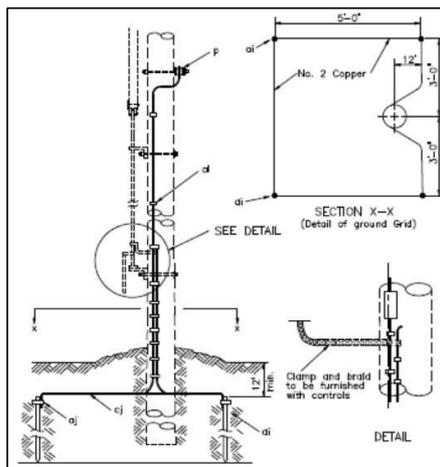
RUS Bulletin
1728F-804
drawing H3.1
four rods and 2
AWG solid
copper wire loop

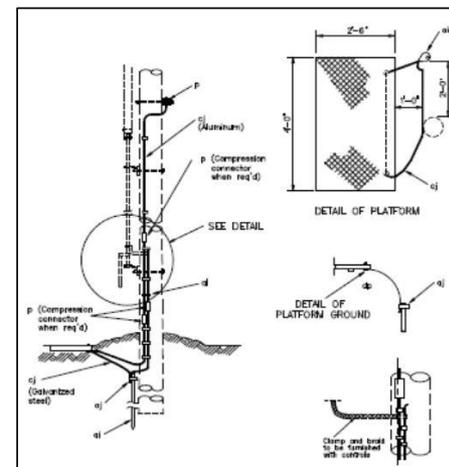
RUS Bulletin 1728F-
804 drawing H4.1
galvanized steel
platform, one rod and
2 AWG solid copper
loop

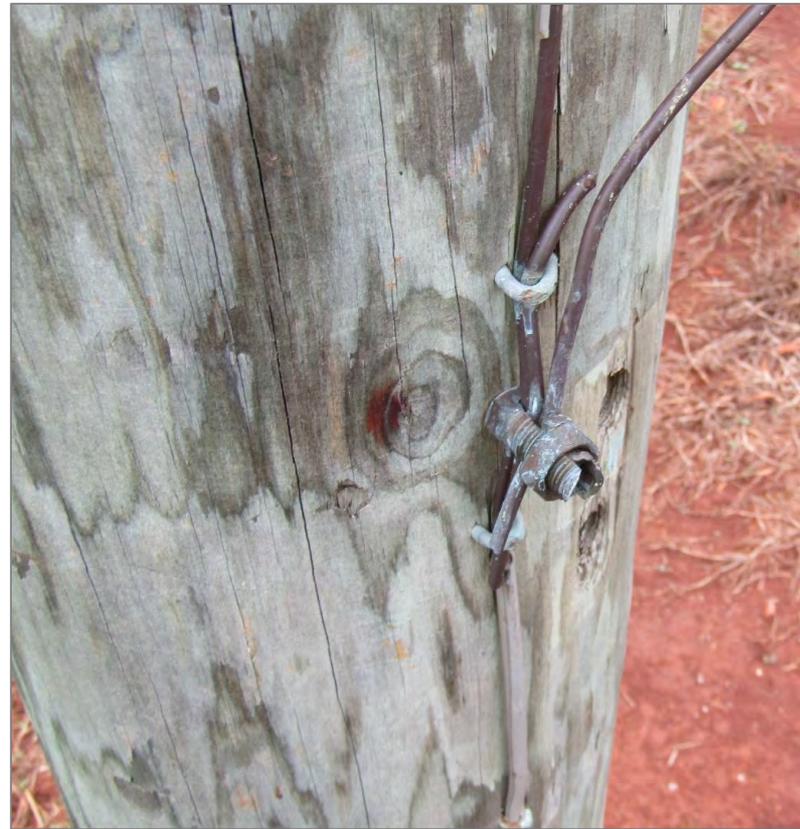
Pole Ground Splice

- Pole ground splice made with a mechanical connector
- 3 wires connected with a split-bolt connector rated for 2 wires
- Compression connectors are required

NEC 110.3(B); Duke 02.03-102B; RUS 1728F-803 Construction Specifications for Grounding and drawings H3.1 and H4.1

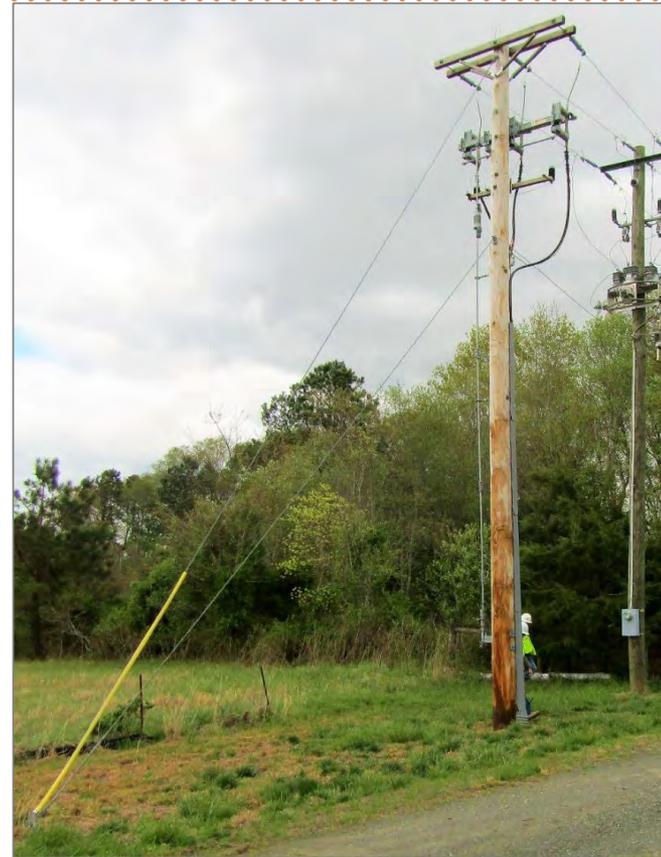
Ungrounded Guy Wires

- The guy wires at the riser pole are not grounded
- The upper guy wire is installed above energized parts but does not have a guy insulator stick
- The guy wires are located outside the facility fence, creating a risk to the public

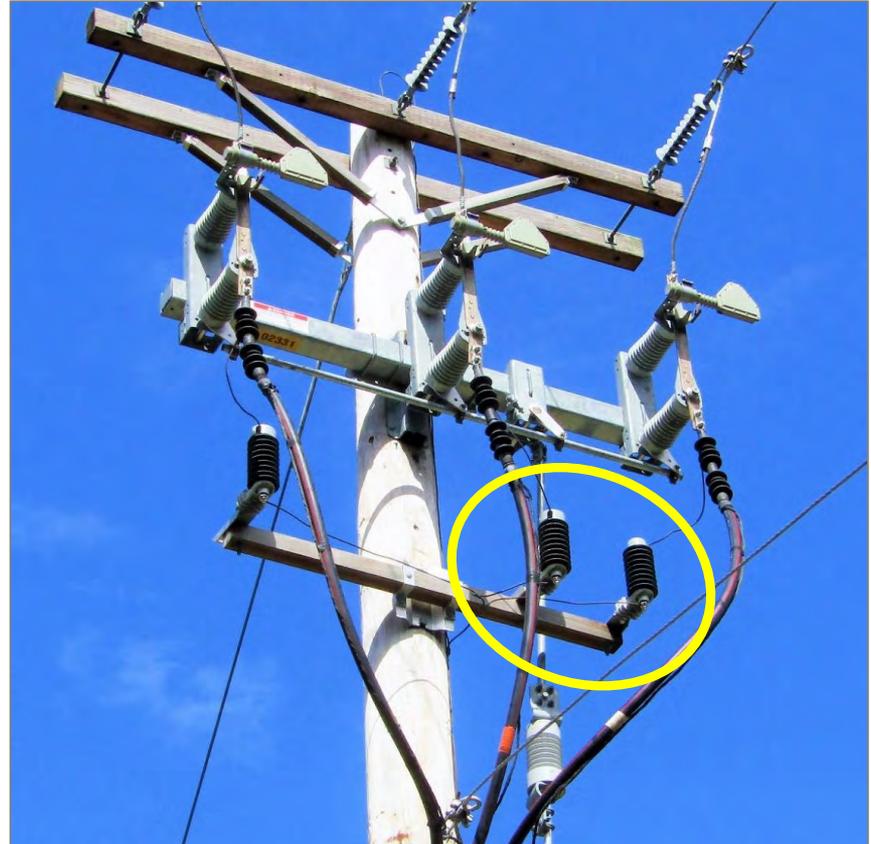
Insufficient Clearance

12 inches of phase-to-phase clearance between lightning arrester primary terminals where NESC requires 18 inches minimum

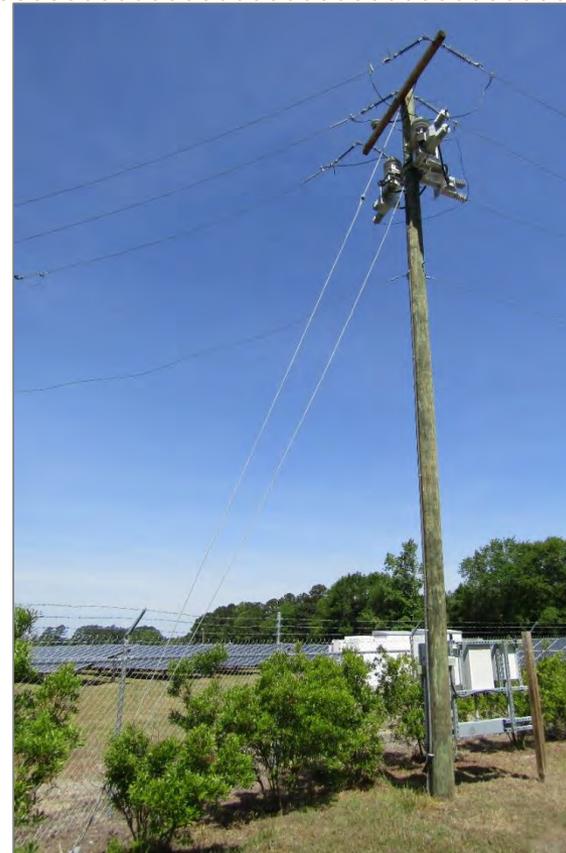
Ungrounded Guy Wires

- The guy wires are not grounded
- The lower guy wire connects to the pole above the system neutral less than 24 inches below energized primary parts and does not have a guy insulator installed
- The guy wires are located outside the facility fence, creating a risk to the public

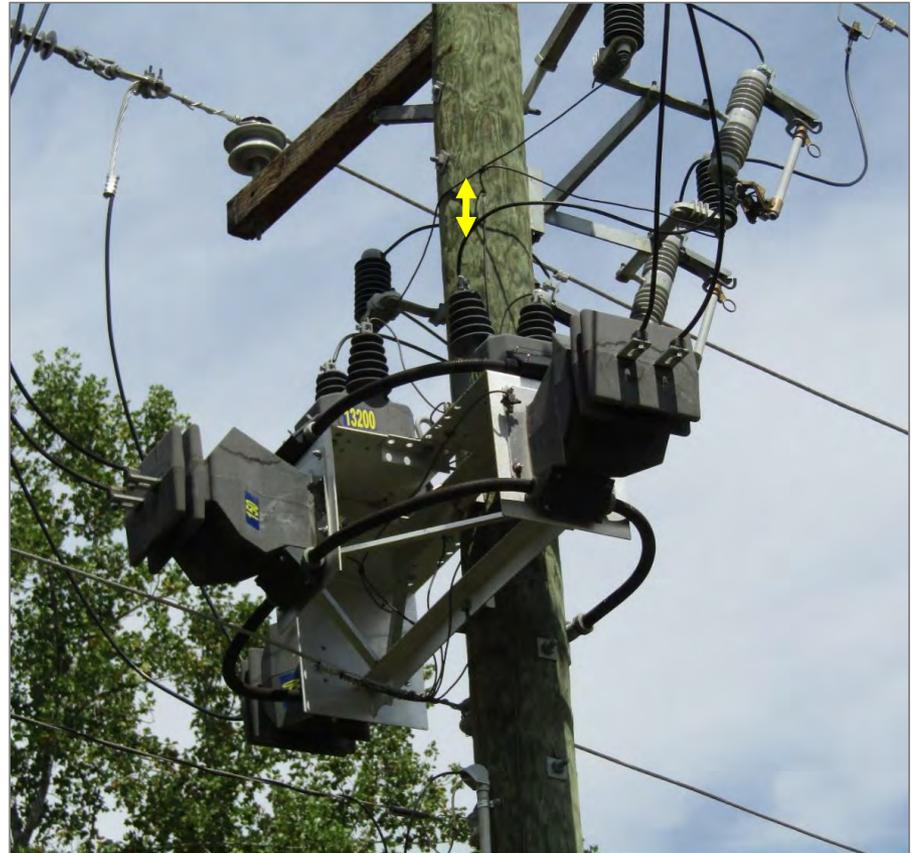
Insufficient Clearances

- 12 inches vertical phase-to-ground clearance where NESC requires 18 inches minimum
- System neutral and meter frame too close to crossarm results in congested meter pole framing with insufficient clearances

NESC Tables 235-1 and 235-5; DEC-DEM Distribution Standards Manual-Part 1 – 10003DUK and 88420DUK; Duke 06.00-120

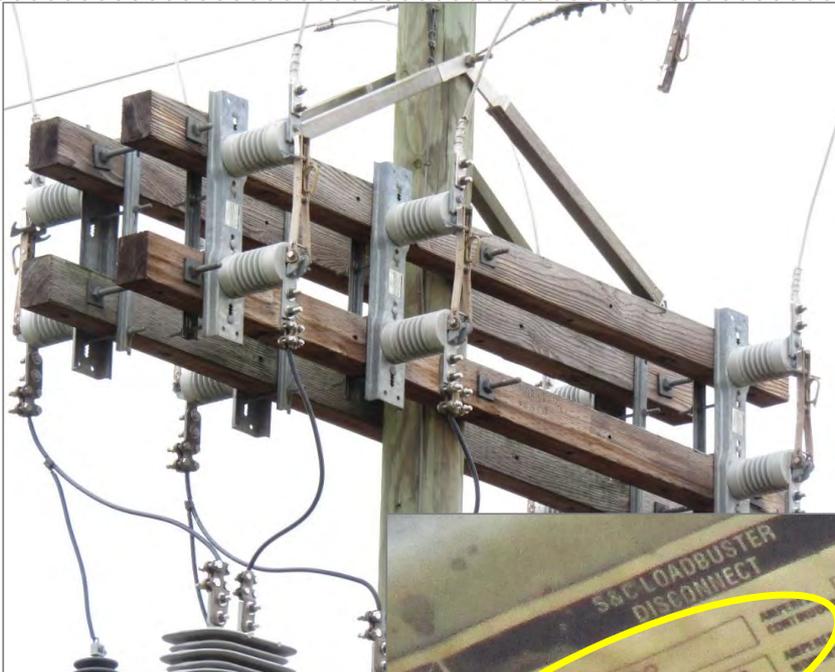
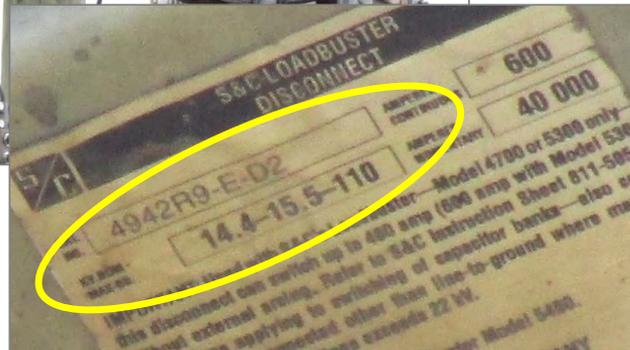
Insufficient Switch Voltage Rating

- 14.4 kV switches used where 27 kV switches are required for 23 kV nominal voltage
- 14.4 kV switches only have 110 kV BIL
- 125 BIL required for 23 kV system

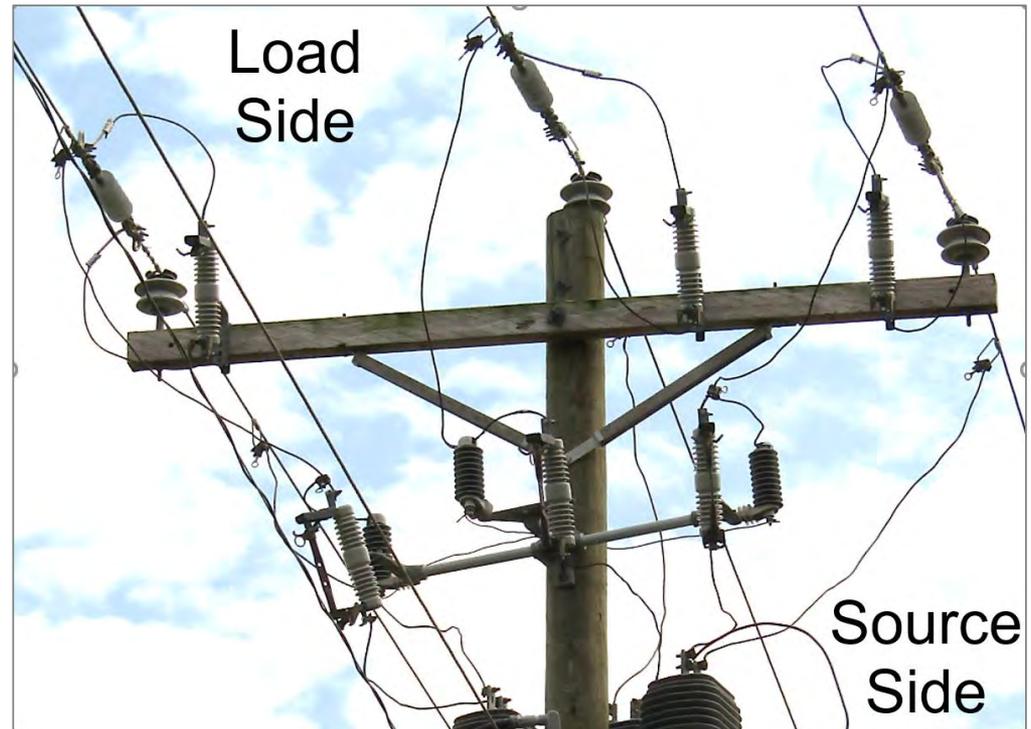
Backwards Framed Meter Pole

- Pole is built backwards so cutouts cannot be opened safely without first de-energizing the site
- Meter and bypass cutouts are reverse fed, with utility source connected to the bottom, causing the blades to remain energized when the switches are opened

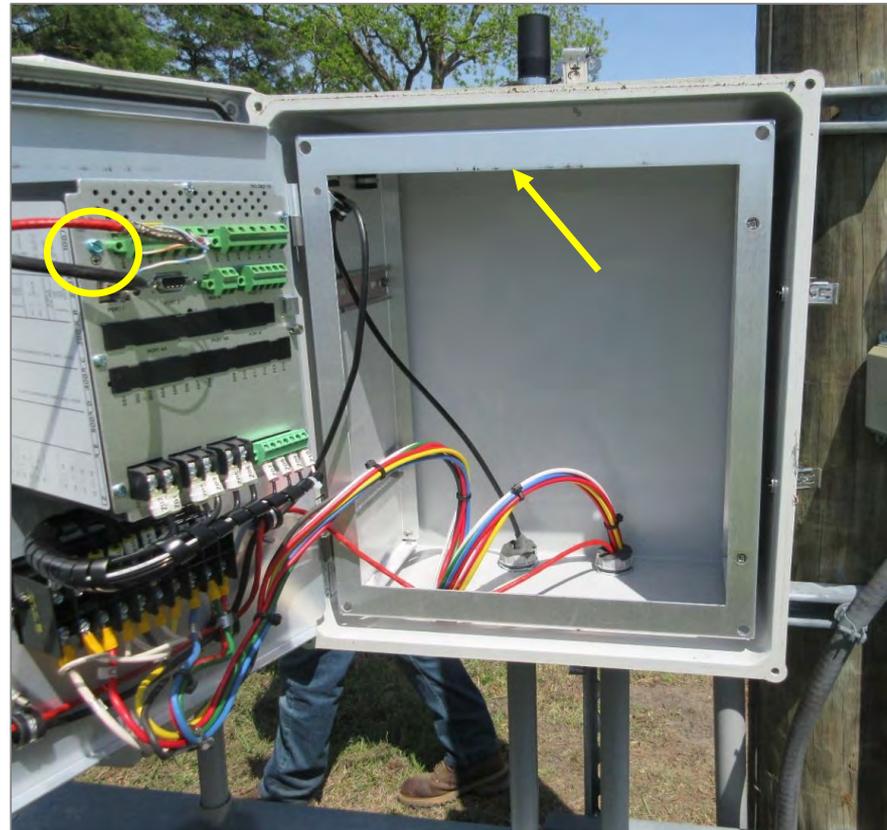
Meter Grounding

- Pole mounted aluminum meter enclosure not bonded to pole ground
- Meter chassis not grounded at green marked grounding screw

NESC 123A and 215C1; NEC 110.3(B), 250.4(A)(2) and 250.190; Duke 11.00-01, 02.03-110 and 20.04-143; RUS 1728F-803 Construction Specifications for Grounding

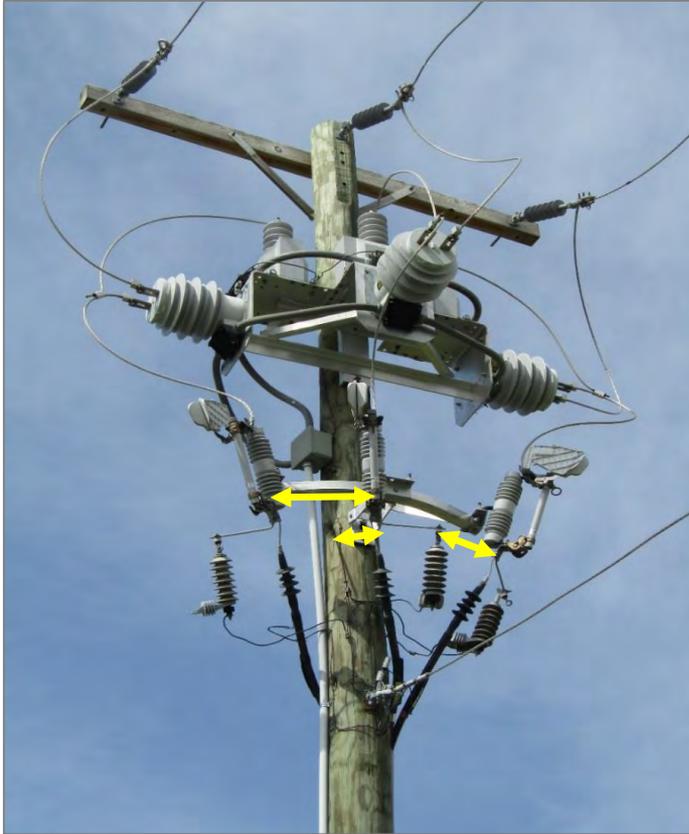
Insufficient Clearances

- Meter/riser pole with undersized 12 kV COLA bracket where 23 kV bracket is required
- Insufficient phase-to-ground clearance of 8 inches where NESC requires 14 inches min
- Insufficient phase-to-phase clearance of 12 inches where NESC requires 18 inches min

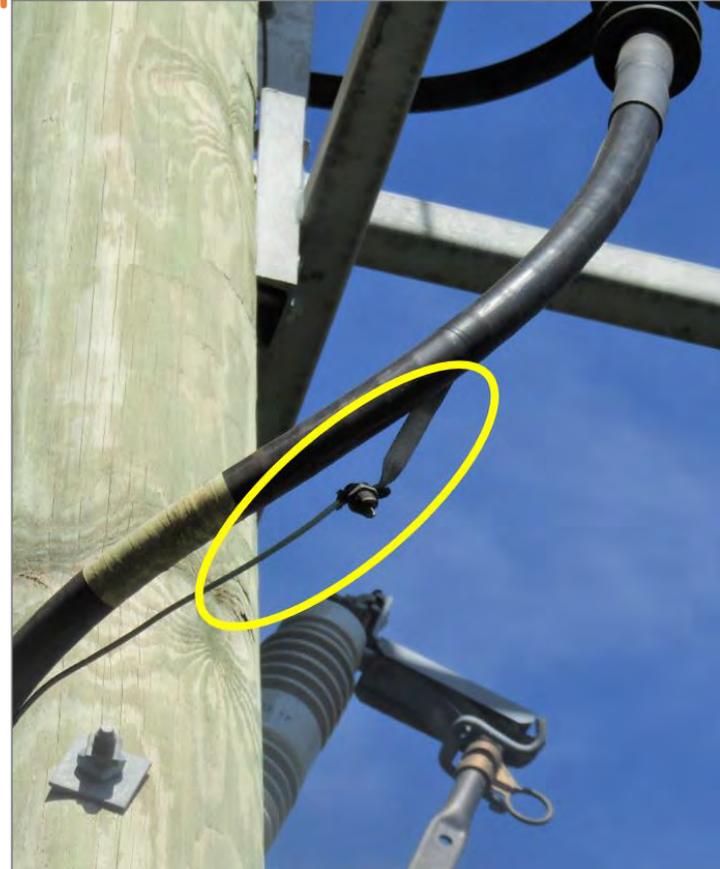
Undersized Terminator Braid Jumpers

- The 10 AWG insulated copper ground jumper is undersized for the 6 AWG copper terminator ground braid
- The conductor must be equivalent in circular mils to the ground braid to be sufficient to carry neutral current

NEC 110.3(B) and 250.190(C); IEEE 576 section 14.2(h)

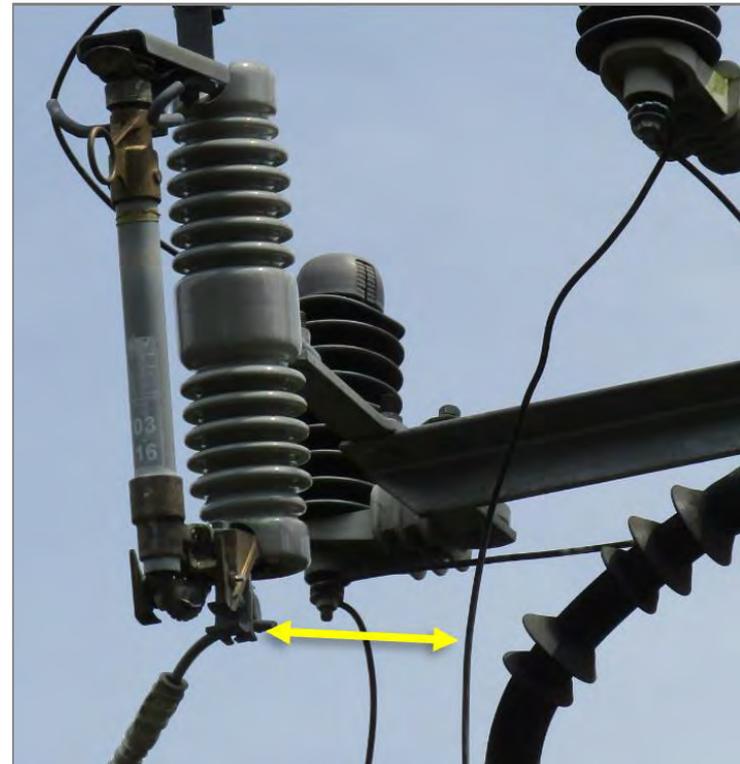
Insufficient Clearances

- Arrester ground leads too close to MV cable terminations of opposite phase
- 8 inches of phase-to-ground clearance where NESC requires 14 inches minimum

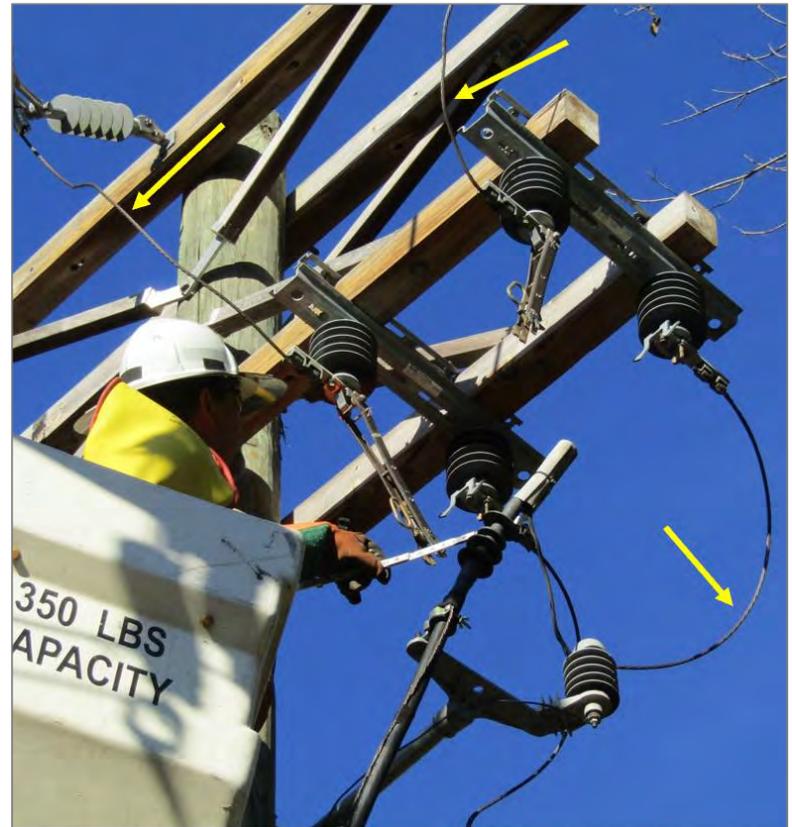
Undersized Equipment Jumpers

- 2 AWG stranded bare copper equipment jumpers are undersized for 232 Amp site rated current
- Minimum 1/0 AWG covered copper jumpers are required for rated current and wildlife protection

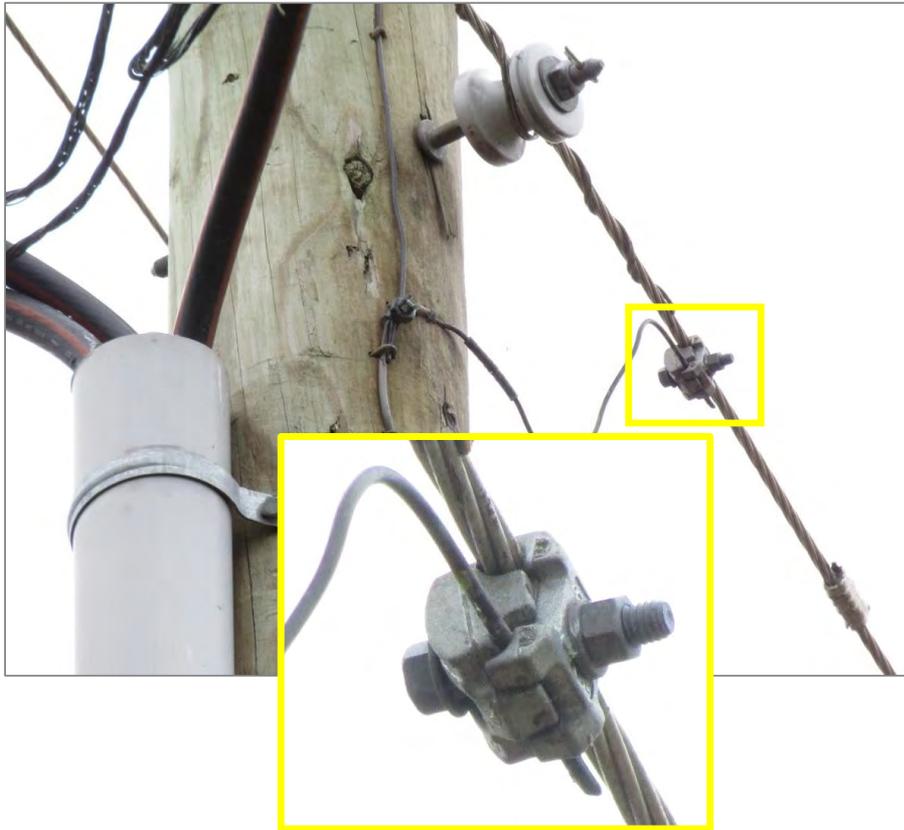
Pole Ground Connection to Neutral

- Pole ground connection to system neutral using a mechanical connector
- A compression connector is required

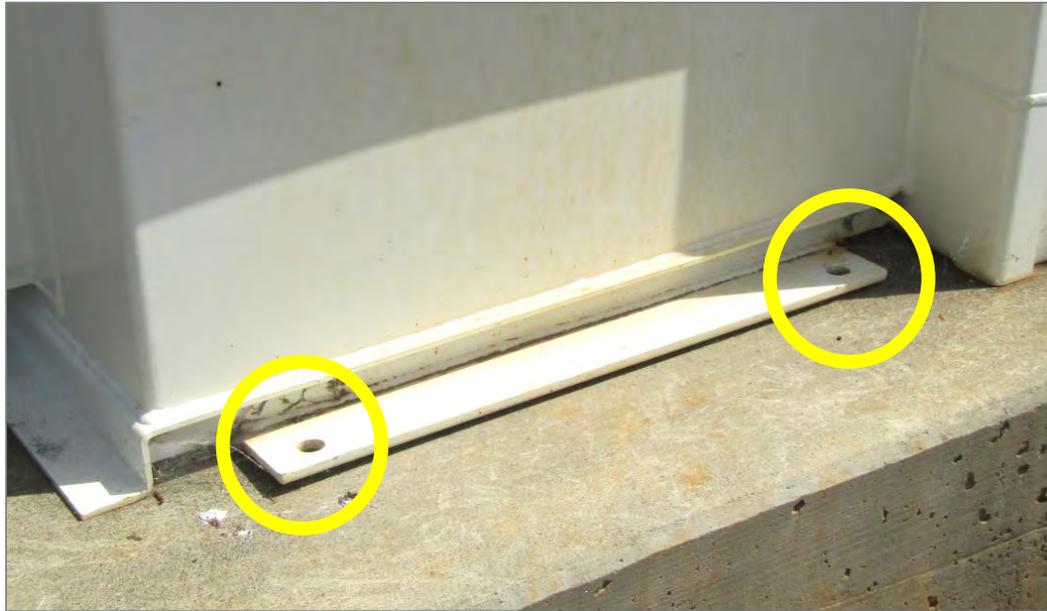
Transformer Not Secured to Pad

Transformers must be secured to resist movement during seismic activity, flooding, physical impacts and electrical faults.

NEC 110.3(B) and 110.13(A); Duke 27.00-109; RUS 1728F-806 drawings UF1.PC and UF3.BC

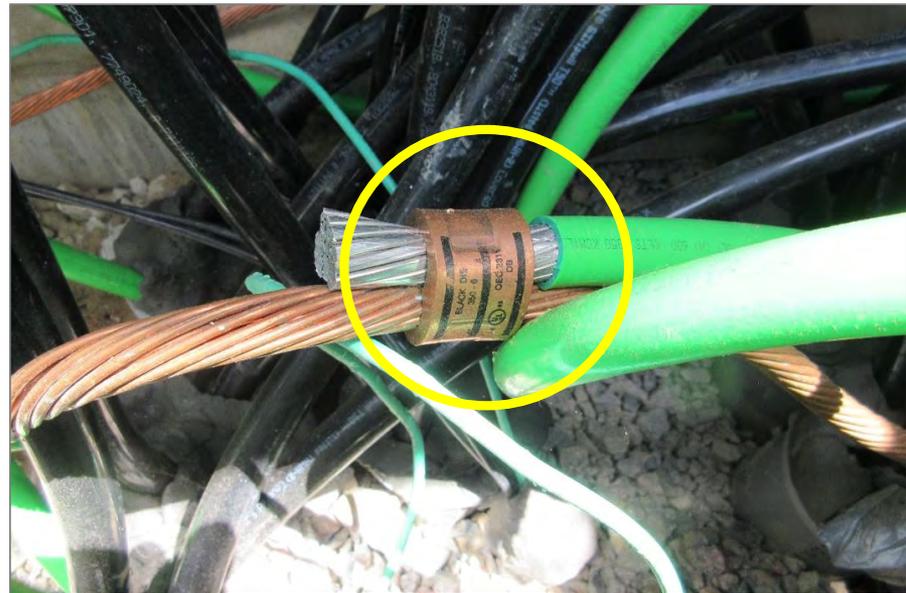
Incompatible Connector

- Copper connector used on aluminum wire
- Aluminum wire and aluminum-to-copper wire connections require tin-plated aluminum connectors

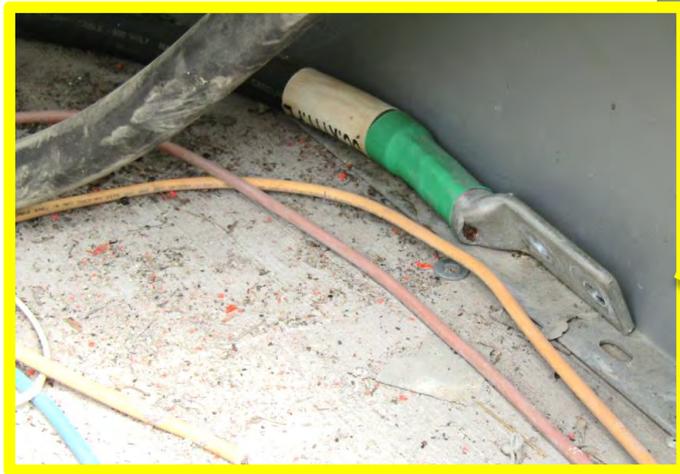
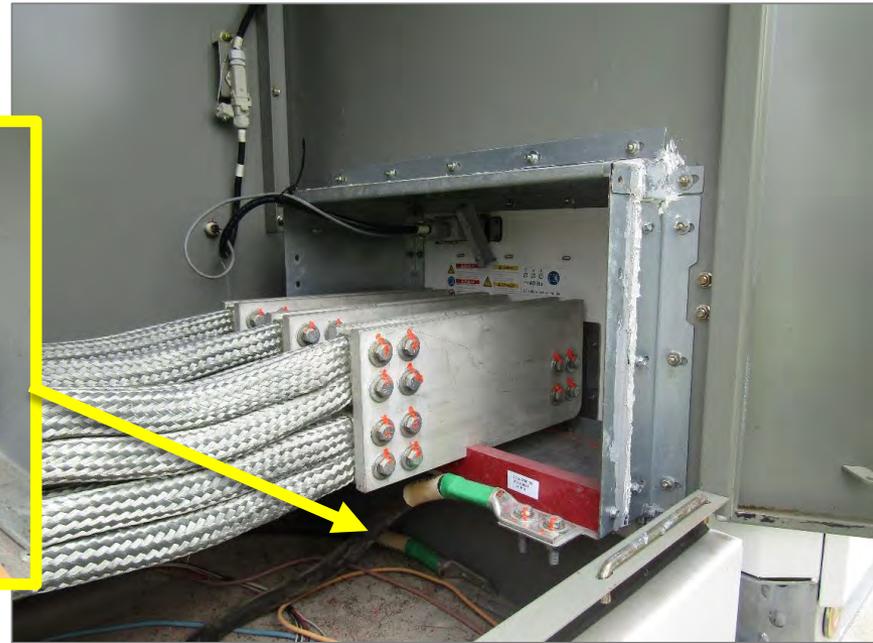
Disconnected Inverter Ground

The 500 kcmil flexible copper ground cable between the inverter and transformer was not connected to the inverter ground bus bar in the throat connection cabinet.

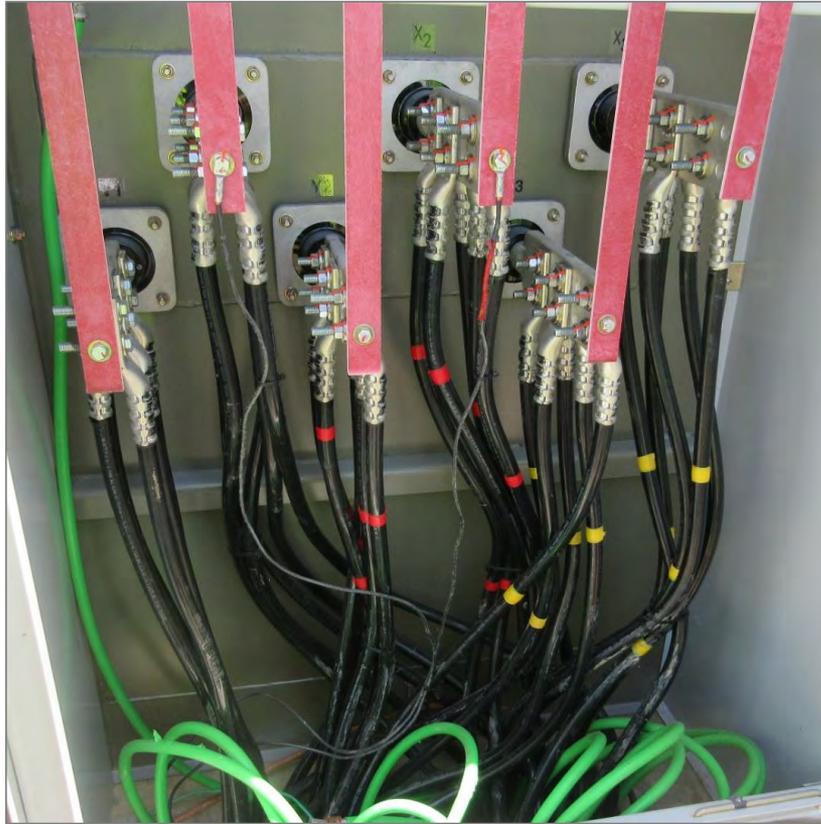
Insufficient Secondary Conductor Voltage Rating

- 600-Volt conductors (THWN-2) have insufficient insulation
- Inverter RMS voltage to ground is 800 Volts and peak pulsed voltage to ground is 1450 Volts

NEC 110.3(B)

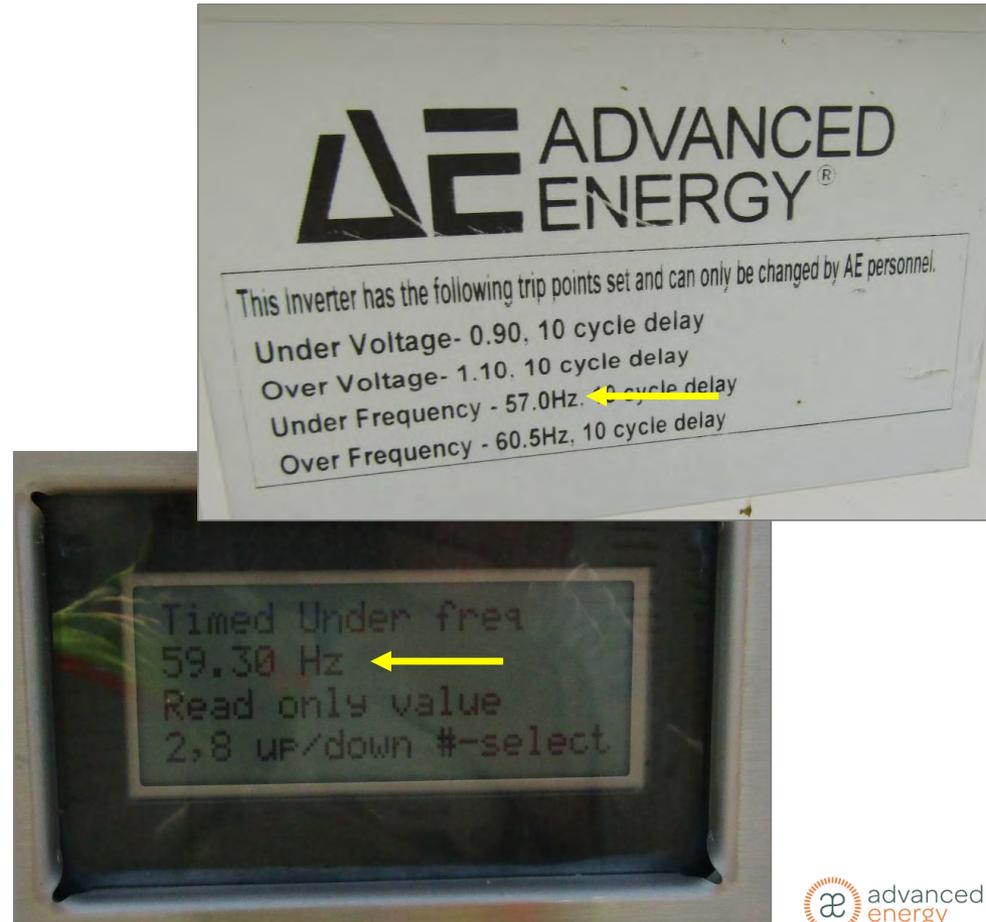
- Settings programmed into inverter do not agree with factory applied label
- Voltage and frequency settings set to default IEEE-1547 settings instead of Interconnection Agreement (IA) required settings

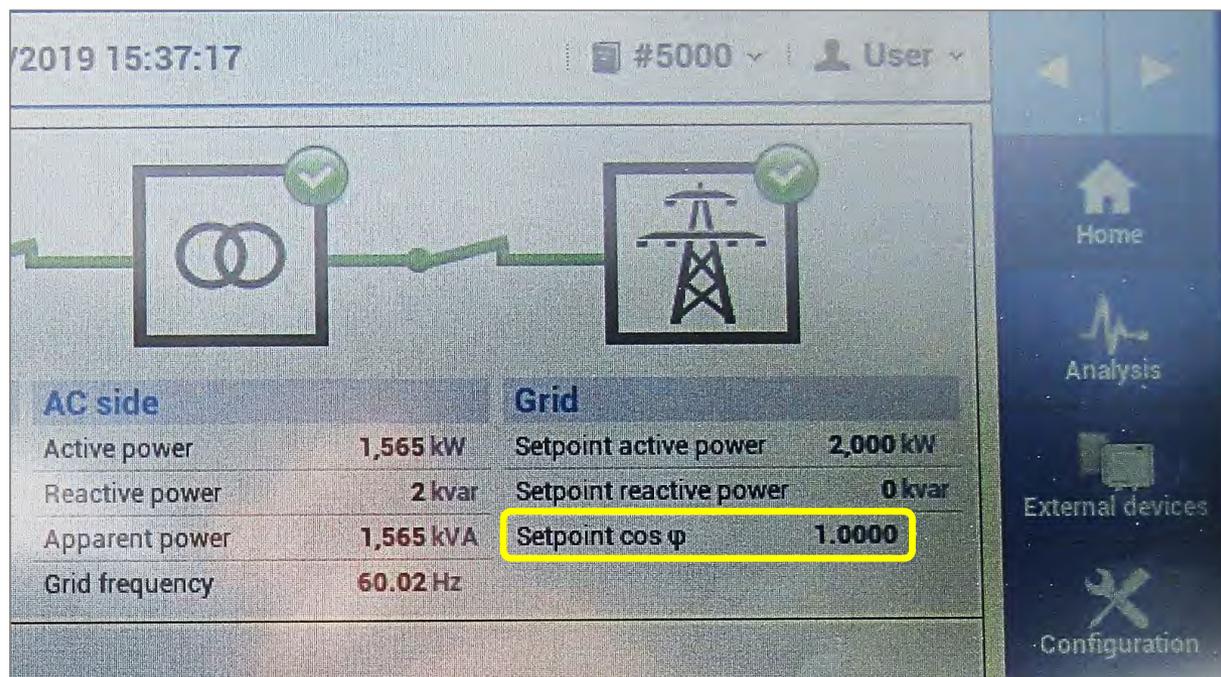
Power Factor

- IA requires 0.98 power factor
- One inverter set to 1.0 with other set to 0.98

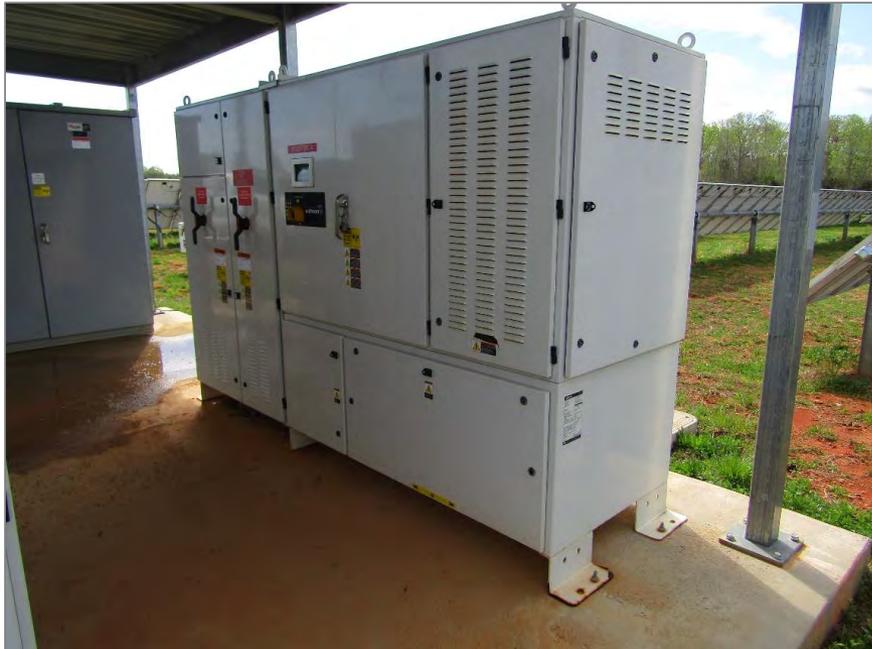
Number of Inverters and Transformers

- 3 MW facility expected but 2.5 MW installed
- (6) AE Solaron 500 inverters expected but only (5) were installed
- (3) 1000 kVA transformers expected but (2) 1000 kVA and (1) 500 kVA installed

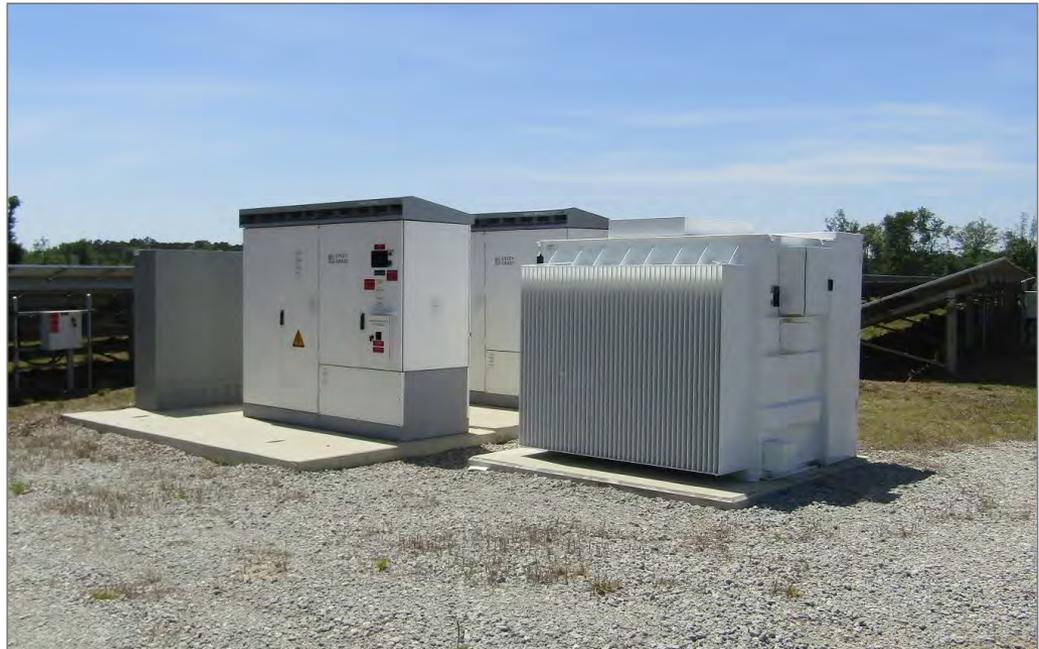
Number and Type of Inverters and Transformers

- (5) AE 1000NX inverters expected but (6) SMA SC800CP installed
- (5) 1000 kVA YG/ yg transformers expected but (3) 1760 kVA YG/y/y installed

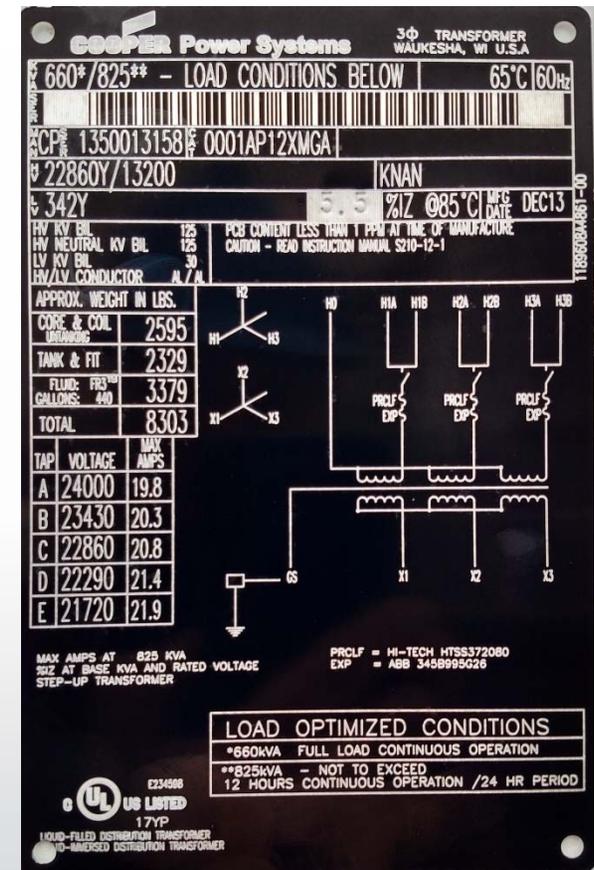
Transformer Requirements

- Inverter manufacturers specify the types of transformers that can be used with their inverters
- Advanced Energy (AE) found that with some transformer types, inverters do not always detect a loss of single phase power on the three phase utility distribution line
- 4 of the 15 sites inspected have a transformer type that desensitizes the inverter's ability to detect a loss of single phase power on a three phase line
- This is a potential safety concern and Duke Energy has taken measures to address the issue

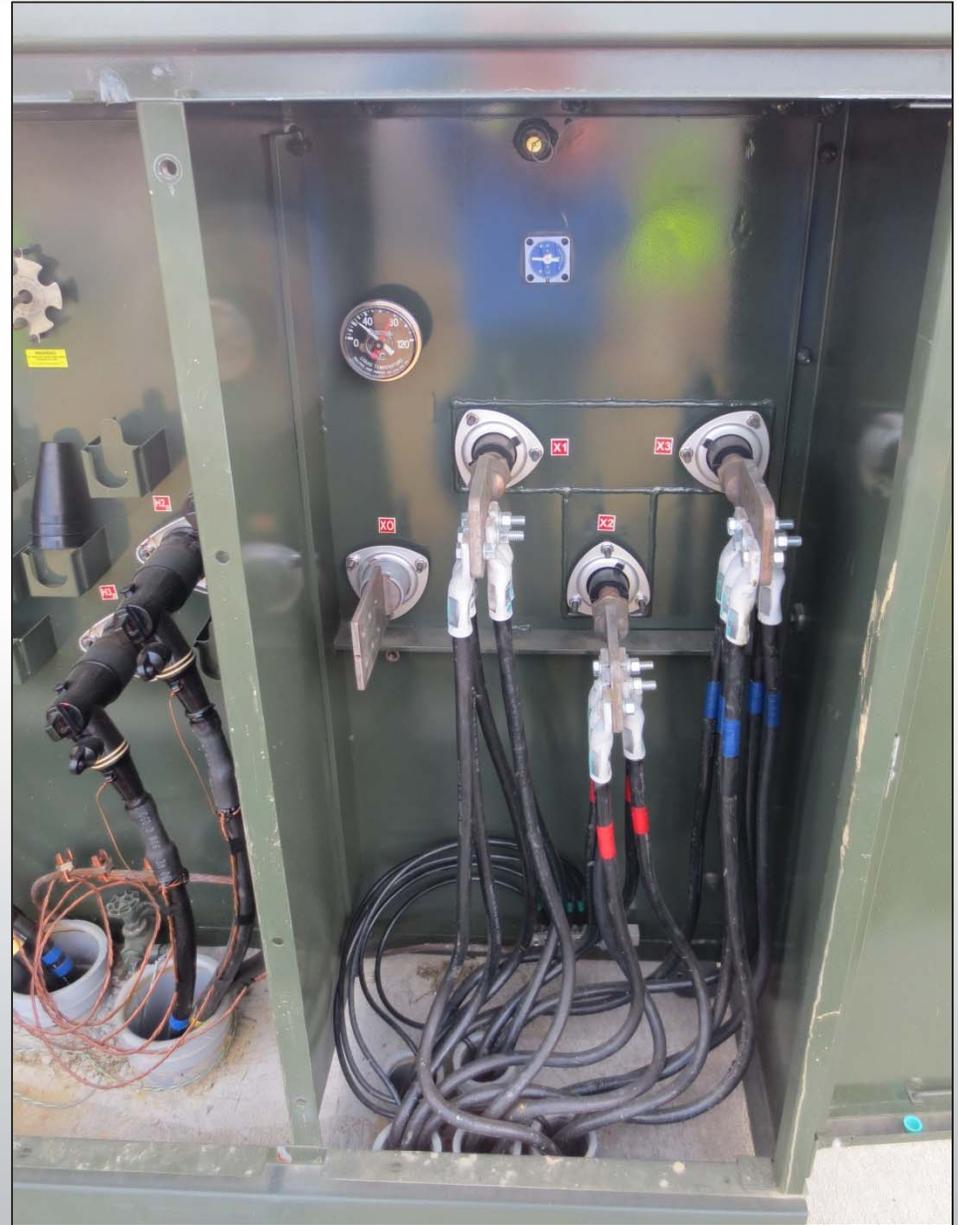
Missing AC Ground Detectors

- 8 of the 15 sites do not have the required AC ground detectors on ungrounded AC inverter feeders

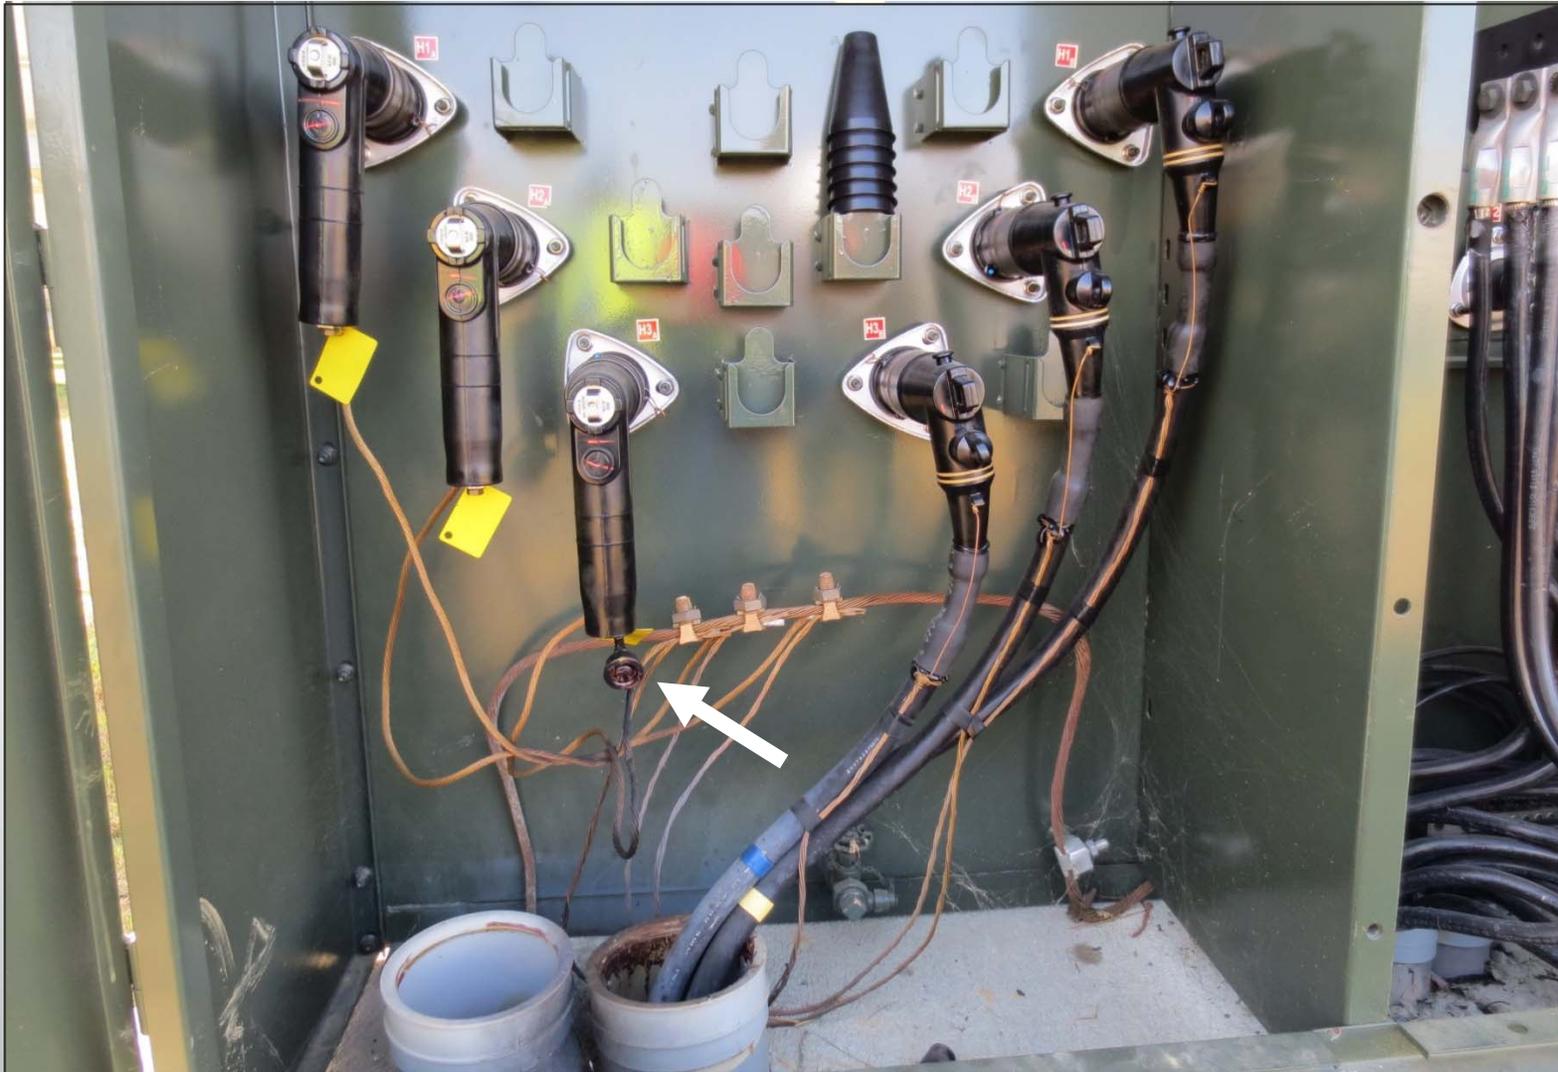
- One surge arrester was blown out

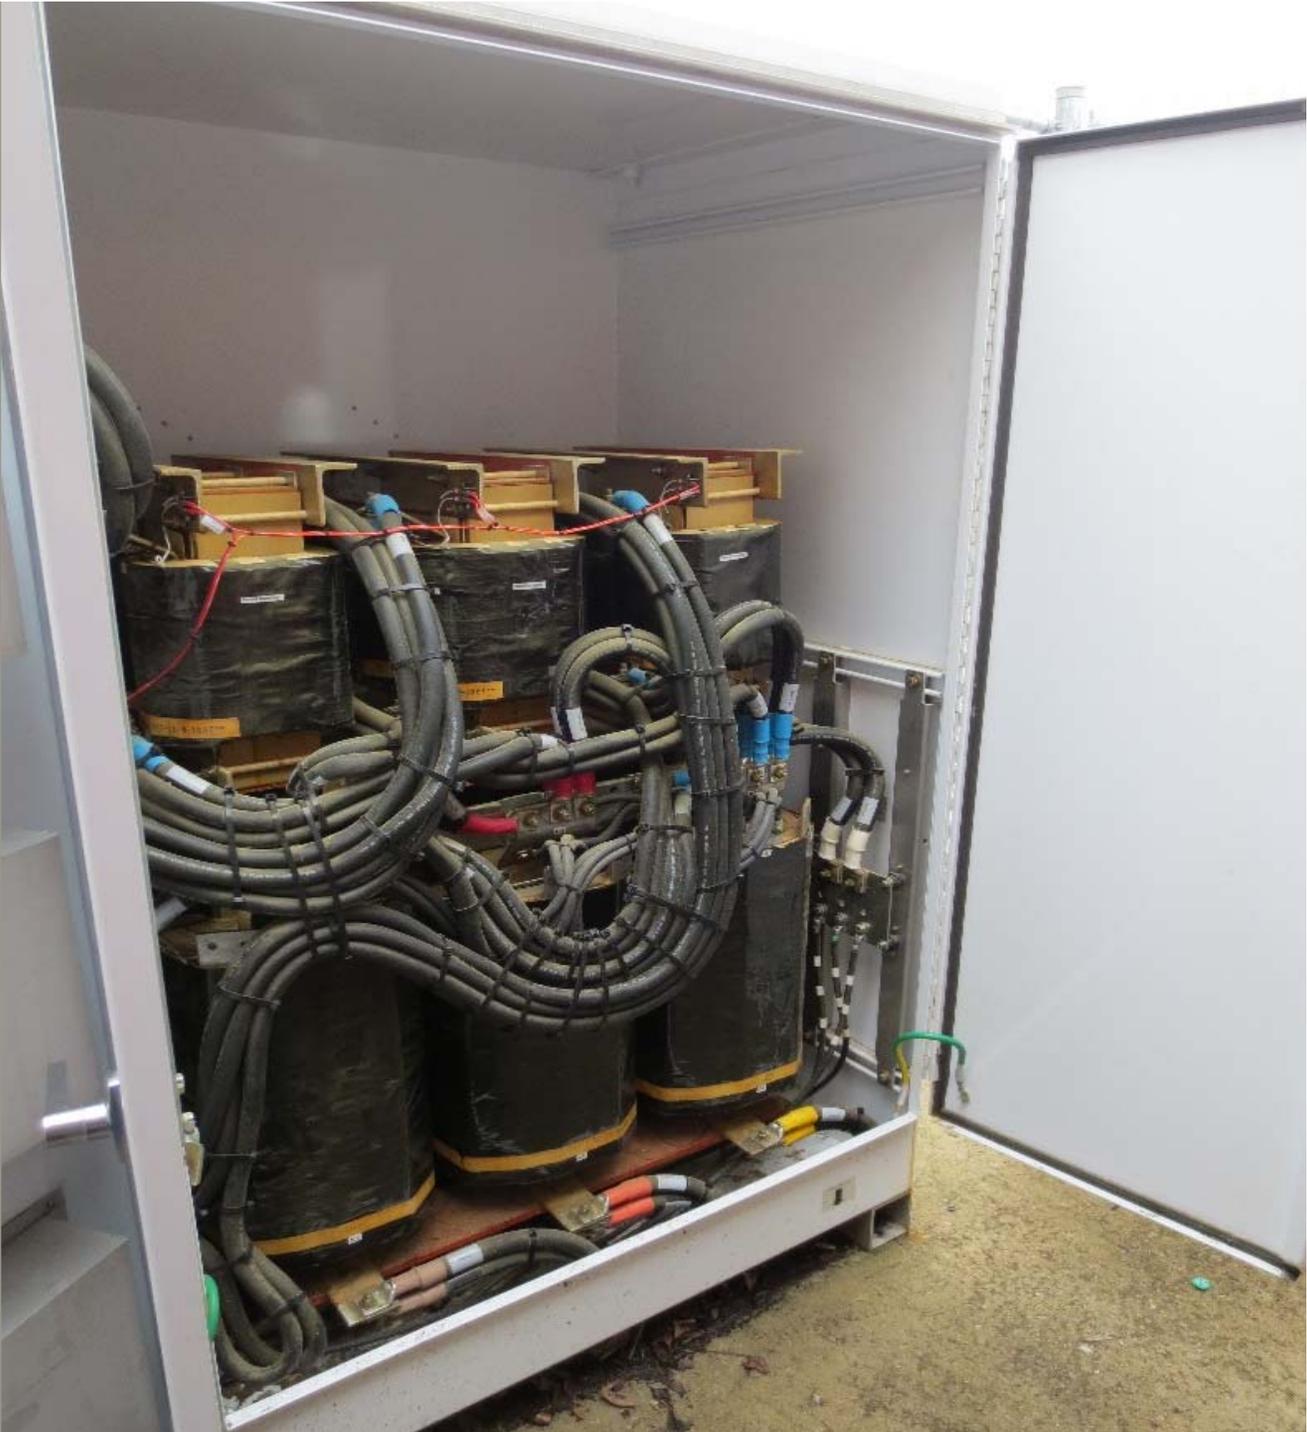
OPEN PHASE DETECTION PROBLEM

- Some inverter manufacturers have documentation cautioning that certain transformer vector groups desensitize the inverter's ability to detect a single open phase condition on the utility distribution feeder
- Grounded Wye/delta (YNd) transformers with delta on the inverter side are known to cause single open phase detection problems for inverters
- SMA cautions Grounded Wye/ungrounded wye (YNY) transformers desensitize the Sunny Central HE and CP inverters to single open phase detection at low power level

One site has a grounded YNd transformer (delta on the inverter side), creating an open phase detection problem

- Loss of a single phase in a three phase utility distribution system is a common occurrence
- Desensitized open phase detection may allow the PV facility to energize an otherwise deenergized phase, resulting in:
 - Reduced power quality for other customers
 - Damage to utility and other customer property
 - Life threatening conditions for the general public and utility personnel
