**RE: Duke Energy Carolinas, LLC's and Duke Energy Progress, LLC's
Comments in Support of Inspections for Legacy Solar Generating
Facilities
Docket No. E-100, Sub 101**

- Present the technical findings from the nine sites in the 2018/2019 periodic inspection pilot
- Provide examples of safety, reliability and power quality issues to look for in a self-inspection
- Not a comprehensive list of all items that could be found in a self-inspection
- Not a training on the self-inspection program details. The self-inspection program is still under development through the 2021 pilot process.

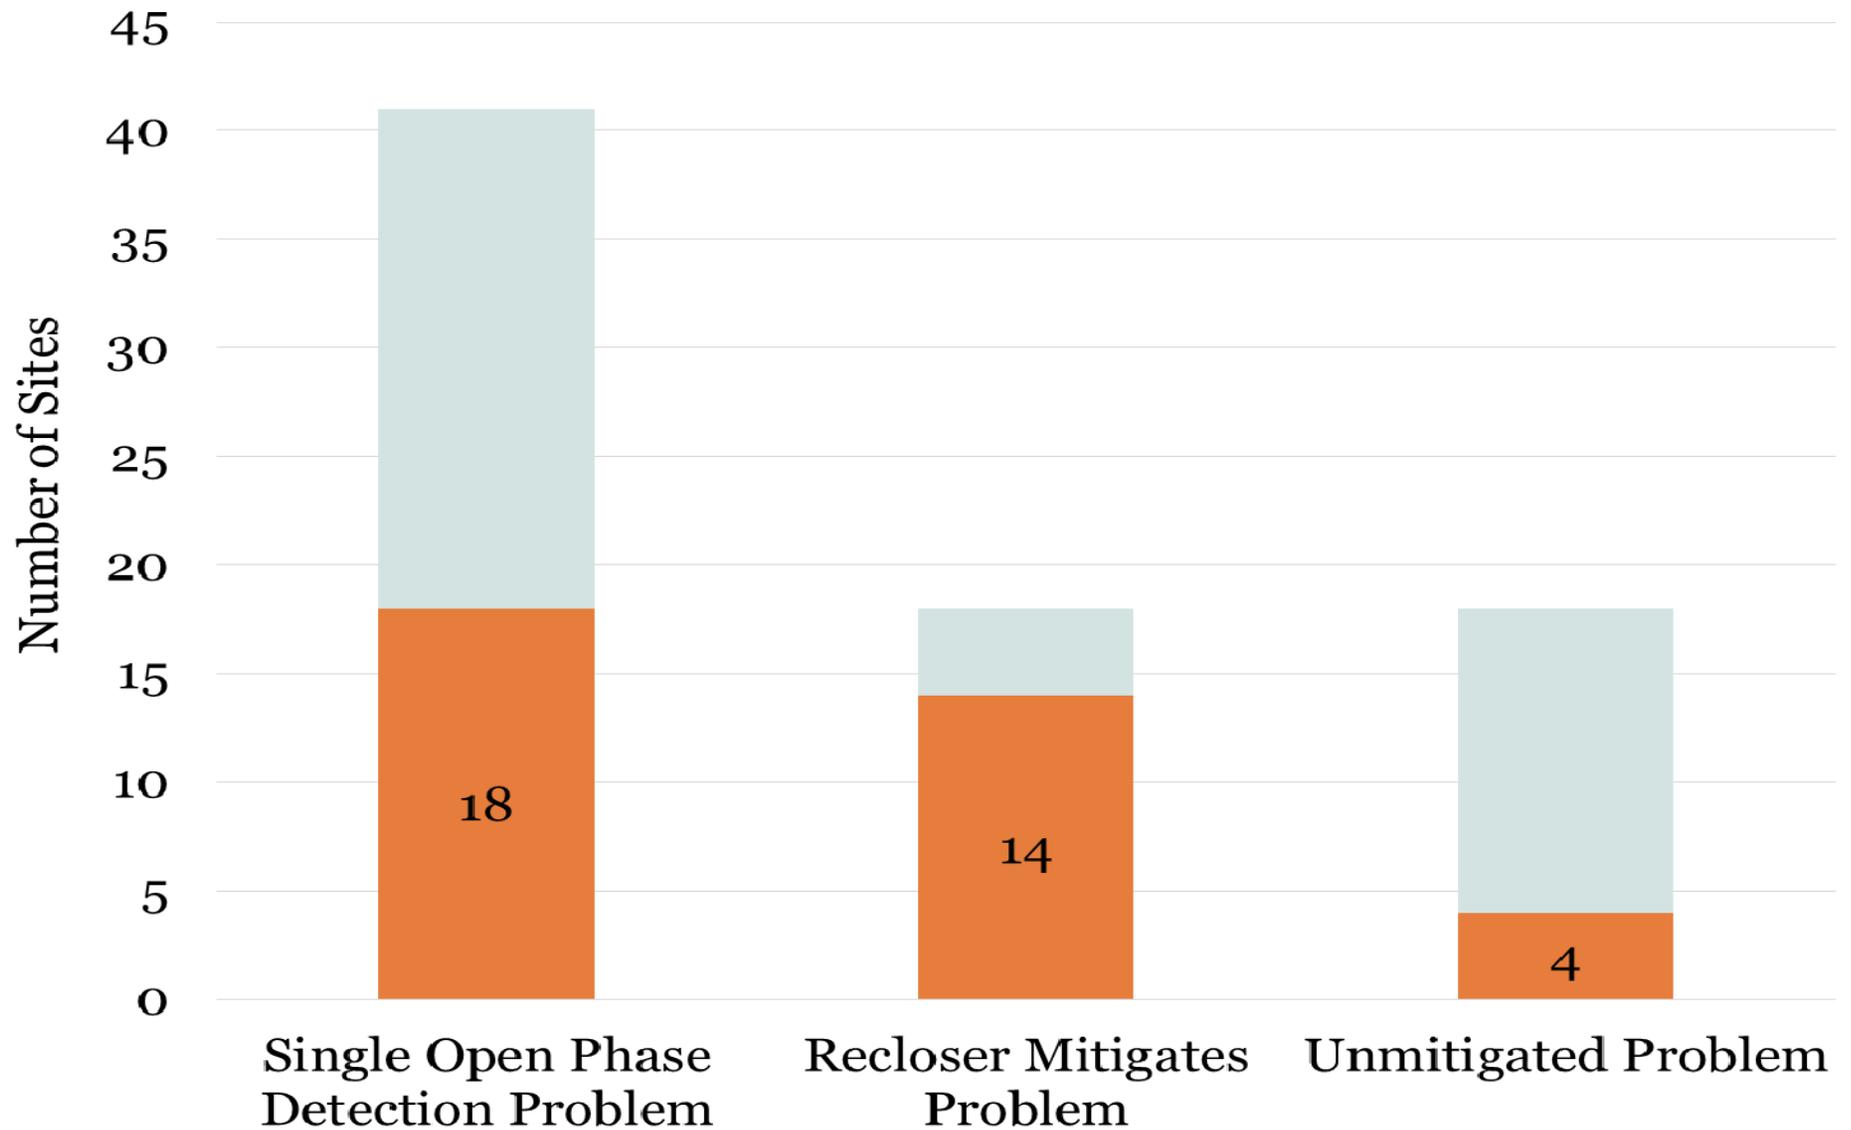
Open Phase Detection Problem

- 17 sites have SMA HE or CP inverters with grounded YNy transformers (grounded on utility side), leading to a single open phase detection problem
- Duke Energy recloser mitigates the problem at most sites

- Loss of a single phase in a three phase utility distribution system is a common occurrence
- Desensitized open phase detection may allow the PV facility to energize an otherwise deenergized phase, resulting in:
 - Reduced power quality for other customers
 - Damage to utility and other customer property
 - Life threatening conditions for the general public and utility personnel
