Century Engineering Evaluation Feb. 28, 2022

Eagle Creek Subdivision Vacuum Sewer Collection System Independent Engineering Evaluation

February 28, 2022

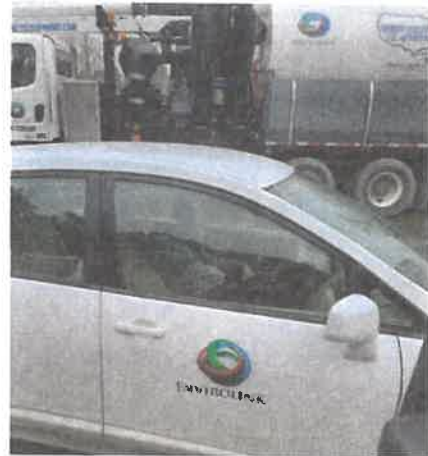
When the Engineer arrived at the vacuum sewer receiving station at 9:30 am on February 4, 2022, the one and only operator at the facility was asleep in his car. It took a few minutes of tapping on the window of the car to wake the operator.

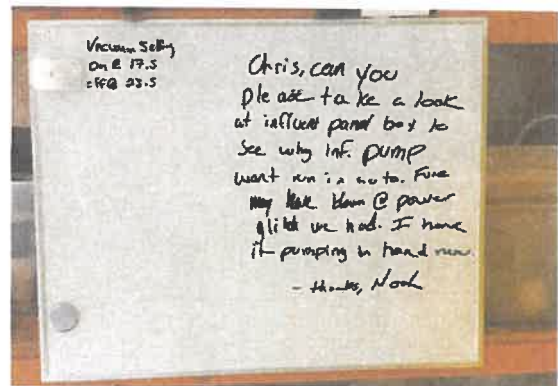
Mounted on wooden shelves on the main floor level of the vacuum sewer receiving station building is a white board for operator instructions, comments and communications. On the white board the lead operator left instructions to an assistant operator as follows: "Chris, can

you please take a look at influent panel box to see why the influent pump won't run in auto.

Fuse may have blown @ power glitch we had. I have it pumping in hand now. Thanks, Noah."

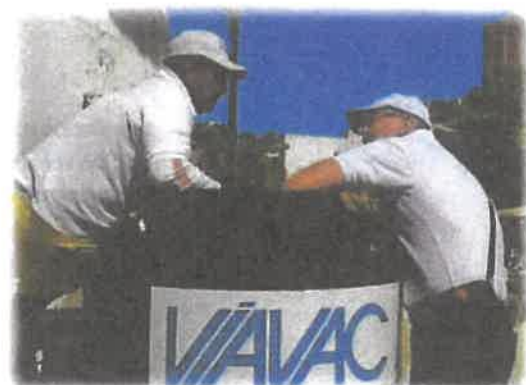
Airvac collector tank in poor condition, with serious leaks of sewage into the subsoil and water table.

VIAVAC/ Vacuflow collection tank supplied; its characteristics and operation were explained to the operating personnel. Immediately highlighting that they work without a vacuum sensor and external vents.

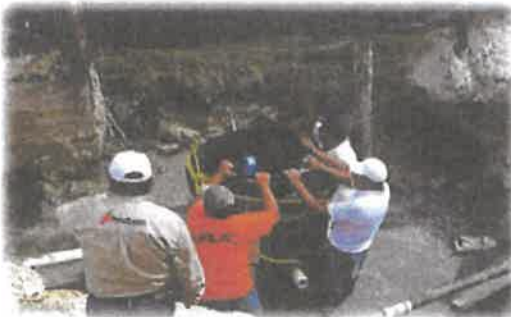
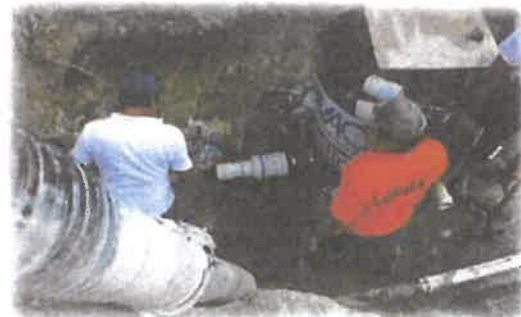
Excavation process, to reach the adequate depth of connection of the gravity lines, it was necessary to open a circumference of approximately 4.00 mt due to the landslides of the sand.

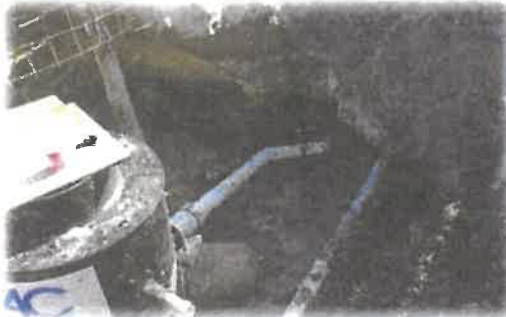
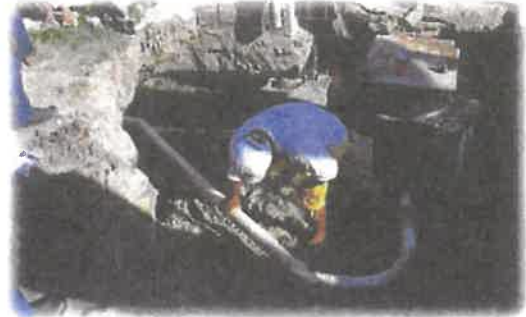
Installation and interconnection process, due to the water table it was difficult to leave the tank in place, it was necessary to use sacks with gravel.

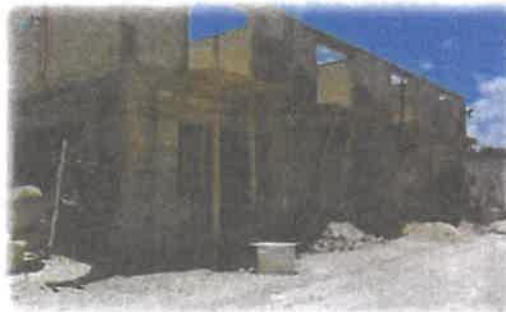
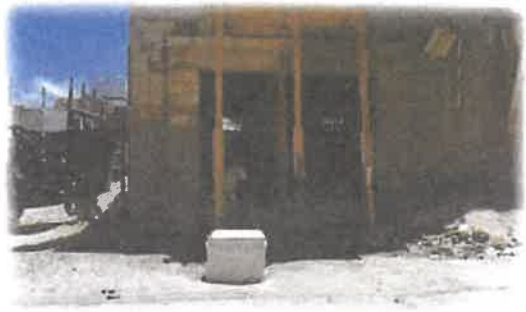
First activation, the VIAVAC/Vacuflow system worked satisfactorily immediately after installation. It was observed to work on three occasions, raising and lowering the float without any problem.

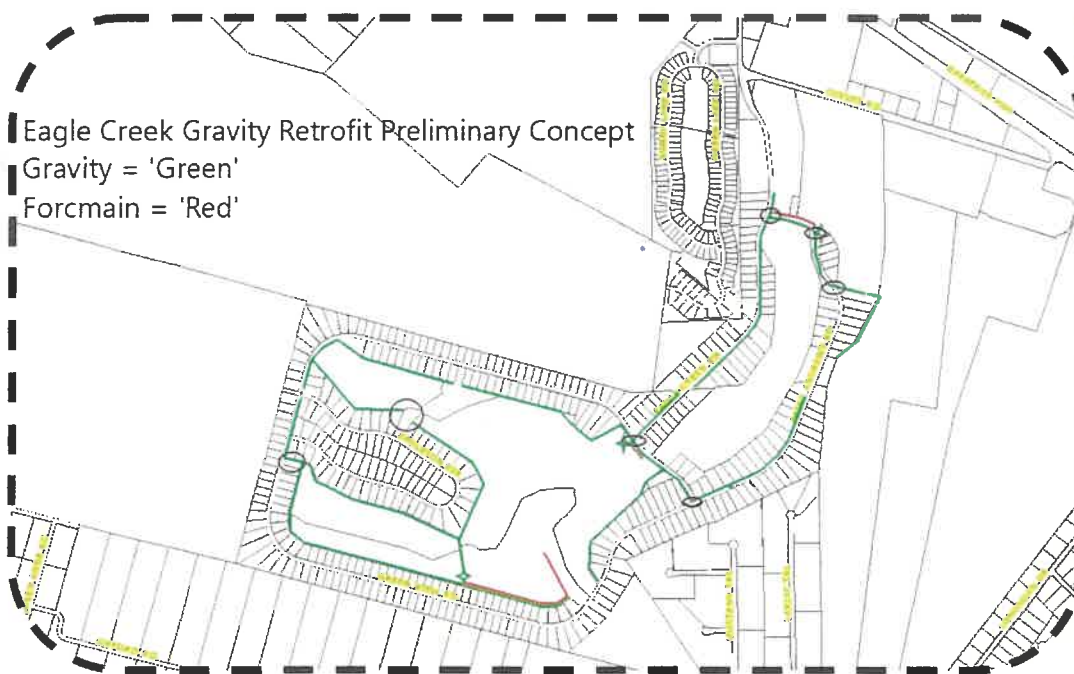
Conceptual Plan for Conversion to Gravity

Eagle Creek Gravity Retrofit Preliminary Concept
Gravity = 'Green'
Forcmain = 'Red'

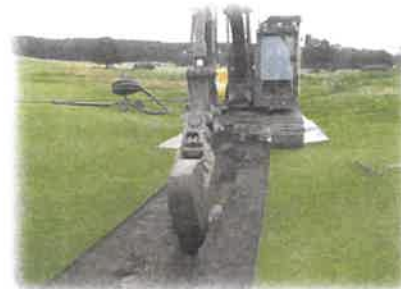
Typical excavation on golf course

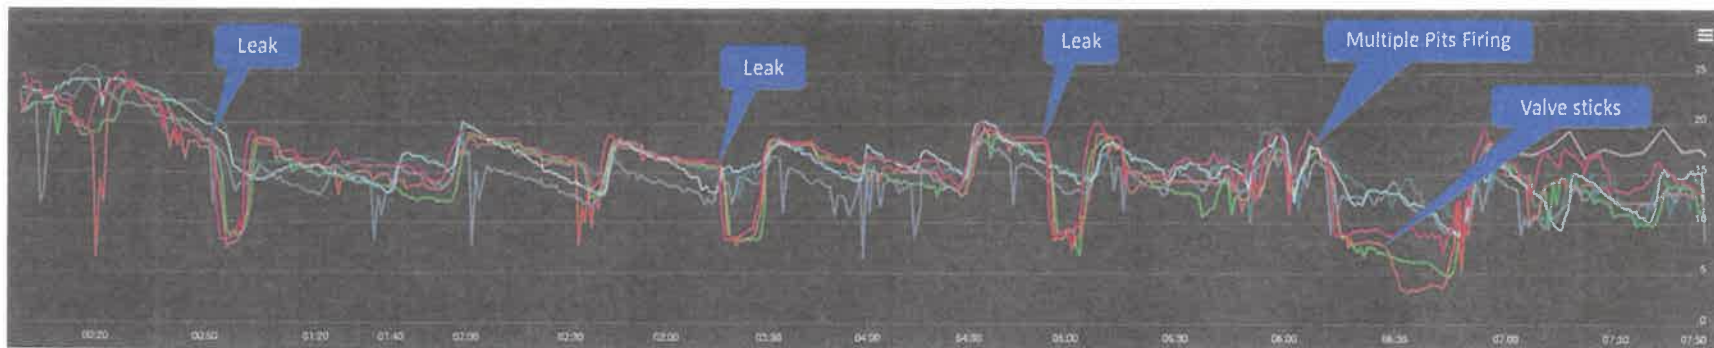
- Time elapsed: 2 minutes
- Vacuum loss: 50%

- Time elapsed: 3 minutes
- Vacuum loss: 52.7%

- Time elapsed: 4 minutes
- Vacuum loss: 52.2%
- Stage 2
 - Time Elapse: 20 min
 - Vacuum Loss: 81.5%
