KRJ, Inc.

In Re: North Carolina Utilities Commission Docket No. W-1075, Sub 12

This narrative is being provided to explain the background of KRJ's water and wastewater systems associated with the above referenced docket, and the methodology that was utilized in the preparation of the General Rate Case thereof.

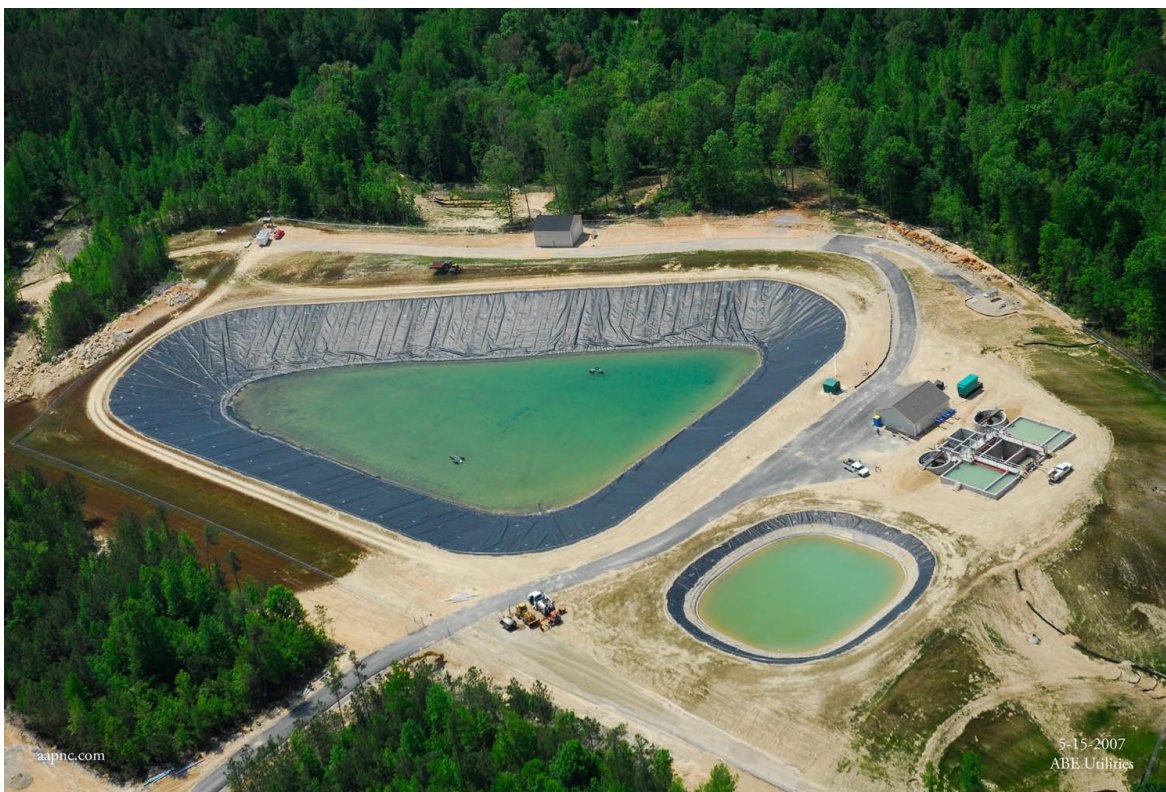
The water treatment building is located at the center top of the above picture, the long term storage pond is in the middle, the operations building to its right, and the water reclamation plant to the right of the operations building. The small square pond in the foreground is the upset pond. For scale, the small white object between the ops building and the upset pond is a full-size pick-up truck.

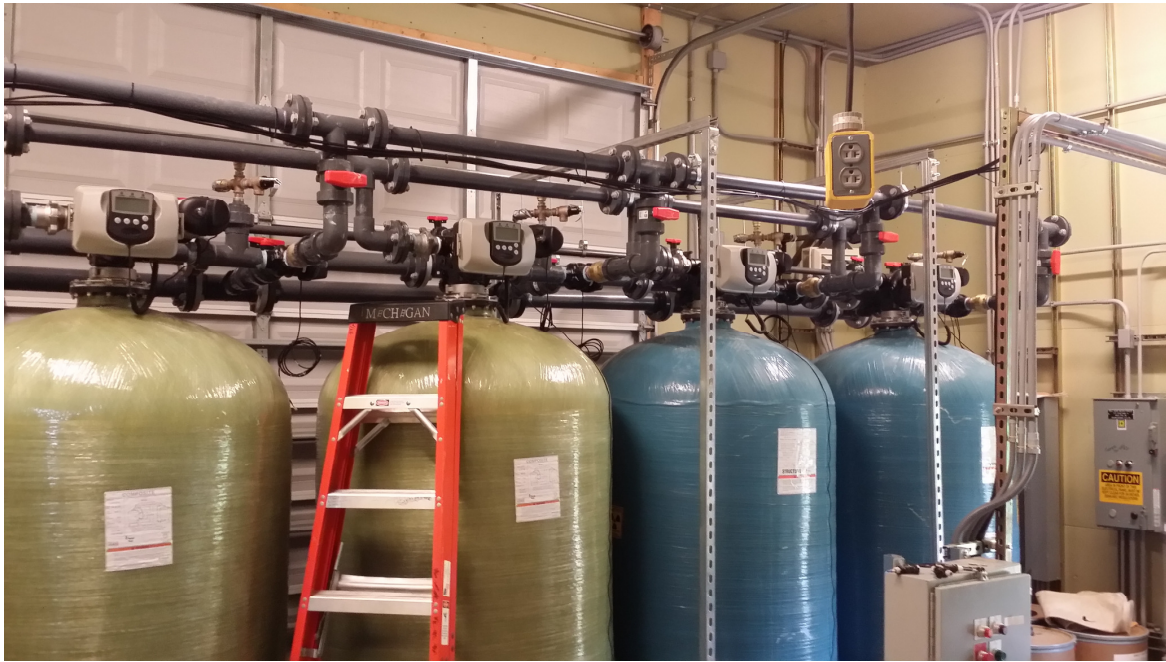
A picture of the completed uranium removal system follows.

The two blue vessels and the alarm panel in front of them are part of the decommissioned uranium removal system for well 1.

In January 2016, a different firm was hired to provide certified operator services for both Southern Trace and Rockbridge. Approximately the same time, JRBea was retained to evaluate and ultimately design a uranium removal system to replace the original system and to treat flow from both wells 1 & 2, rather than well 1, alone, as was the original system. The replacement uranium removal system design involved four ion exchange columns each with automatic control valves, two bag pre-filters, an alarm panel with associated pressure sensors, and a brine tank. The resulting regeneration waste is routed to the sanitary sewer system. Potassium Chloride was selected as the brine salt, to prevent excess sodium being contributed to the reuse fields which could bind the soils.

Several items were re-used from the original non-regenerable system, specifically: two pressure vessels (2 were new), two bag filter units, and the original alarm panel and its associated pressure sensors. The "spent" resin from the original system was removed and disposed of by a duly licensed rad-waste contractor. Once system installation was completed (20-Jun-2016) a 'proving' sample was run using ICPE-MS, due to the near immediate availability of results; the results were exceptional, nearly 100% removal of uranium. The quarterly regulatory sampling beginning with Q3.2016 have returned uranium concentrations uniformly below Regulatory Reporting Level (aka BDL).
